**AIRCRAFT ACCIDENT
INVESTIGATION REPORT**

**SETOUCHI SEAPLANES INC.
JA02TG**

AIRCRAFT DAMAGE DURING WATER LANDING
AT THE SEA SURFACE ABOUT 1.2 KM OFF SAKAIGAHAMA
URASAKI TOWN, ONOMICHI CITY,
HIROSHIMA PREFECTURE, JAPAN
AT AROUND 11:13 JST, APRIL 15, 2018

SETOUCHI SEAPLANES INC.
QUEST KODIAK 100 (AMPHIBIAN), JA02TG

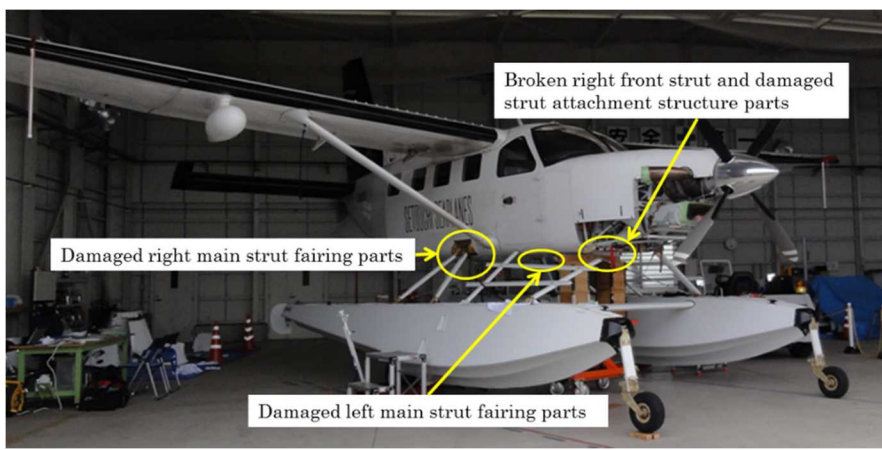
2.2 Injuries to Persons	None
2.3 Damage to Aircraft	<p>Extent of damage: Substantial damage</p> <ol style="list-style-type: none"> 1. Right front strut; Broken 2. Right front strut attachment structure parts; Damaged 3. Fairings of left and right main struts; Damaged

<p style="text-align: center;">Photo 1: Damaged parts of the Aircraft</p>

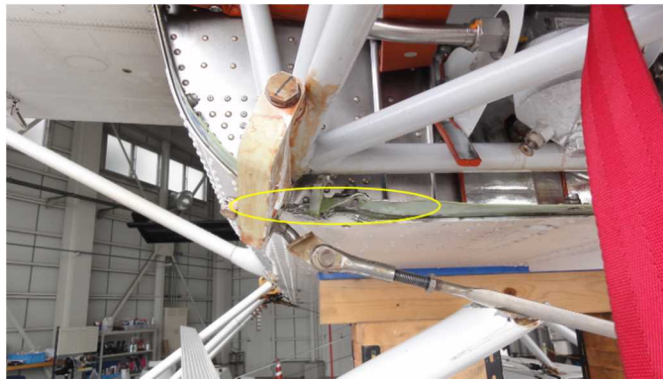
Photo 2: Damaged right front strut attachment structure parts

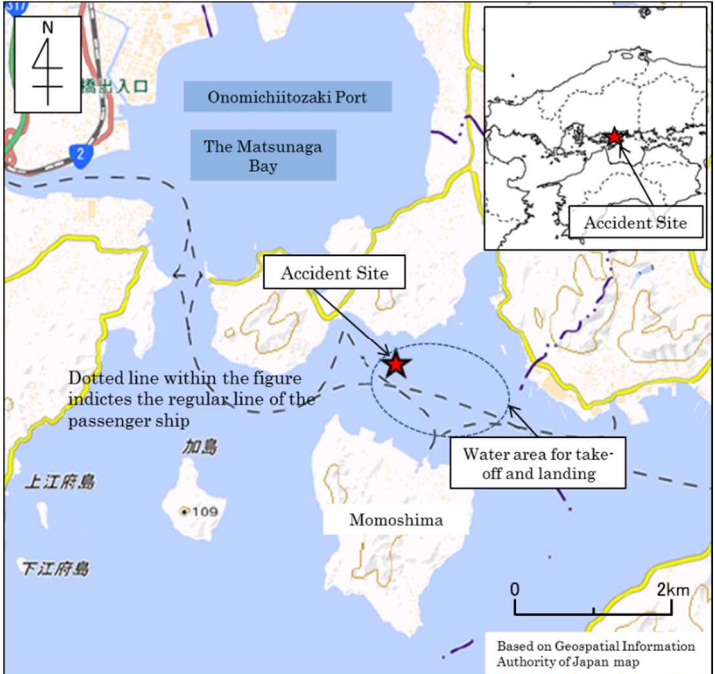
Figure 1: Accident Site

The accident site was at the sea surface about 1.2 km westward of the Company's pier in Sakaigahama, Urasaki Town, Onomichi City, Hiroshima Prefecture; and the site was in the vicinity of central part of sea surface, which is surrounded by several lands with small hills and islands; and there is a channel (approximately 1 km width) opening from the west to the southeast in this water area, where the Company usually uses for take-offs and landings of its aircraft. As being close to every land located in the north or the south, this water area has geographical features that the winds blowing from north or south tend to change the direction and velocity due to the effects of those surrounding lands.
