**AIRCRAFT SERIOUS INCIDENT
INVESTIGATION REPORT**

**JETSTAR JAPAN CO., LTD.
JA04JJ**

UNRELIABLE AIRSPEED ON BOTH THE CAPTAIN'S SIDE AND THE
CO-PILOT'S SIDE
AT AN ALTITUDE OF 37,000 FT, 96 KM SOUTH-SOUTHEAST OF
CHUBU CENTRAIR INTERNATIONAL AIRPORT
AT 09:38 JST, JULY 9, 2016

JETSTAR JAPAN CO., LTD.
AIRBUS A320-232, JA04JJ

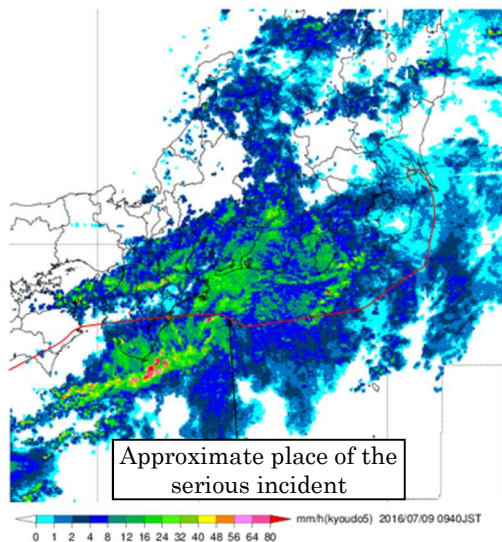
Figure 4: Composite chart of echo intensity chart and estimated flight path

to as “the echo peak altitude chart”), there was an echo with a peak altitude of 12 to 14 km (39,370 to 45,931 ft) at directly south of the area near the place of the serious incident at 9:40 (JST). (See Figure 5 Composite chart of echo peak altitude chart and estimated flight path.)

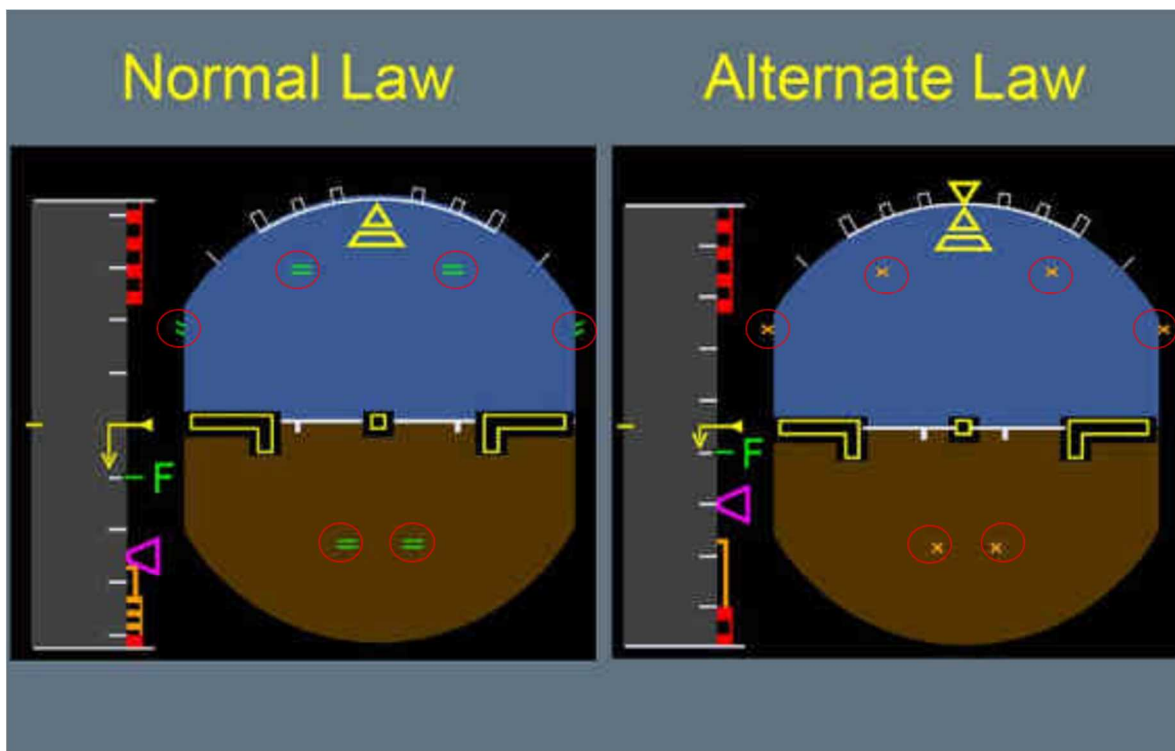
The unreliable airspeed indication that occurred on the Aircraft caused the Law of the computer to change from the Normal Law to the Alternate Law. As a result, the protection function to prevent stalling (high angle of attack protection) and the protection function to prevent overspeed (high speed protection) stopped, the caution message “F/CTL ALTERNATE LAW” appeared on the ECAM, and an amber “x” mark was displayed on the PFD. (See Figure 8 Change from Normal Law to Alternate Law displayed on the PFD.)

Inside red circles
Normally, green “=” marks are displayed.

Inside red circles
Green “=” marks change to amber “x” marks.

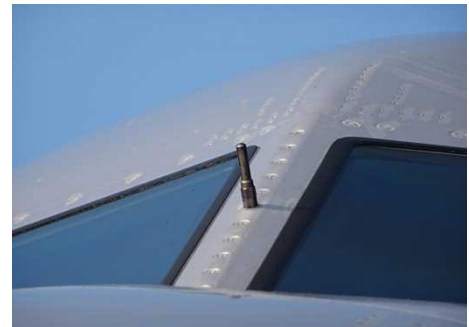
Photo 1: Ice Indicator on the Aircraft

The ice indicator on the Aircraft is the protruding part on the outside of the front cockpit window, which is used by the Captain and Co-Pilot to visually check for icing. (Refer to Photo 1 Ice indicator on the Aircraft.)
