**AIRCRAFT SERIOUS INCIDENT
INVESTIGATION REPORT**

**FUJI DREAM AIRLINES CO., LTD.
J A 0 6 F J**

ABNORMAL DECOMPRESSION INSIDE AN AIRCRAFT AT AN ALTITUDE ABOUT 33,000 FT ABOVE SEA AT ABOUT 100 KM SOUTHWEST OF AKITA AIRPORT AT AROUND 15:24 JST, JULY 7, 2015 FUJI DREAM AIRLINES CO., LTD. EMBRAER ERJ170-200STD, JA06FJ

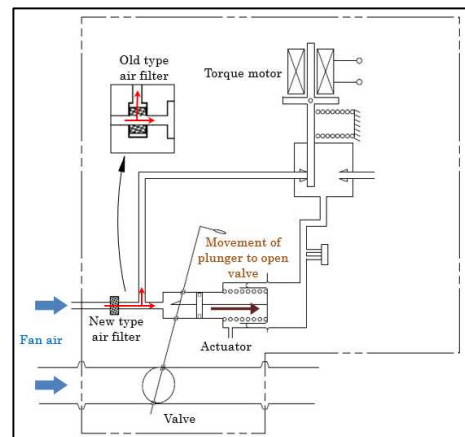
Figure 2 Fan Air Valve Internal Structure

In the investigation of the both fan air valves, the change of air pressure that controlled the valve in response to current running in the torque motor was measured. It was confirmed that the value exceeding the prescribed value was measured at both of the fan air valves. The inspection of the valve opening revealed that the both of fan air valves could not be fully opened and the left fan air valve could not be fully closed. In both of fan air valves, abrasion and corrosion were found on the linkage, and, in addition, small amount of fine particles were found on the air filter inside of the valve.

- (i) Abrasion and corrosion found on the linkage of the right and left fan air valves brought adverse impact on the operation of the valve.
- (ii) The torque motor could not operate as directed by the signal from the AMS controller because the valve could not be fully opened and air pressure to operate the valve was sometimes not as prescribed.
- (iii) Left and right fan air valves were attached to the old type air filter, so fan air sent to the actuator was not filtered out, the particles entered the inside of the fan air valve and affected the operation of the valve.
- (iv) Deterioration of the torque motor by the heat influence from the precooler.

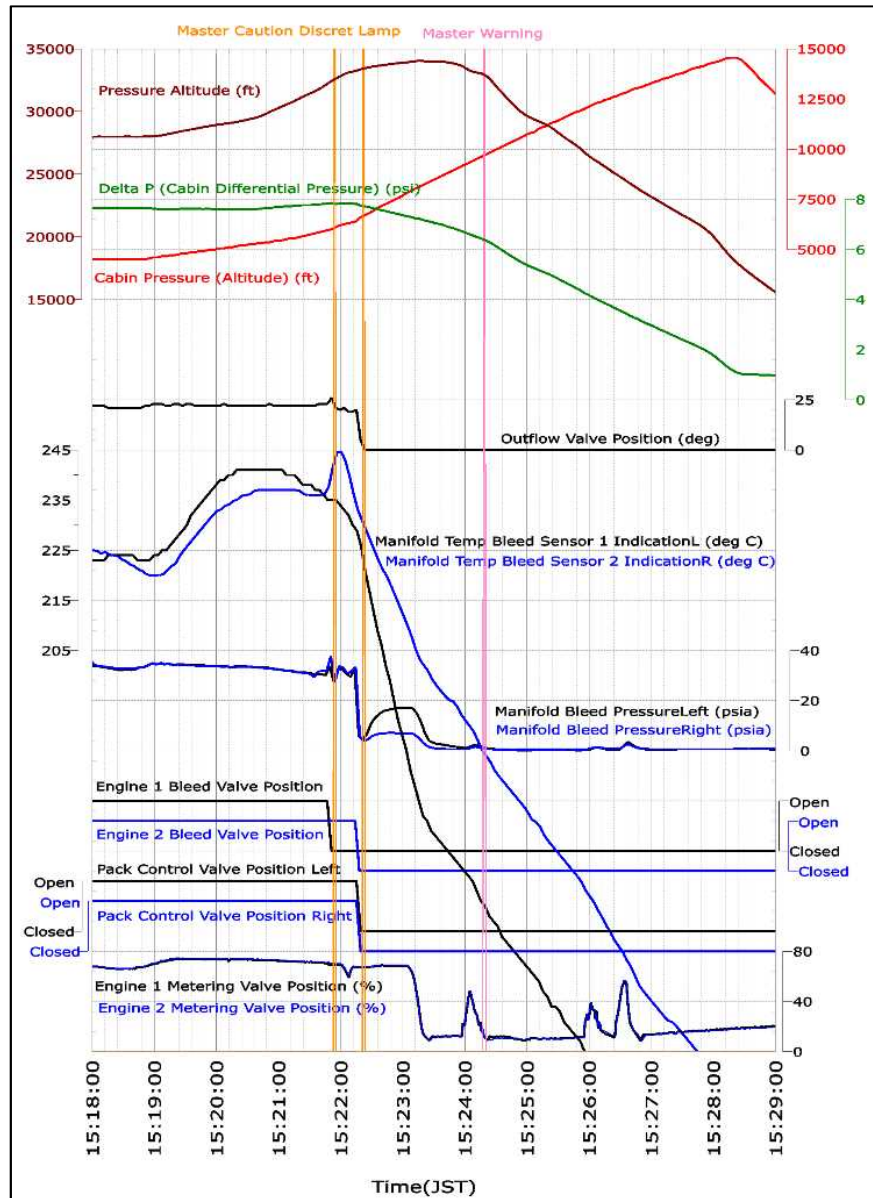
Figure 3 Data recorded in Flight Recorder

At 15:21:53, the message, "BLEED 1 FAIL" was displayed followed by the closure of No. 1 NAPRSOV. In about 30 seconds the message "BLEED 2 FAIL" was displayed and the bleed air was stopped due to the closure of No. 2 NAPRSOV.

The cabin altitude of the Aircraft kept rising, and at 15:24:18 the EICAS message, "CABIN ALT HI" indicating that the cabin altitude exceeded 9,700 ft was displayed. The highest cabin altitude was 14,550 ft. (See Figure 3.)

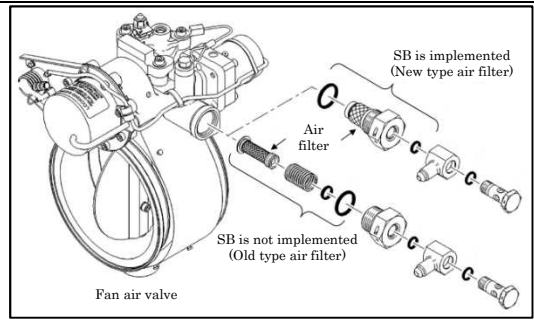
Figure 4 Air Filter

The NTSB examined the fine particles found on the air filter with the scanning electron microscope and it was found that the particles were mainly composed of silicon and aluminum. In addition, sodium oxide, potassium, magnesium, and iron were also found. The form and composition of these fine particles were similar to those of volcanic ashes.

this Service Bulletin does not require the "MANDATORY" action, the Company was planning to replace the fan air valve installed the new type of air filter when it became necessary to replace the fan air valve. The right and left air filter installed to the Aircraft were the old type air filter.

The quality of the torque motor has been improved and AMS software has been modified by 2010, and the Service Bulletin (SB170-36-0021) has been issued, in which it is recommended to replace the air filter inside of the valve with new type of air filter that has wider surface area and smaller mesh size in order to enhance the filtration capacity. Because
