**AIRCRAFT SERIOUS INCIDENT
INVESTIGATION REPORT**

**JAPAN AIR COMMUTER CO., LTD.
JA07JC**

RUNNING OFF THE SIDE OF RUNWAY JAPAN AIR COMMUTER CO., LTD. ATR 42-500, JA07JC AMAMI AIRPORT, KAGOSHIMA PREFECTURE ABOUT 10:01 JST, JANUARY 8, 2020

February 25, 2022

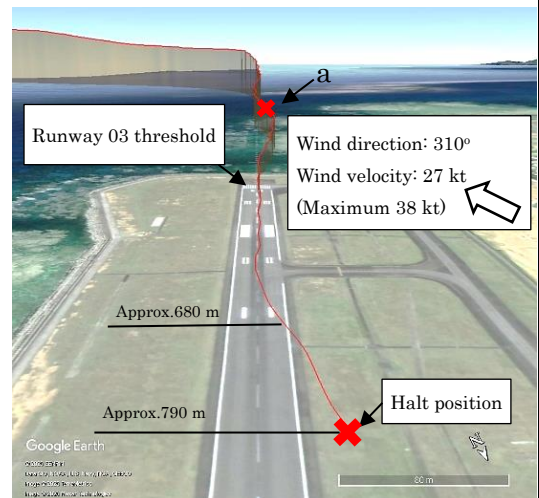
Figure 2 Estimated flight route (1)

The FO performed a deviation call against the speed at an altitude of about 300 ft and recognized that the Aircraft was deviating to the left of the final approach course (see Figures 2 a, 3 a, and 4 a)

The Aircraft flew returning its flight path to the right at an altitude around 250 ft and passed over the vicinity of the threshold while flying on almost the final approach course at approximately 50 ft AGL with bank angle at approximately 4° to the left and magnetic heading at approximately 023°.

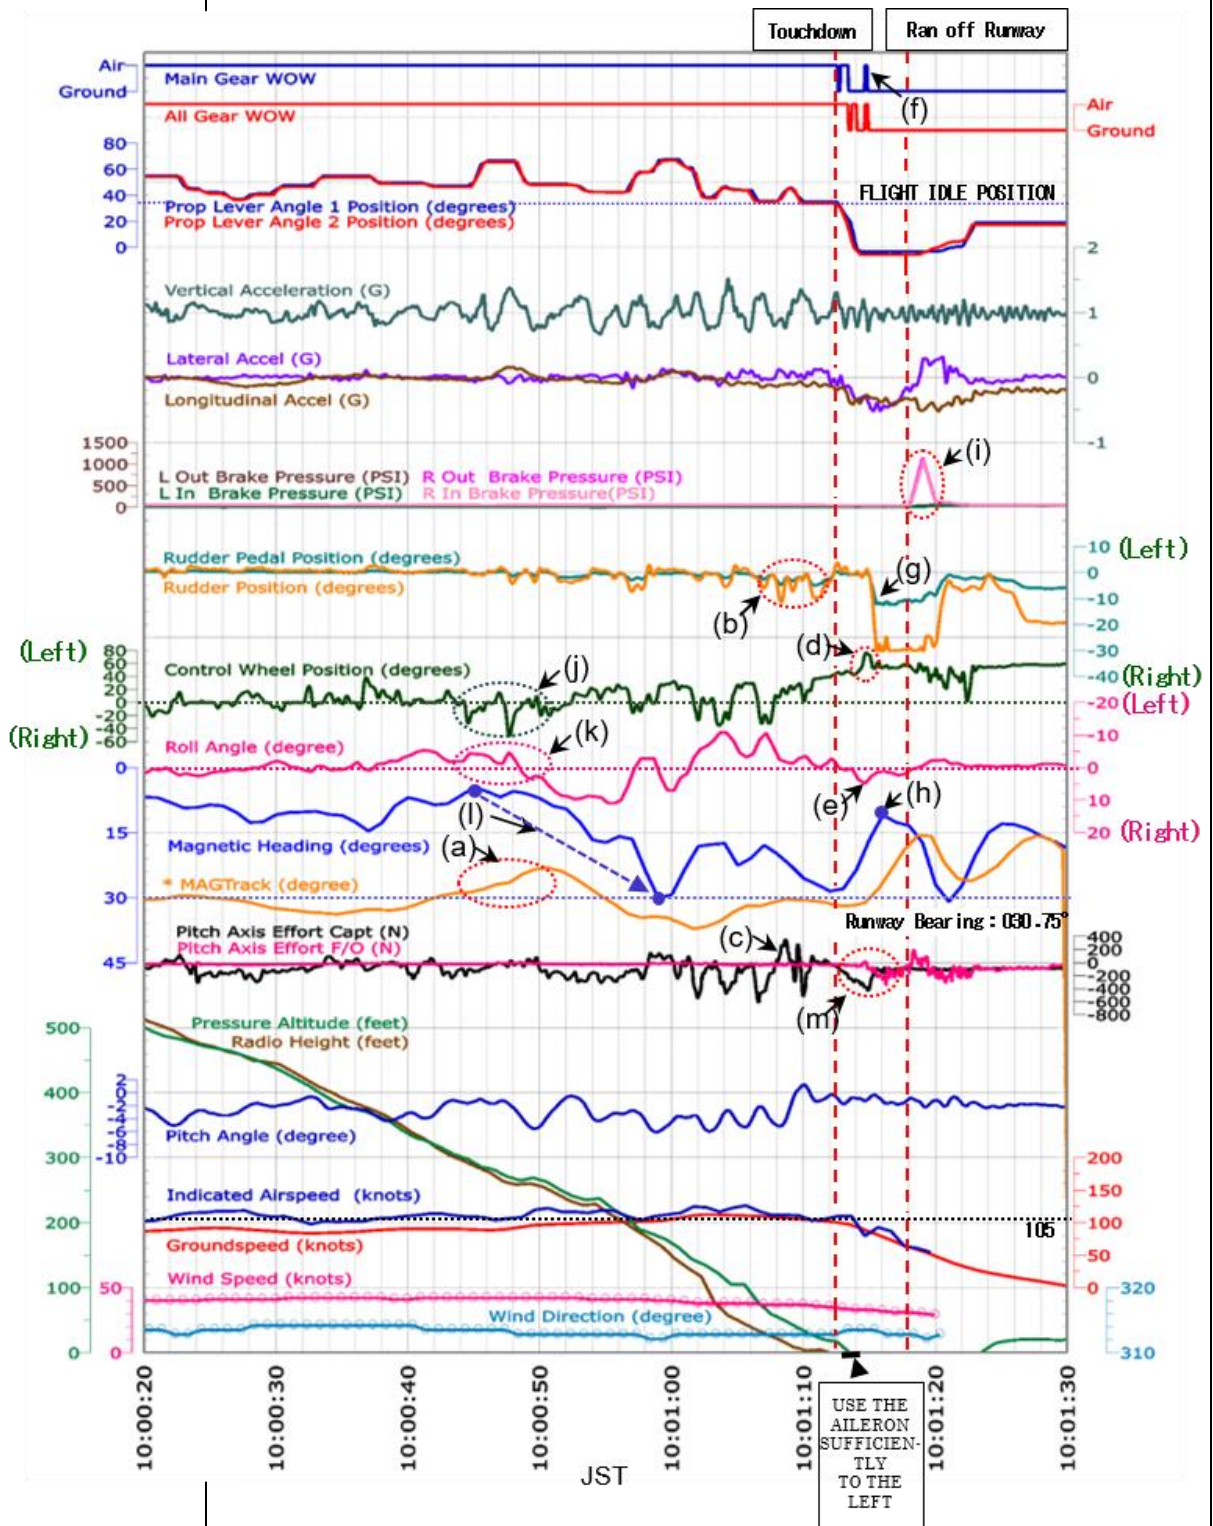
Figure 4 FDR record

The right rudder pedal of the Aircraft was applied at approximately 30 ft AGL (see Figure 4 b), and the elevators were moved in the nose-up direction at around 20 ft AGL (see Figure 4 c). When the Aircraft touched down from the left main wheel almost on the runway centerline at approximately 400 m from the threshold of Runway 03, the engines’ power were in the flight idle position, the rudder pedals were in the nearly neutral position, the bank angle was approximately 2.6° to the left, and the magnetic heading was approximately 029°. Approximately one second later, the weight on wheels*2 (WOW) of all gears changed to the ground mode.

Around this time, the attitude of the Aircraft began to bank to the right, and the control wheel input of the Aircraft to the left increased (see Figure 4d), however, the right roll angle of the Aircraft increased to about 5° (see Figure 4e).), and the magnetic heading changed to about 019°. In addition, the WOW of either of the main landing gears temporarily changed to the air mode (see Figure 4 f).

Approximately three seconds after the touchdown, the captain fully pushed the right rudder pedal kept using reverse (see Figure 4 g). The magnetic heading of the Aircraft began to change toward the runway centerline after it had changed to 011° approximately four seconds after the touchdown (see Figure 4 h). The captain continued pushing the right rudder pedal and simultaneously used the nosewheel steering and the right brake only (see Figure 4i). The status of the nosewheel steering was not recorded in the FDR.

It is probable, however, that because the right rudder pedal input was reduced for de-crab and the rudder pedals were in an almost neutral position when touching down from the left main wheel, the Aircraft changed its heading to the left because of weathercock effect. Besides, although the control wheel was deflected into the wind (left) after the touchdown, the bank to the right became a maximum of about 5° about 2 seconds after the touchdown, and the attitude continued banking to the right until 6 seconds

after the touchdown, therefore, it is probable that the control wheel input against crosswinds was not sufficient, and the yawing to the left added to weathercock effect, the heading changed about 18° into the wind in about 4 seconds after the touchdown and became 011°.

Both the captain and FO remembered that the captain called, “YOU HAVE CONTROL,” which, however, was not recorded in CVR. On the other hand, the captain’s voice of, “USE THE AILERON SUFFICIENTLY TO THE LEFT,” was recorded in CVR almost simultaneously with the touchdown, which the captain is likely to have called, instead of, “YOU HAVE CONTROL,” intending to transfer handling of control wheel and control column to the FO. It is, however, likely that the captain’s intention was not immediately and clearly understood by the FO since the FO’s response to the captain’s call was not recorded in CVR. Besides, it is probable that the captain, even after having called, “USE THE AILERON SUFFICIENTLY TO THE LEFT,” continued nose-down input for approximately three seconds after the touchdown, and the FO added nose-down input into the control column when the captain’s input into control column began to cease (see Figure 4 m).

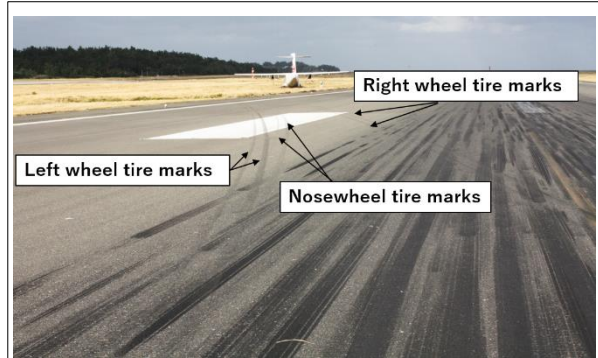
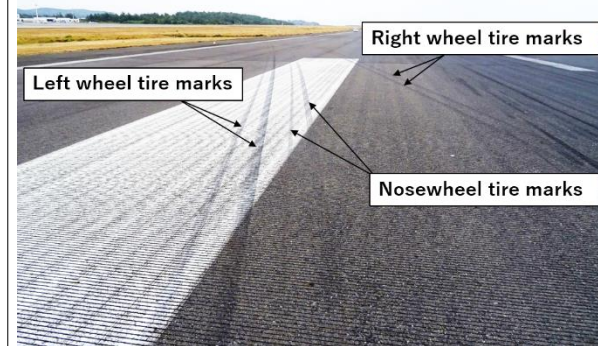
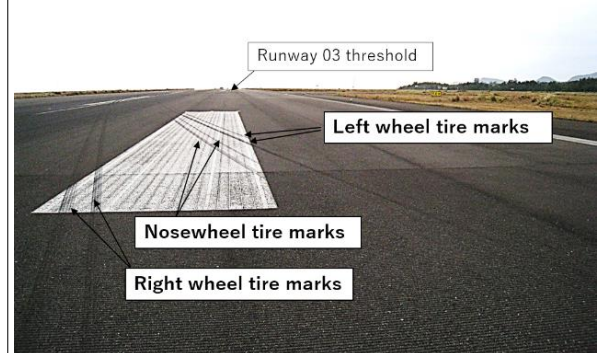
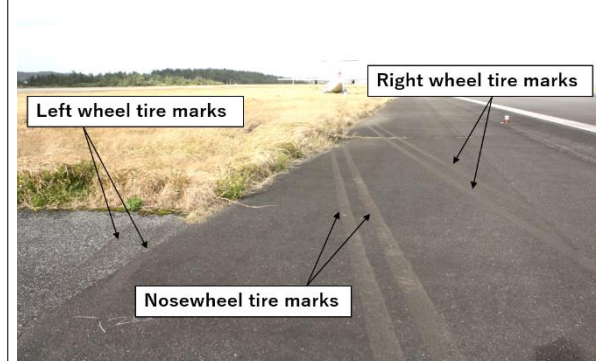
Figure 5 Tire Marks

The Aircraft, however, entered a grassy area on the left side of the runway beyond the runway side stripe marking*⁴, came to a stop, and was disabled to perform taxiing.

From what is described above, the JTSB concludes that the Aircraft most likely ran off the side of the runway, halted in the grassy area, and was disabled to move on its own because the correction for the deviation to the left immediately after the touchdown was delayed.
