AIRCRAFT SERIOUS INCIDENT INVESTIGATION REPORT

ALL NIPPON AIRWAYS FLIGHT 198
AIRBUS INDUSTRIE A321 – 131, JA102A
AIR ABOVE APPROXIMATELY 90 KILOMETERS EAST-SOUTHEAST OF
CHUBU INTERNATIONAL AIRPORT
SEPTEMBER 29, 2005

July 28, 2006

Aircraft and Railway Accidents Investigation Commission
Ministry of Land, Infrastructure and Transport

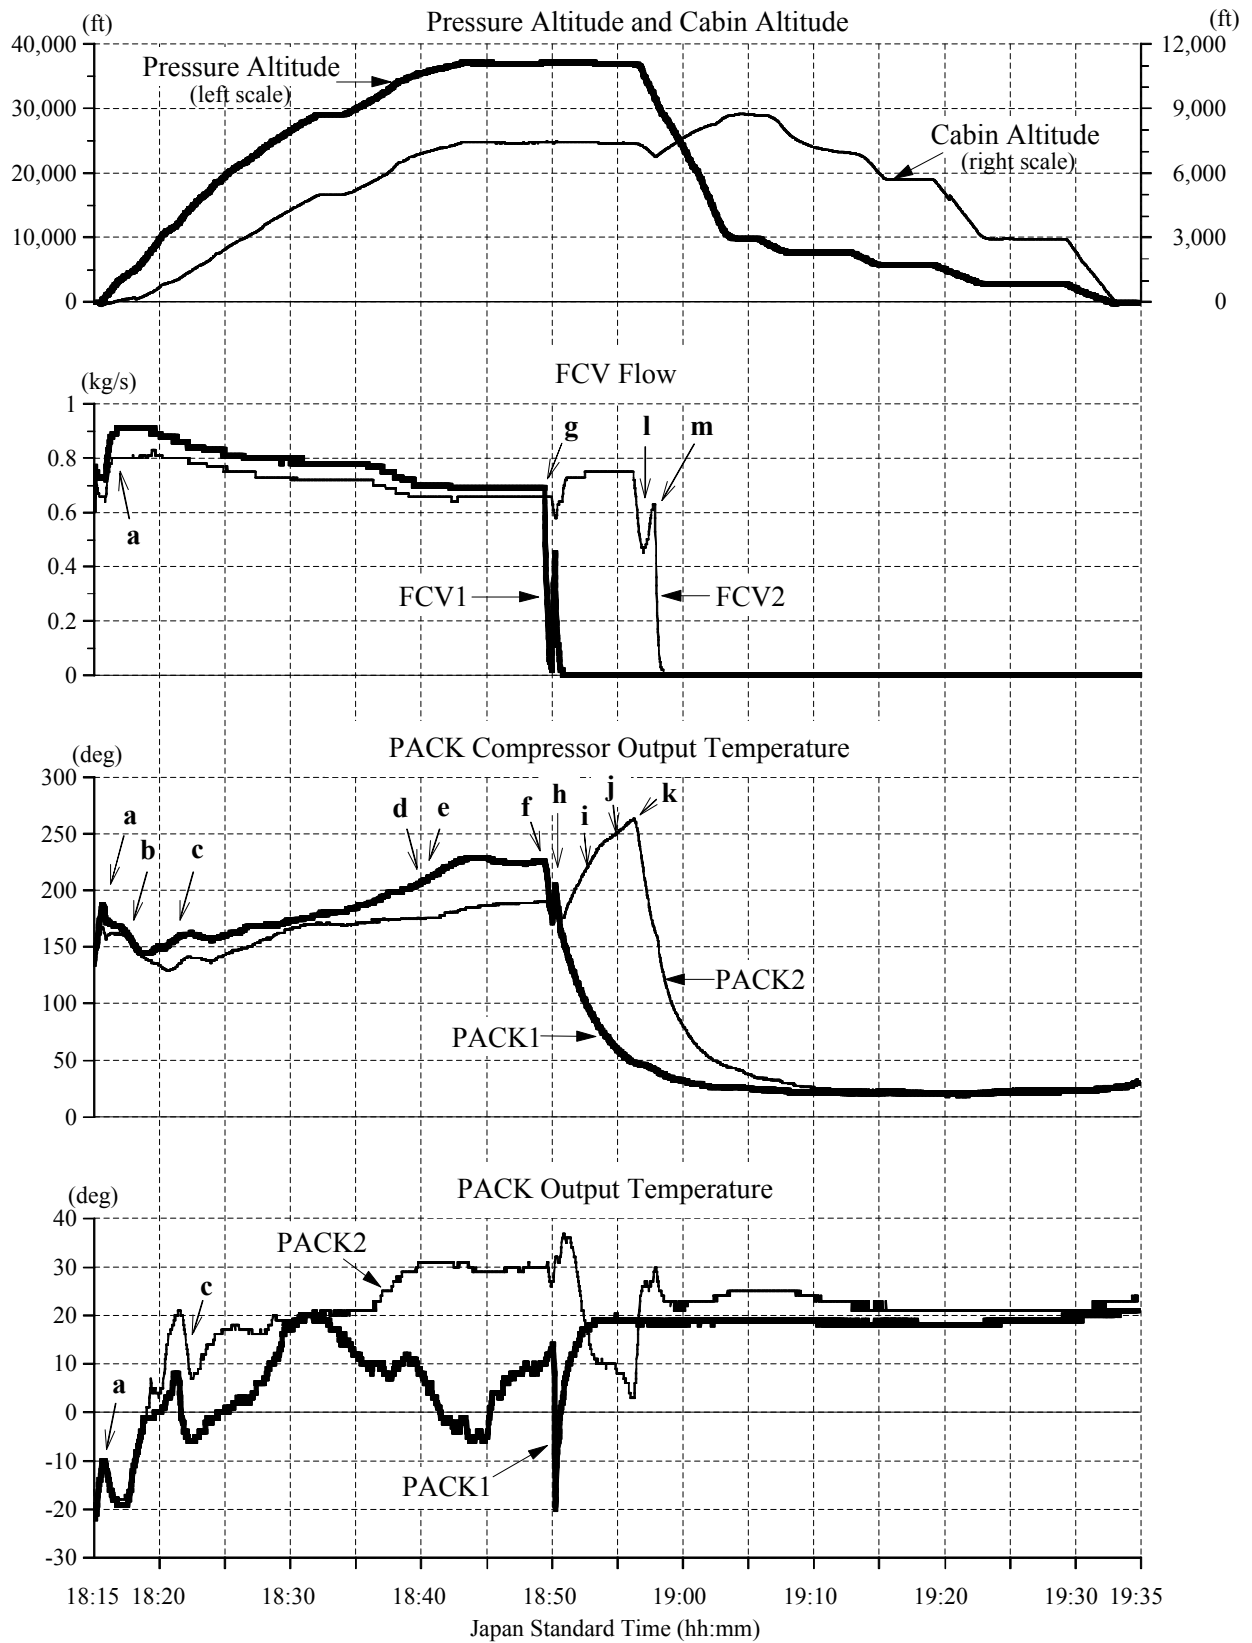
Figure 3 Relevant Parameters for Air Conditioning System

18:15:31	The aircraft took off from Oita Airport.
18:43:12	The aircraft reached a cruising altitude of 37,000 ft (cabin altitude at 7,400 ft).
About 18:49	PACK1's compressor outlet temperature reached approx. 230°C four times.

18:49:22	"AIR PACK1 OVHT" warning was displayed on ECAM.* ⁶
18:49:22	"AIR PACK1 FAULT" warning was displayed on ECAM.
18:49:38	PACK1 was switched OFF.
18:49:38	Flow rate of the flow control valve (hereafter called "FCV") 1 began decreasing.

18:49:40	FCV1 was fully closed.
18:50:10	PACK1 was switched ON.
18:50:10	Flow rate of FCV1 began increasing.
18:50:14	"AIR PACK1 OVHT" warning was displayed on ECAM.

18:50:14	"AIR PACK1 FAULT" warning was displayed on ECAM.
18:50:24	PACK1 was switched OFF.
18:50:24	Flow rate of FCV1 began decreasing.
18:50:26	FCV1 was fully closed.

18:55:58	PACK2's compressor outlet temperature reached approx. 260°C.
18:55:58	"AIR PACK2 OVHT" warning was displayed on ECAM.
18:55:58	"AIR PACK2 FAULT" warning was displayed on ECAM.

18:56:07	The aircraft started an emergency descent from altitude of 37,000 ft.
18:57:19	"Descending to 13,000 ft" was radioed to Tokyo Control.
18:58:05	PACK2 was switched OFF.

18:58:05	Flow rate of FCV2 began decreasing.
18:58:06	FCV2 was fully closed; cabin altitude began increasing.

When estimated mainly based on the factors discussed in 3.4.1, the process in which the series of events described in 2.1 and 2.8 concerning with the air conditioning system took place would have been as follows. The small alphabets at the end of each process step correspond to those in Figure 3.

- ① As the FCV flow control thresholds had high-shifted on both PACKs, a greater-than-normal flow of air entered the ACMs. This caused the compressors to run faster, resulting in higher-than-normal temperatures at the compressor outlets. At the same time, the speed of the ACM turbines increased, causing the temperatures at the PACK outlets to drop below the normal level. …… a

- ② In order to achieve PACK outlet temperatures corresponding to the temperature settings for each zone, the two PTCs caused the RADs to move towards the closing direction. …… b

- ③ As the PTC had reached its capability limit for controlling the temperature (through moving the RADs and bypass valves according to change in compressor outlet temperature), the compressor outlet temperature rose, while the PACK outlet temperature dropped again. …… c

- ④ The compressor outlet temperature continued to rise until the compressor outlet temperature sensor (hereafter called “CDS”) in PACK1 sensed a temperature of 205°C, upon which the PACK1 PTC initiated its control to prevent the RAD from moving further in the closing direction. …… d

- ⑤ The PACK1 compressor outlet temperature still continued to rise until the CDS sensed 210°C, in response to which the PACK1 PTC operated so as to drive the RAD to the fully-open position. …… e

⑦ The flight crew turned OFF the PACK1 control switch, which caused FCV1 to close, the compressor outlet temperature to drop in turn, and the warning to extinguish. The flight crew switched ON PACK1 again.g

⑨ Switching off the PACK1 caused the PACK2 to automatically shift into the HIGH flow mode. However, due to a high-shift of the pressure release threshold temperature in FCV2, air entered the ACM at an abnormally high flow rate (130% of normal flow) rather than at the designed HIGH flow rate (120% of normal flow rate), causing the compressor outlet temperature to rise rapidly.i

⑫ The flow rate of air to PACK2, which had decreased once, started to increase again. This was caused by FCV2 moving in the closing direction, with a consequent drop in the compressor outlet temperature and resetting of the CPNOH overheat protection.l

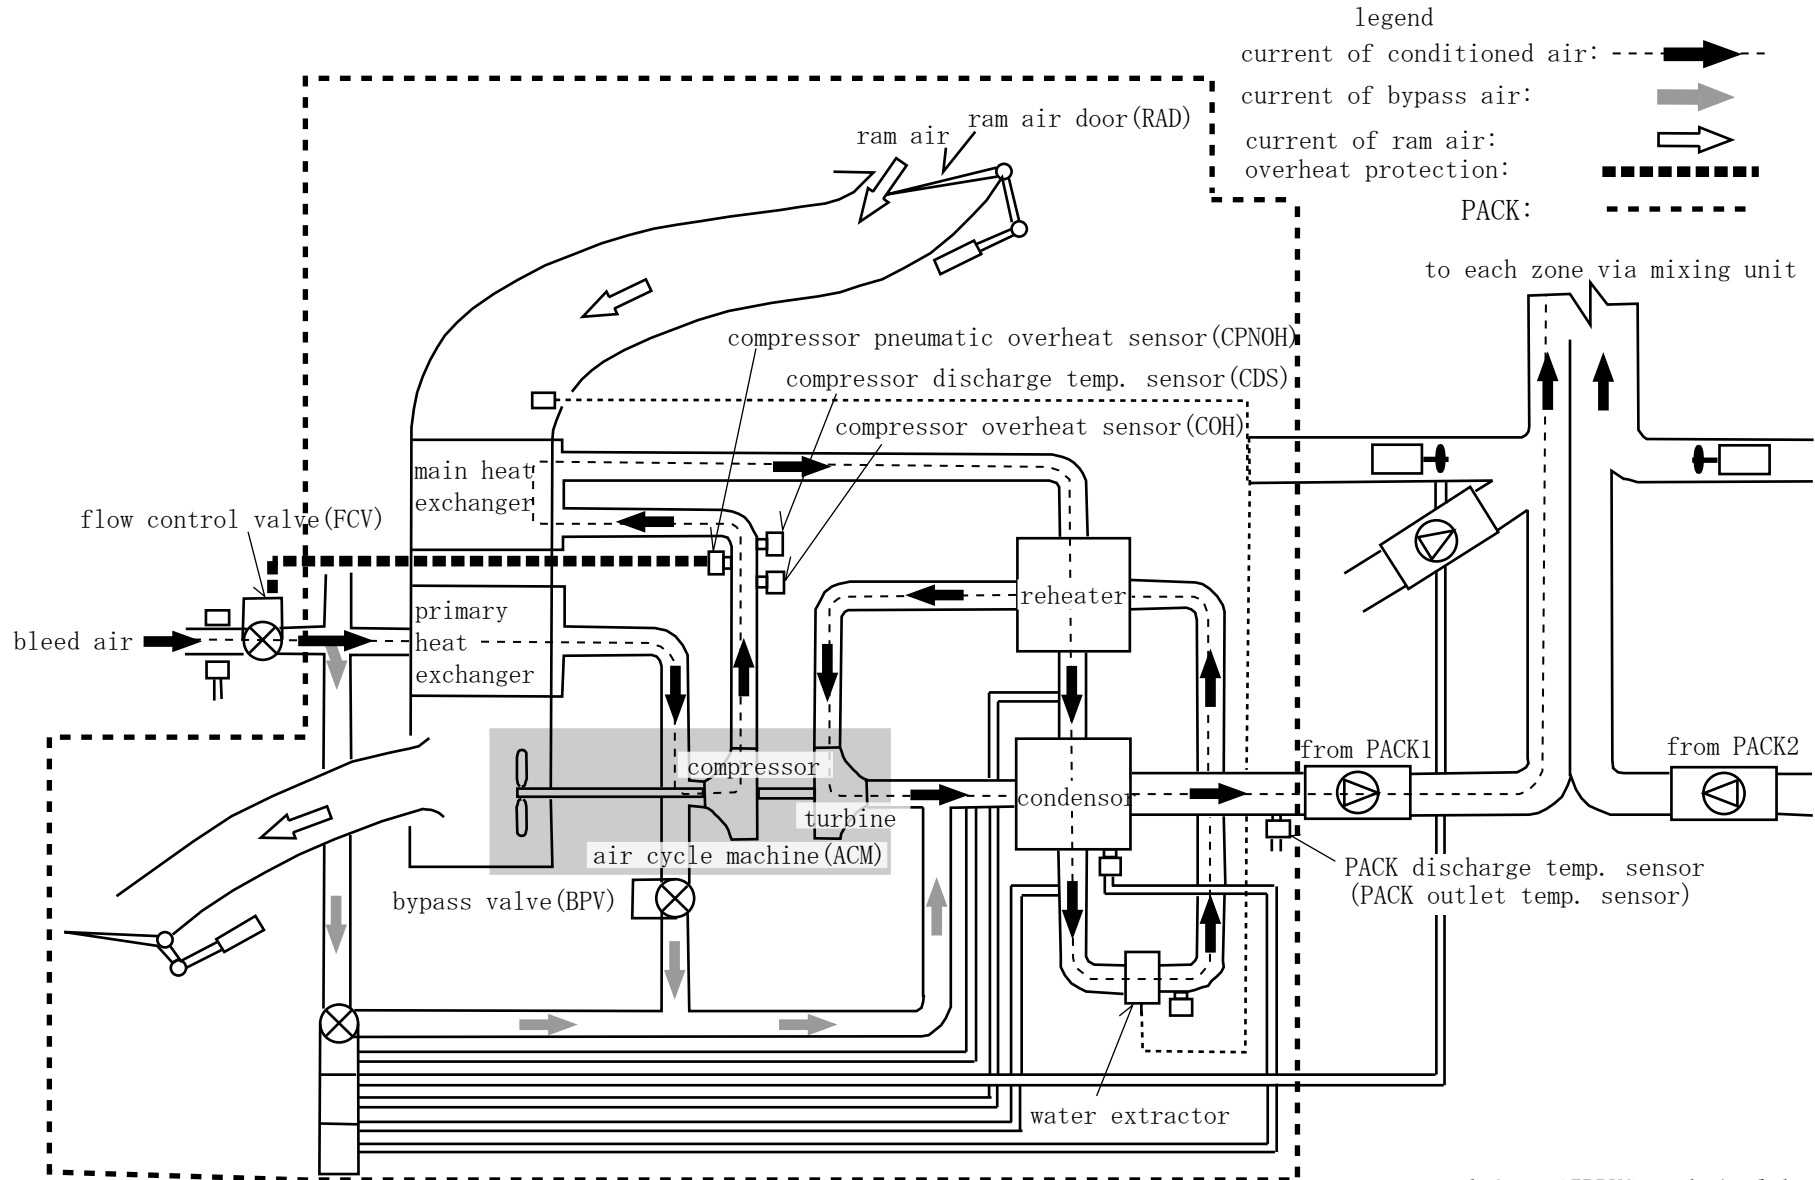
Figure4 air-conditioning system chart

(5) The PACK OVHT warning comes on when either of the following conditions is met concerning the compressor outlet temperature:

① A 230°C temperature is reached four times (once after resetting has been made).

② A 260°C temperature is reached once.

- ① When the compressor outlet temperature reaches 205°C, the PTC prevents the ram air door (hereafter called “RAD”) from closing further.
- ② When the compressor outlet temperature reaches 210°C, the PTC causes the RAD to fully open.
- ③ When the compressor outlet temperature reaches 230 °C , the compressor pneumatic overheat sensor (hereafter called “CPNOH”) opens the vent and releases the pressure, which moves the FCV in the closing direction.
- ④ When the compressor outlet temperature reaches 260°C, the CPNOH releases the pressure, which moves the FCV to the fully closed position.

FCV1	FCV2
Functional inspection	Under dynamic pressure ^{*10}	121.3 pounds/min (ppm) (Standard value: 86.9 – 93.4 ppm)	102.8 ppm (Standard value: 86.9 – 93.4 ppm)
	Under static pressure ^{*11}	192 mbar (Standard value: 105 – 115 mbar)	128 mbar (Standard value: 105 – 115 mbar)
		122 mbar after installing a new filter in P1 probe. ^{*12}	114 mbar after installing a new filter in P1 probe.
Teardown inspection	Blocked filter in P1 probe	5.63 psig (Upper limit: 0.87psig)	2.06 psig (Upper limit: 0.87 psig)
	Contamination	Contamination on inner sliding/contact surfaces Traces of black soot-like substance present near G11 jet located downstream of P1 probe filter	
		Large contamination	Small contamination

CPNOH1	CPNOH2
Functional inspection	Failed to fall within the standard ranges in both leak and functional checks.	
Teardown inspection	Large contamination (adhesion of foreign matter and blockage)

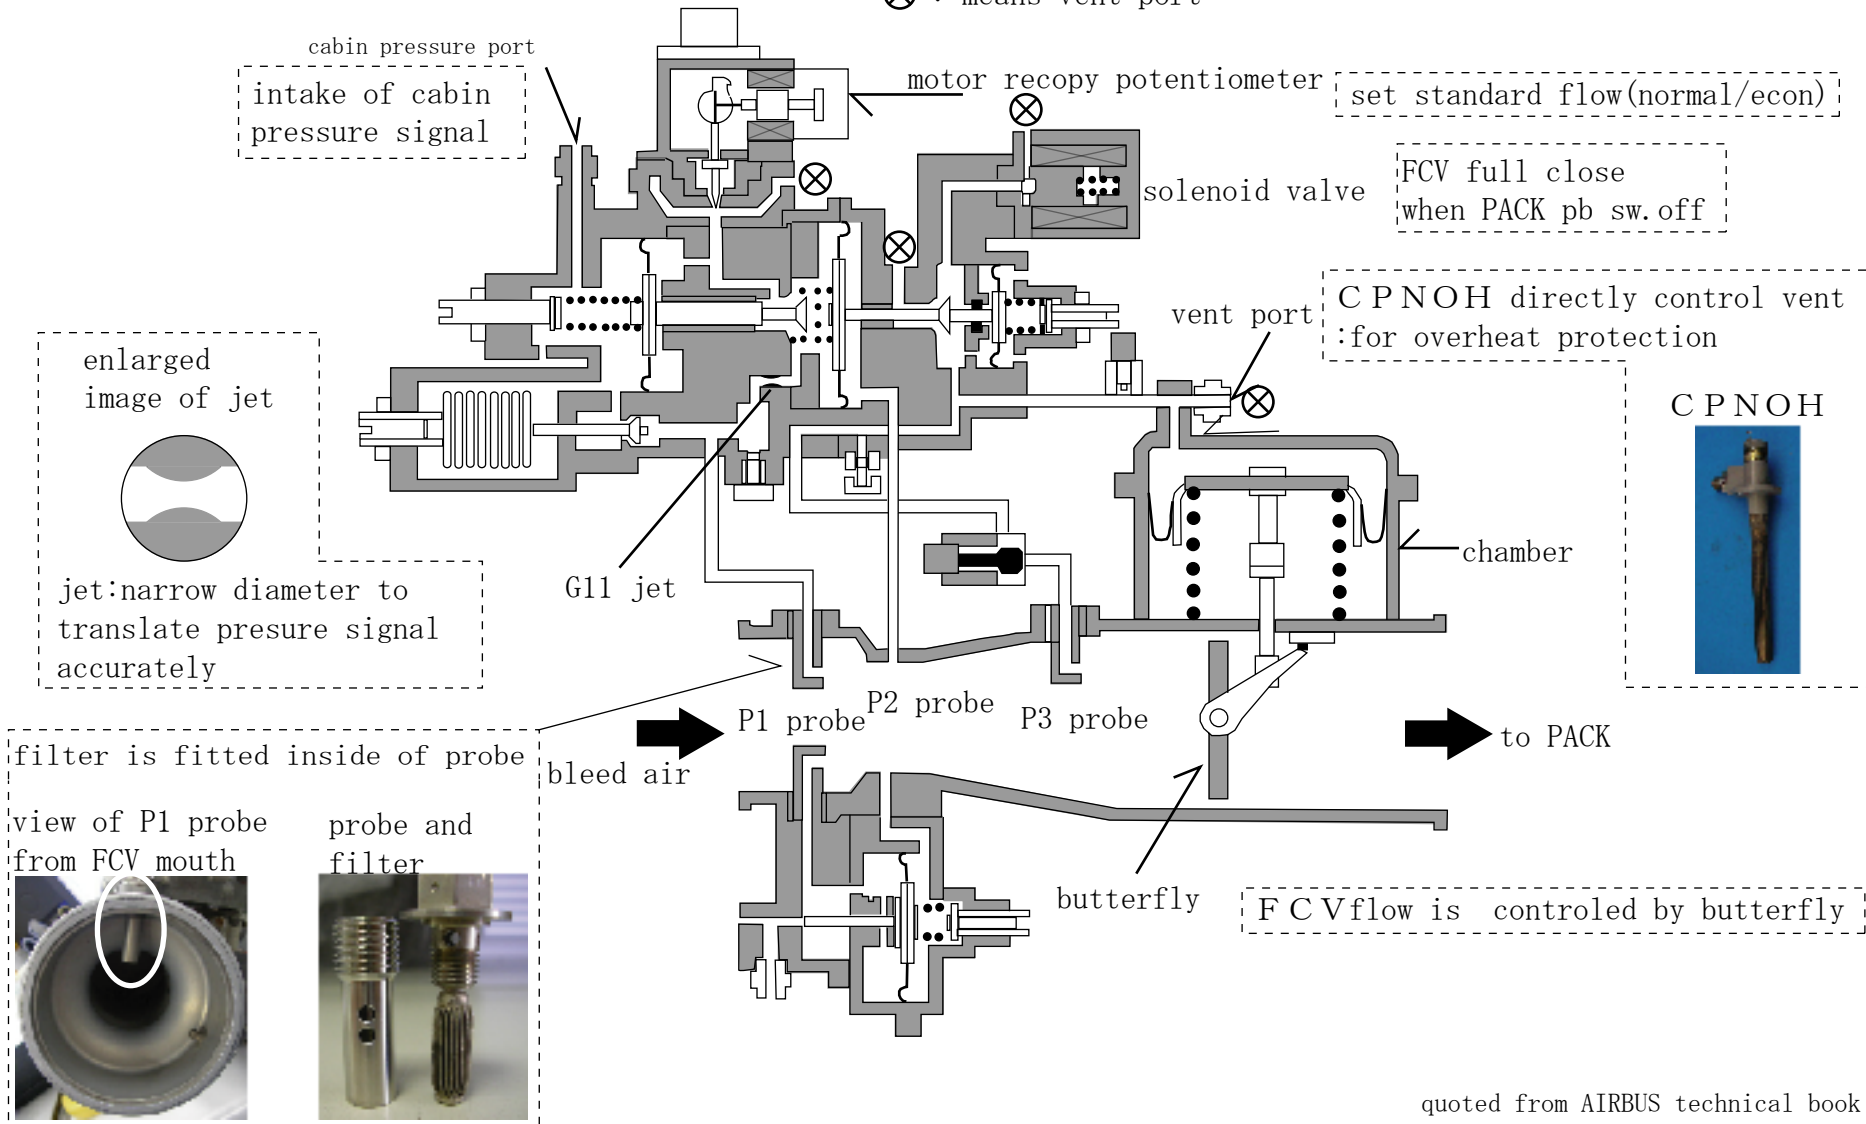
Figure5 F C V structure

^{*12} The filter is installed in the P1 probe, which picks up the pressure in the FCV, in order to remove foreign matter from bleed air.

The filter in the P1 probe having become blocked impaired the normal flow-rate control function of the FCV, which resulted in 130% or more bleed-air flow, as measured at FCV1, to PACK1 and 110% or more bleed-air flow, as measured at FCV2, to PACK2, both exceeding the demanded level (100%) set by the flight crew.

On the other hand, when PACK1 was switched OFF and an automatic shift to the HIGH flow mode then took place, bleed air at flow rate of 130%, rather than 120% as designed, flowed through the FCV2 to the PACK2.

Having been affected by contamination, the CPNOH lost its function to properly release pressure depending on temperature change. This functional deterioration of the CPNOH resulted in the FCV failing to move in the closing direction when the compressor outlet temperature exceeded 230°C.

In other words, the threshold at which the overheat protection function should start working had high-shifted^{*13}, causing a delay in pressure releasing.

- (1) Modification of FCVs (installation of new-type filters in P1 probes - Permanent measure)
- (2) Periodical replacement of current-type FCV P1 probe filters (temporary measure until completion of the modification)
- (3) Replacement of CPNOHs with those for which prescribed maintenance has been accomplished
- (4) Establishment of a system for in-flight monitoring of the PACKs on each aircraft
