**AIRCRAFT SERIOUS INCIDENT  
INVESTIGATION REPORT**

**Fuji Dream Airlines Co., Ltd.  
J A 1 0 F J**

ATTEMPT OF LANDING ON A RUNWAY  
BEING USED BY OTHER AIRCRAFT ETC.

EMBRAER ERJ170-200STD, JA10FJ

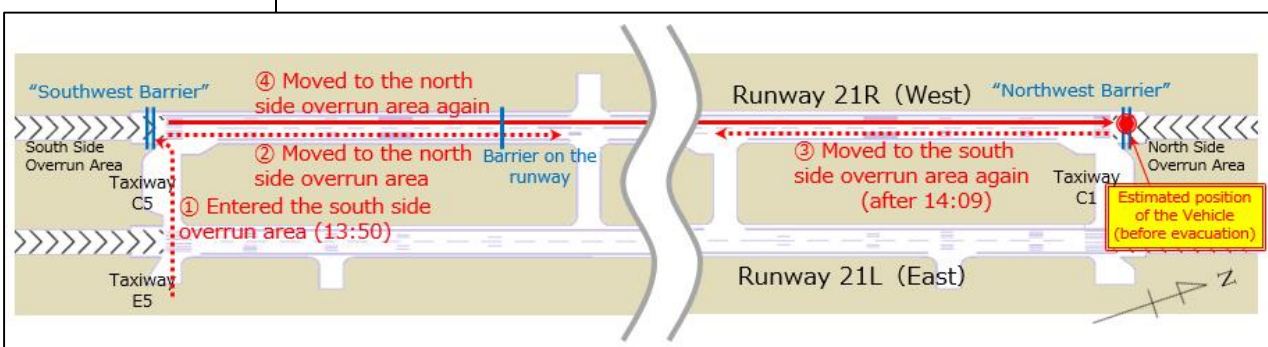
Figure 4: Movements of the Vehicle

The two Engineers got on the Vehicle to conduct a daily inspection for the aircraft arresting barrier\*<sup>1</sup> (hereinafter referred to as “the Barrier”) of Runway 21R, called a ground control position from the Self-Defense Forces (SDF) apron at 13:47, and moved and stopped short of the runway after being cleared. At 13:50, the Vehicle was comprehensively permitted by the ground control position to enter the runway for the inspection of the Barrier, and entered (Figure 4 ①). After conducting the inspection of “Southwest Barrier” located in the south side overrun area on the runway, the Vehicle headed for the north side overrun area through the runway for the inspection of “Northwest Barrier” (Figure 4 ②).

the south side overrun area via the runway (Figure 4 ③).

<p>The Vehicle returned from the south side overrun area to the north side one through the runway in order to conduct inspection of “Northwest Barrier” again (Figure 4 ④), and stopped facing almost northward. When the two Engineers were going to get off the Vehicle, one of them found an aircraft ahead over the sky. At 14:50:32, the one Engineer asked the ground control position about whether there would be any arriving aircraft to the runway after consulting with the other Engineer. Almost at the same time, the Vehicle started to move while turning left to prepare for the ground control position’s instruction to vacate the runway.</p> <p>Upon receiving the inquiry from the Vehicle, Trainee C instructed the Vehicle to evacuate to a taxiway at 14:50:37, and Controller B, as watch supervisor, urged Controller A to have Aircraft A make a go-around. As having listened to the inquiry from the Vehicle through the speaker, Controller A also instructed Aircraft A to make a go-around almost at the same time. At 14:50:42, Aircraft A made a go-around and commenced to climb.</p> <p>After the go-around, Aircraft A turned to the west side of the airfield, its communication was transferred to Hyakuri Radar Approach Control Facility, then Aircraft A received an approach clearance again for the runway by the radar approach control facility, and landed at 15:01.</p>																																						
<b>2.2 Injuries to Persons</b>	None																																						
<b>2.3 Damage to the Aircraft</b>	None																																						
<b>2.4 Personnel Information</b>

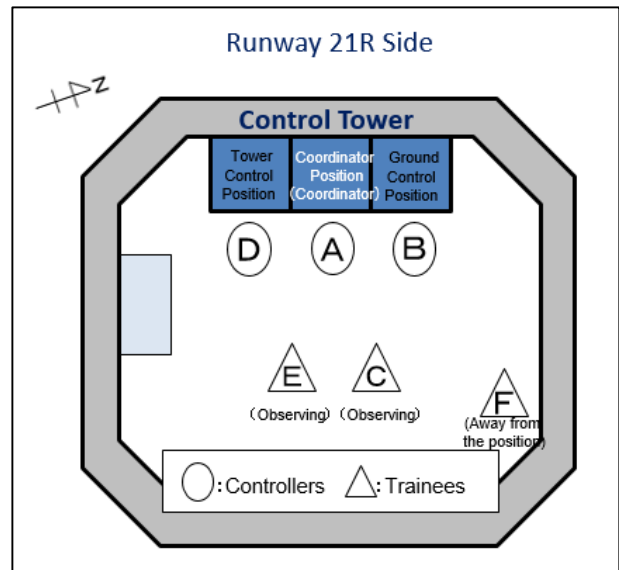
Figure 5: Situation of the Control Tower at 13:50 (when the Vehicle obtained the permission to enter Runway 21R)

At 13:50 (Figure 5), when the Vehicle requested the ground control position to grant it a permission to enter Runway 21R, Trainee F was temporarily away from the ground control position, and Controller B issued the runway entry permission to the Vehicle with the approval by Controller D in charge of the tower control position. Controller B set two types of reminders (described later in 2.7 (3)) indicating that the runway was not available for take-off and landing of aircraft. Controller D also set two types of reminders, and Controller A one type, respectively.

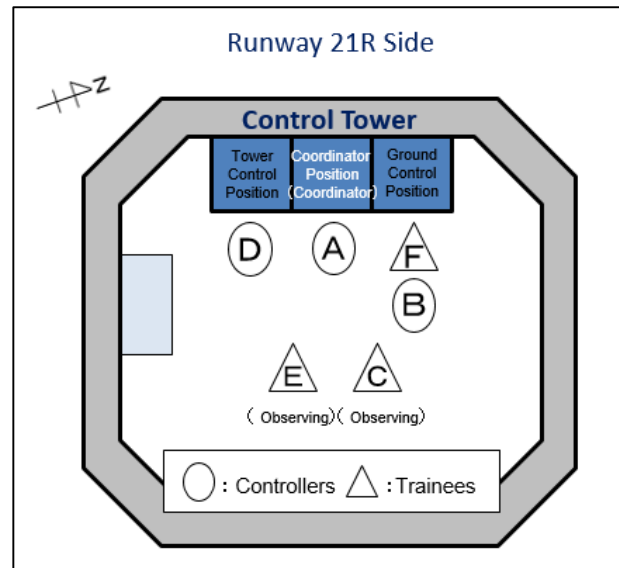
Figure 6: Situation of the Control Tower at 14:06 (at the time of the Northwest Barrier up/down)

At 14:06 (Figure 6), in order to inspect the operating conditions of “Northwest Barrier”, the Vehicle requested the ground control position to raise the Barrier (UP). Upon receiving this request, Trainee F asked Controller D to get the Barrier up, and at about 14:07, Controller D got the Barrier up. At 14:08, the Vehicle requested the ground control position to retract the Barrier (Down). Upon receiving this request, Trainee F asked Controller D to retract the Barrier, and Controller D got the Barrier down at about 14:09. After the inspection of “Northwest Barrier”, the Vehicle left the north side overrun area once in order to conduct inspection of “Southwest Barrier” again, and headed for

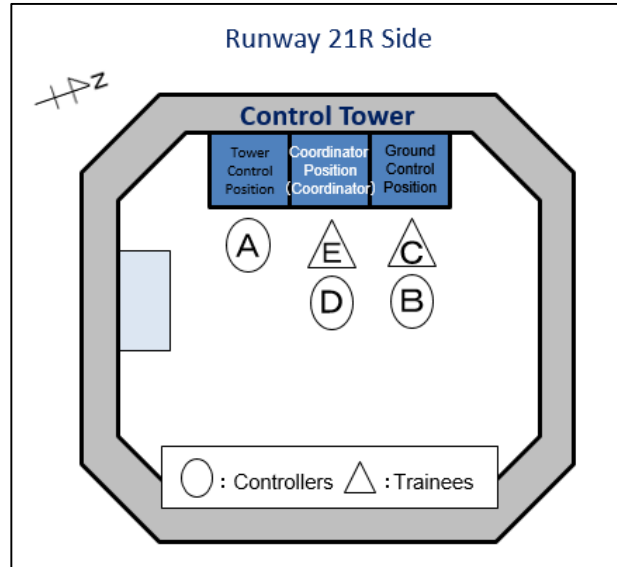
Figure 7: Situation of the Control Tower after 14:10 (at the time of the serious incident)

- (3) At about 14:10 (Figure 7), Controller A and Controller D rotated their control positions in charge, and Trainee C got seated at the ground control position, Trainee E at the Coordinator, respectively. Controller B continued to stay at the ground control position. Trainee F completed the on-the-job training and left the tower.

A short time after a while rotating the position, Trainee E noticed that there might be multiple errors in the radio log and consulted with Controller D. Controller D confirmed they were errors, and pointed out to Controller A, who had written the relevant part, that there were errors in the radio log. After that, Controller D and Trainee E continued to check the radio log. Controller B was making oral confirmation of Trainee C's knowledge on traffic control services in between their ground control service duties.

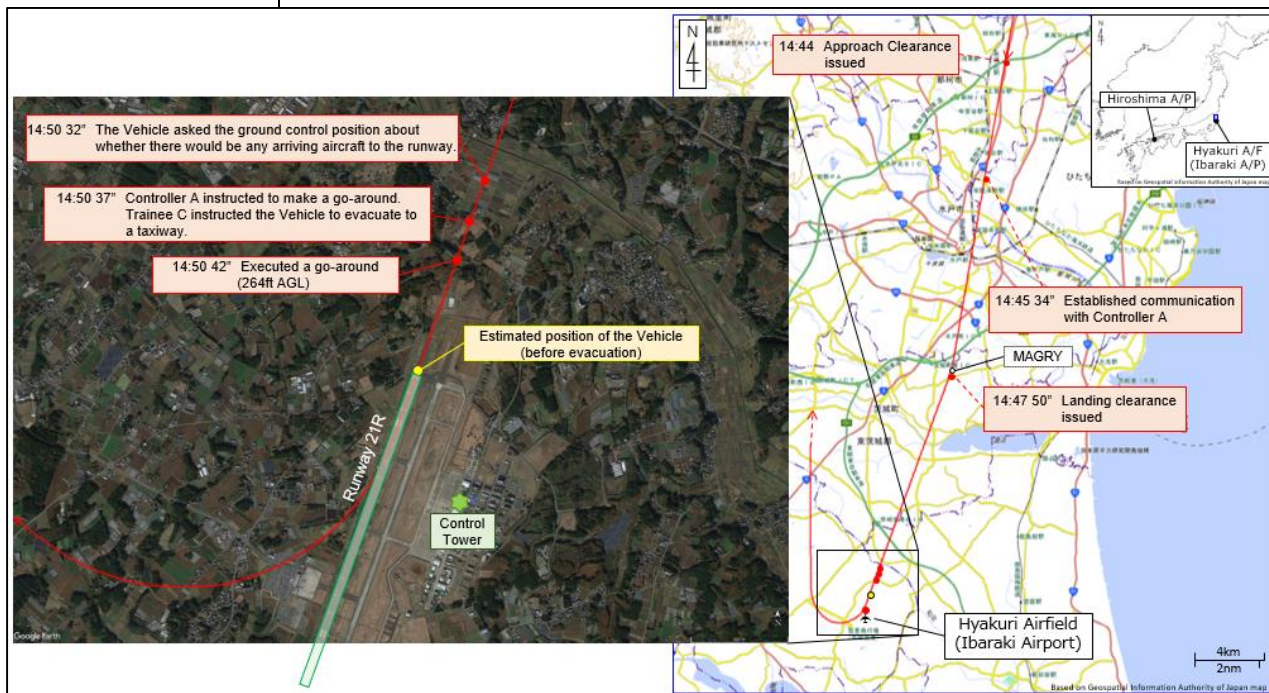
Figure 8: Aircraft A's Estimated Flight Route

approach control facility informed the airfield traffic control tower of the position of Aircraft A through CLS\*3. According to normal procedures, Controller A responded through CLS that the position of Aircraft A was confirmed. While approaching the runway, Aircraft A established communication with Controller A at 14:45:34. Controller A instructed Aircraft A to report its passing Fix\*4 “MAGRY” (7.5 nm (approx. 13.9 km) from the threshold of the runway).

At 14:47:47, Aircraft A reported to Controller A that it had passed “MAGRY”. Upon receiving this report, Controller A issued a landing clearance for the runway to Aircraft A at 14:47:50.

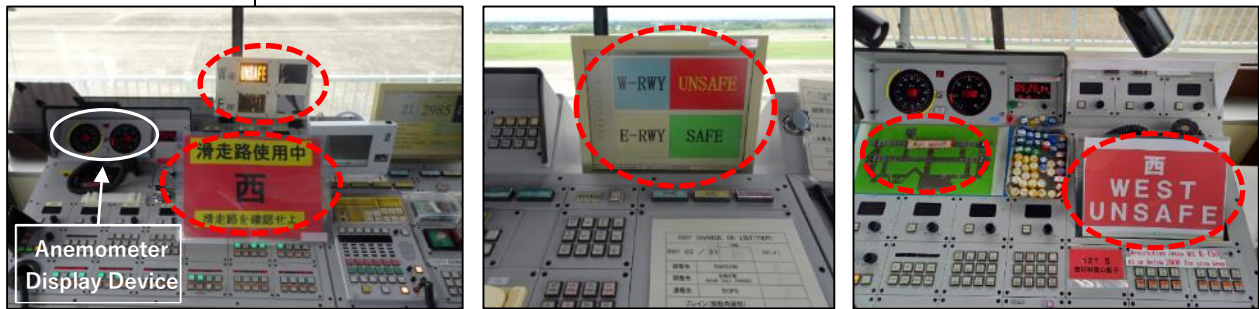
Figure 9: Reminders used at the airfield traffic control tower (from left, at the tower control position, at the Coordinator, and at the ground control position)

The Operation Processing Procedures specified by Hyakuri ATC Squadron stipulates that in case where the runway is not available for take-off and landing of aircraft, reminders shall be set at control positions designated by the watch supervisor, and at the airfield traffic control tower, the five kinds of reminders were supposed to be set at the tower control position, ground control position and the Coordinator by using sheets and magnets, etc.

The JTSTB concludes that it is probable that although in the airfield traffic control tower, reminders set at each control position would be used in case where the runway is not available for take-off and landing of aircraft, and aerodrome control services would be provided while grasping the situation on the runway and its vicinity, the actions to set those reminders had

became a mere formality. It is desirable for Hyakuri ATC Squadron to repeatedly inform all the Controllers who provide ATC services at the airfield traffic control tower of the back ground leading up to the use of reminders and the significance of their use, and to consider and practice the method of use that can prevent it from becoming merely a formality. Besides, various creative examples of effective use of reminders can be seen also in the ATC facilities of CAB. It is desirable for the ATC facilities of the Ministry of Defense to continue to make a technical exchanging with the ATC facilities of CAB including sharing the information on effective use of reminders, keeping in mind that they are also responsible for the ATC services at airports for joint SDF-civilian use like Hyakuri Airfield.
