AA2007-3

# AIRCRAFT ACCIDENT INVESTIGATION REPORT

SHIZUOKA PREFECTURAL POLICE  
AGUSTA A109K2(ROTORCRAFT), JA11PC  
SHIMIZU-KU, SHIZUOKA CITY, SHIZUOKA PREFECTURE, JAPAN  
MAY 3, 2005, AROUND 16:28 JST

April 27, 2007

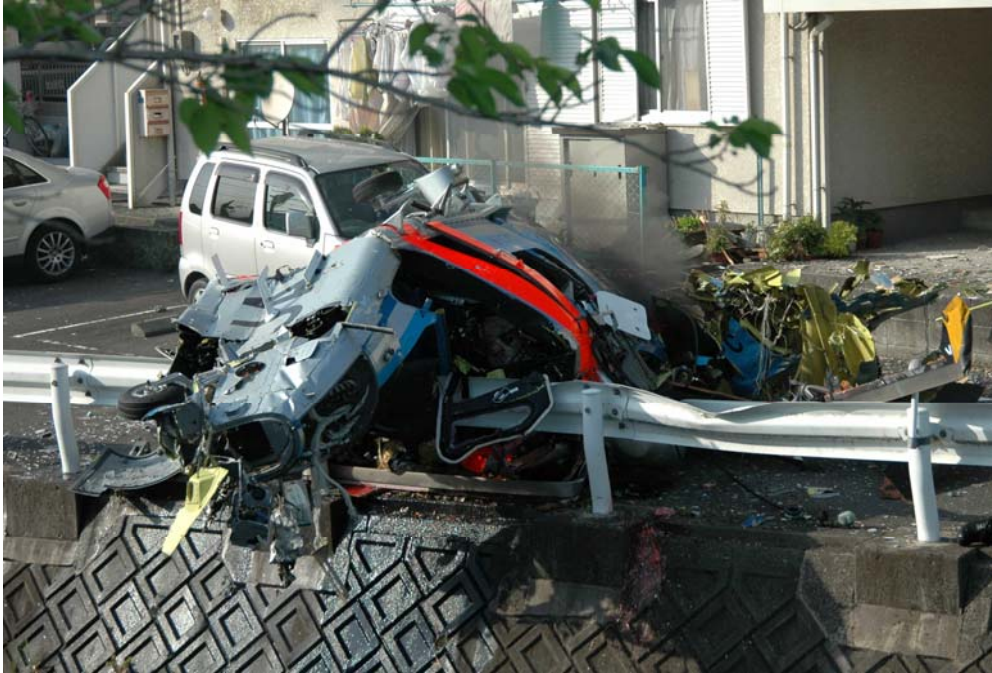
## Photo 1 Crash site (1)

(At 16:30:32 Flame is not observed although smoke rises from the vicinity of the engine.)

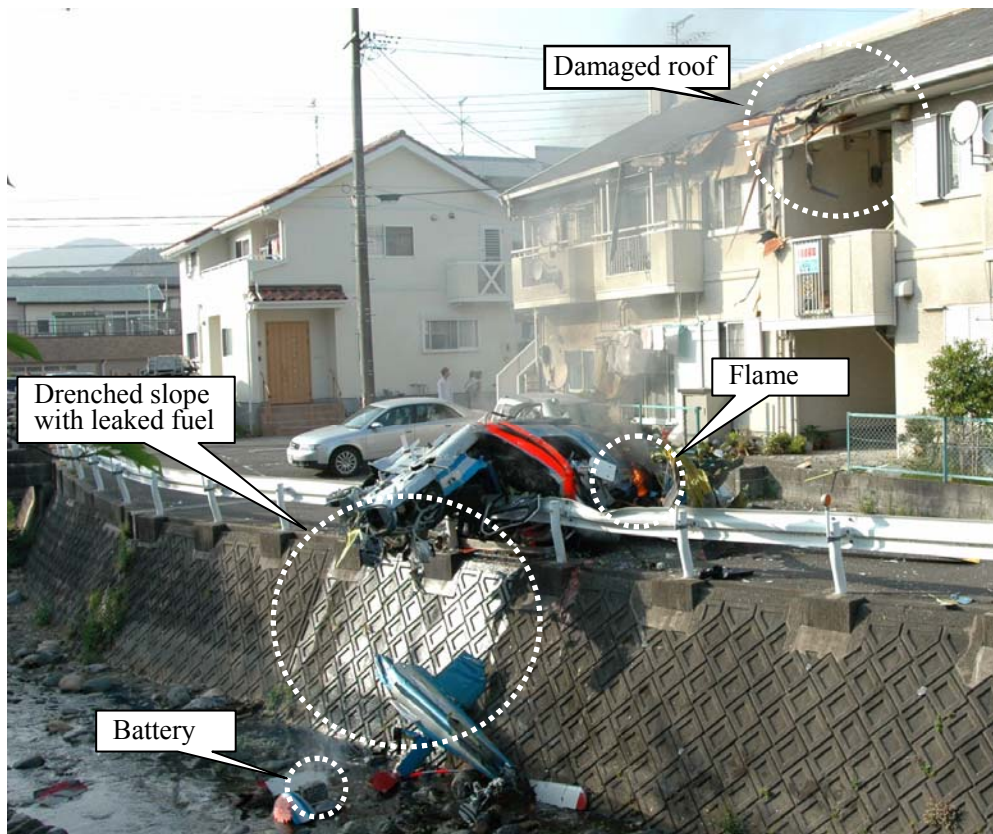
## Photo 2 Crash site (2)

It is considered probable that as a heat source, residual heat in the engines immediately after the crash or sparks generated by the crash impact ignited the leaked fuel and small flame was generated. Subsequently this small flame ignited vaporized leaked fuel and it developed into a fire and engulfed the entire fuselage.

(At 16:31:08 Flame is visible.)

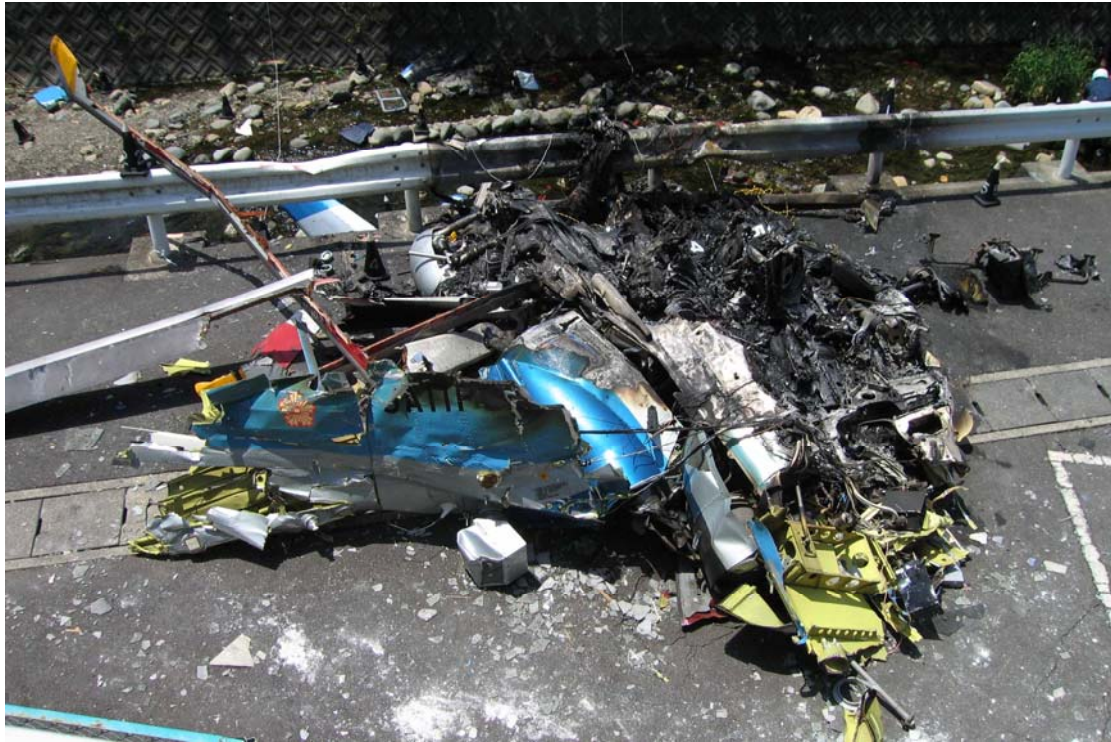
Photo 3 Crash site (the next day of the accident)

The fuselage was destroyed and nearly burned out. All four MR blades were broken but still connected to the MR head. The tail boom was fractured in the middle. The forward half of the tail boom was folded forward onto the fuselage and the rear half was found on the riverbed several meters below with the TR blades still attached. There were traces of leaked fuel on the embankment.

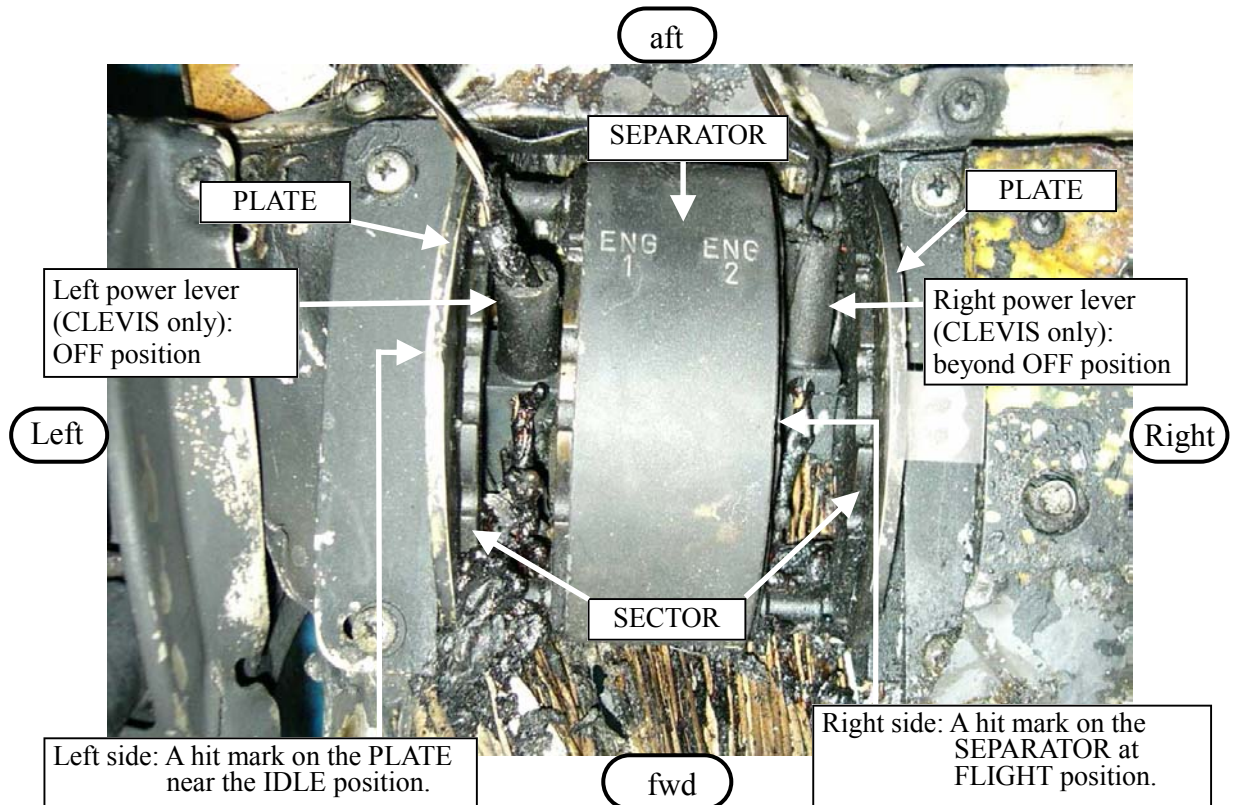
Photo 4 POWER LEVER ASSEMBLY

Power levers                      Broken (both levers).

[Each power lever assembly has sectors with detents to retain the power lever in the OFF, IDLE, FLIGHT or EMERGENCY positions. The power lever consists of a clevis and a handle. The clevis is located between the sectors, and its opposite end of pivot is connected to the engine by cable. On the root of the handle, protrudes a projection that engages a detent of the sectors to prevent the power lever from moving inadvertently. Of the LH and RH power levers, only the clevises remained and the handles were fractured off. The LH clevis was found in OFF position while the RH clevis was found beyond OFF position. There were dents on the parts flanking each handle; plate and separator. The dent corresponding to the LH handle was on the plate somewhere between FLIGHT and IDLE positions (closer to IDLE position). The dent corresponding to the RH handle was on the separator very close to FLIGHT position.]

As described in 2.9.4, both power levers lost their handles and retained only their clevises. LH clevis was found in OFF position while RH clevis was found at a position beyond OFF position. Since power levers with their handles broken away and only their clevises remaining can easily be moved by such external force generated by cables connected to the engines, it is considered very likely that the impact of the crash broke off the handles and moved the power levers with only the remained clevises to the above-mentioned positions.

With regard to the dents that were found on the part that flanked each power lever handle (plates and separator) (near IDLE between the FLIGHT and IDLE positions for LH lever and nearly at FLIGHT position for RH lever), it is considered probable that they were made when the handles broke off by the impact of the crash. Based on the mentioned above, it is considered probable that, immediately before the crash, the power levers were positioned near the IDLE position for LH and nearly FLIGHT position for RH.

If both engines were operating normally, both power levers were set at FLIGHT position. As described earlier, these levers are designed to prevent inadvertent movement. Consequently, it is considered possible that LH power lever being found near IDLE position indicates that the PIC retarded it there.

(Located on the ceiling of the cockpit)

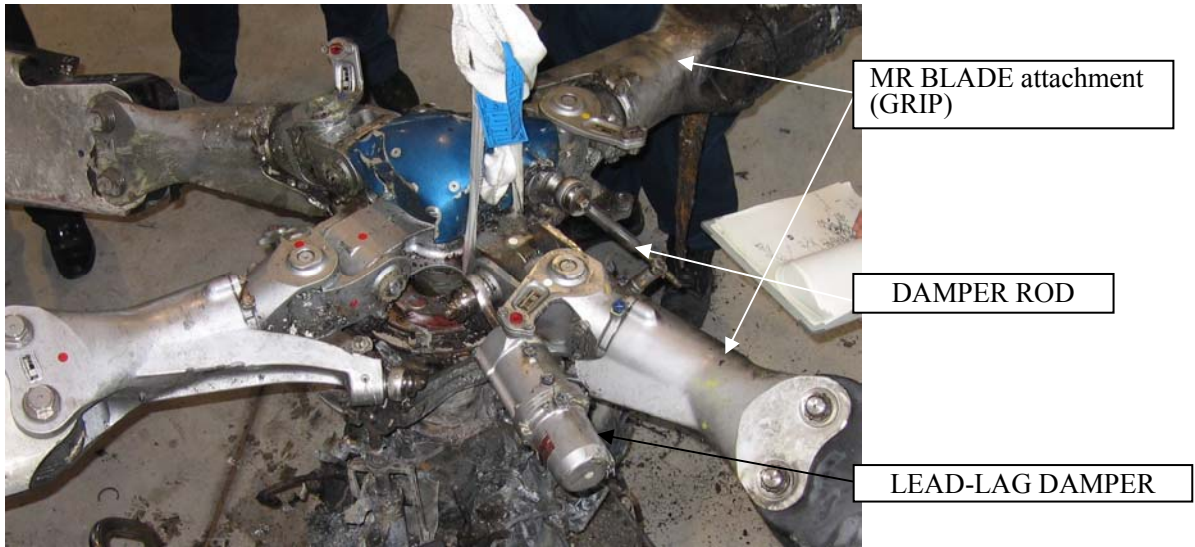
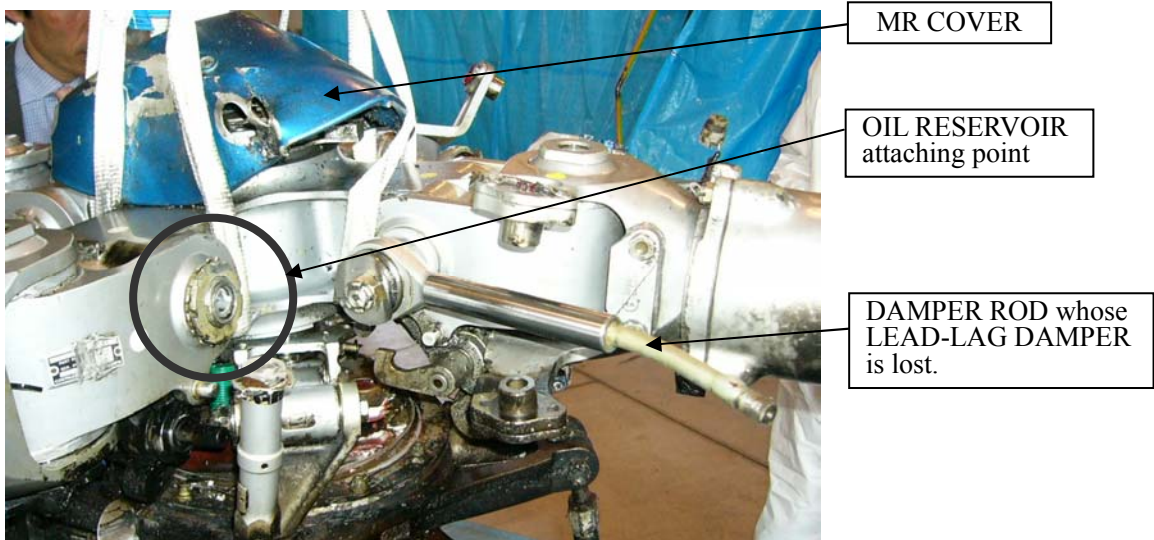
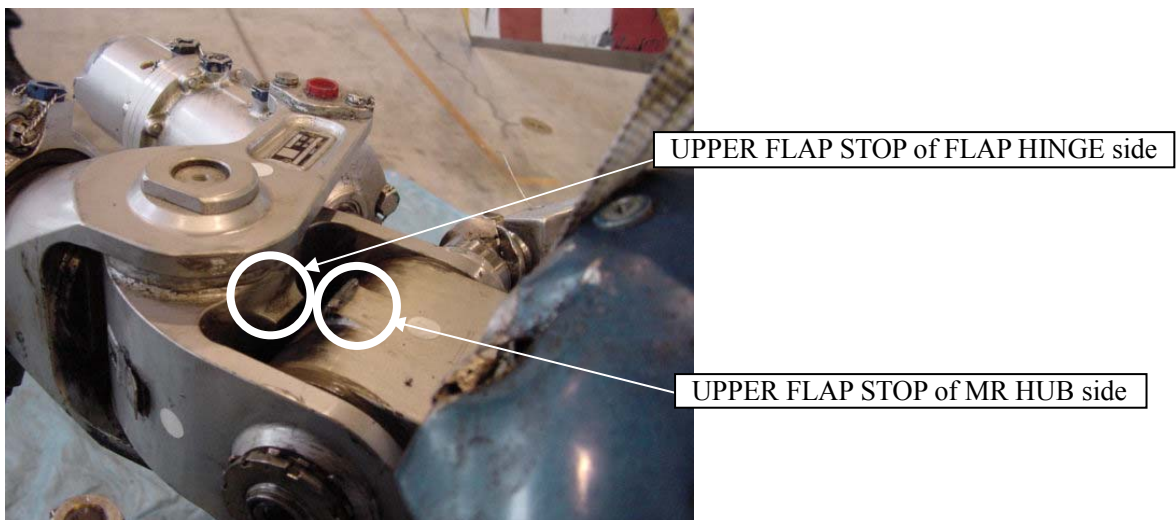
Photo 5 MR HEAD

All four upper flap stops on the MR hub were damaged.

Rotating parts of the transmission could be rotated freely except for seizure by deformed accessory drive gears. MR control and MR head parts were damaged by overload. Attachment parts of the MR blades, such as flap hinges and lead-lag hinges, moved freely. The MR cover was deformed due to contact with the MR blade attachment (flap hinges), and upper flap stops of both the MR head and the flap hinges were damaged.

Because it was proved that the breakage and failure of the MR head and MR control parts were caused by overload as described in 2.13.2 and because the fracture surfaces showed no sign of fatigue fracture, MR head and MR control parts were considered to have been free of anomalies.

Based on the MR blade dynamic behavior learned from the simulation described in 2.13.3, it is considered very likely that the damage to the upper flap stops on the MR hub

described in 2.9.3 (7) and the contact marks on the MR cover caused by the flap hinges described in 2.13.2, resulted from decay in MR rpm, followed by excessive MR blades flap beyond the allowable limits.

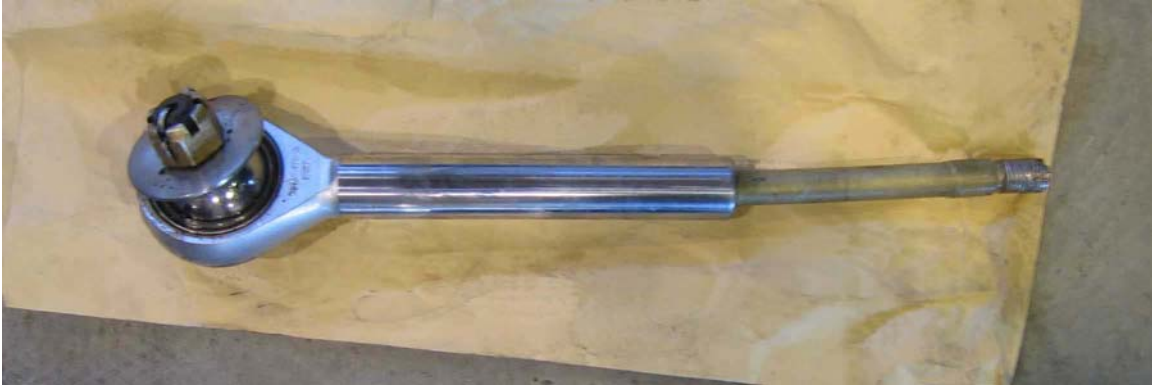
Photo 6 MR DAMPER ROD

It is considered probable that, after both engines had lost power, the aircraft, without entering autorotation, experienced rapid decay of MR rpm, excessive MR blade flapping and lead-lag movement beyond allowable range leading to breakage and falling apart of the oil reservoir and lead-lag dampers on the MR head.

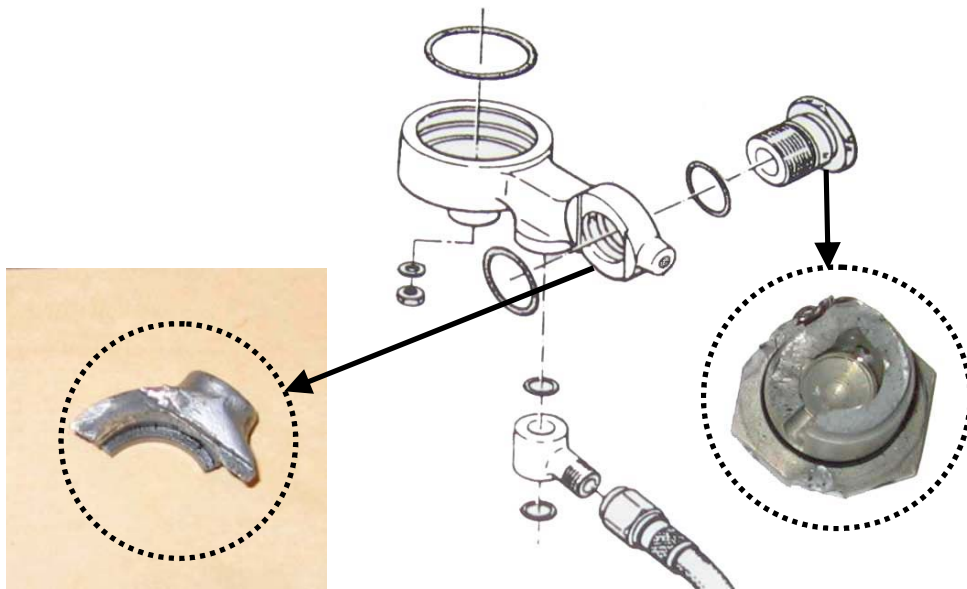
Photo 7 Fragments of MR HINGE LUBRICATING SYSTEM

Considering the mentioned above, the witnessed falling objects from the aircraft described in 2.1.3 (2) and (3) were fragments of the oil reservoir, hub damper attachment pins, and the like that were retrieved from the areas away from the crash site as described in 2.9.2. It is considered very likely that the falling of these objects from the aircraft during flight was not due to damage and breakage resulting from defects originally present in these parts but due to damage and breakage resulting from the decay in MR rpm that led to excessive flapping and lead-lag movement beyond the allowable limits of the MR blades.
