**AIRCRAFT SERIOUS INCIDENT  
INVESTIGATION REPORT**

**ACADEMIC CORPORATE BODY HIRATAGAKUEN  
J A 1 3 5 E**

ENGINE DAMAGE  
TO  
A EUROCOPTER EC135T2 (ROTORCRAFT), JA135E  
OPERATED BY  
ACADEMIC CORPORATE BODY HIRATAGAKUEN  
OVER  
THE SEA ABOUT 6 NM (ABOUT 11 KM) NORTHWEST  
OF KERAMA ISLANDS, OKINAWA PREFECTURE  
AT  
10:20, MARCH 28, 2009

August 23, 2013

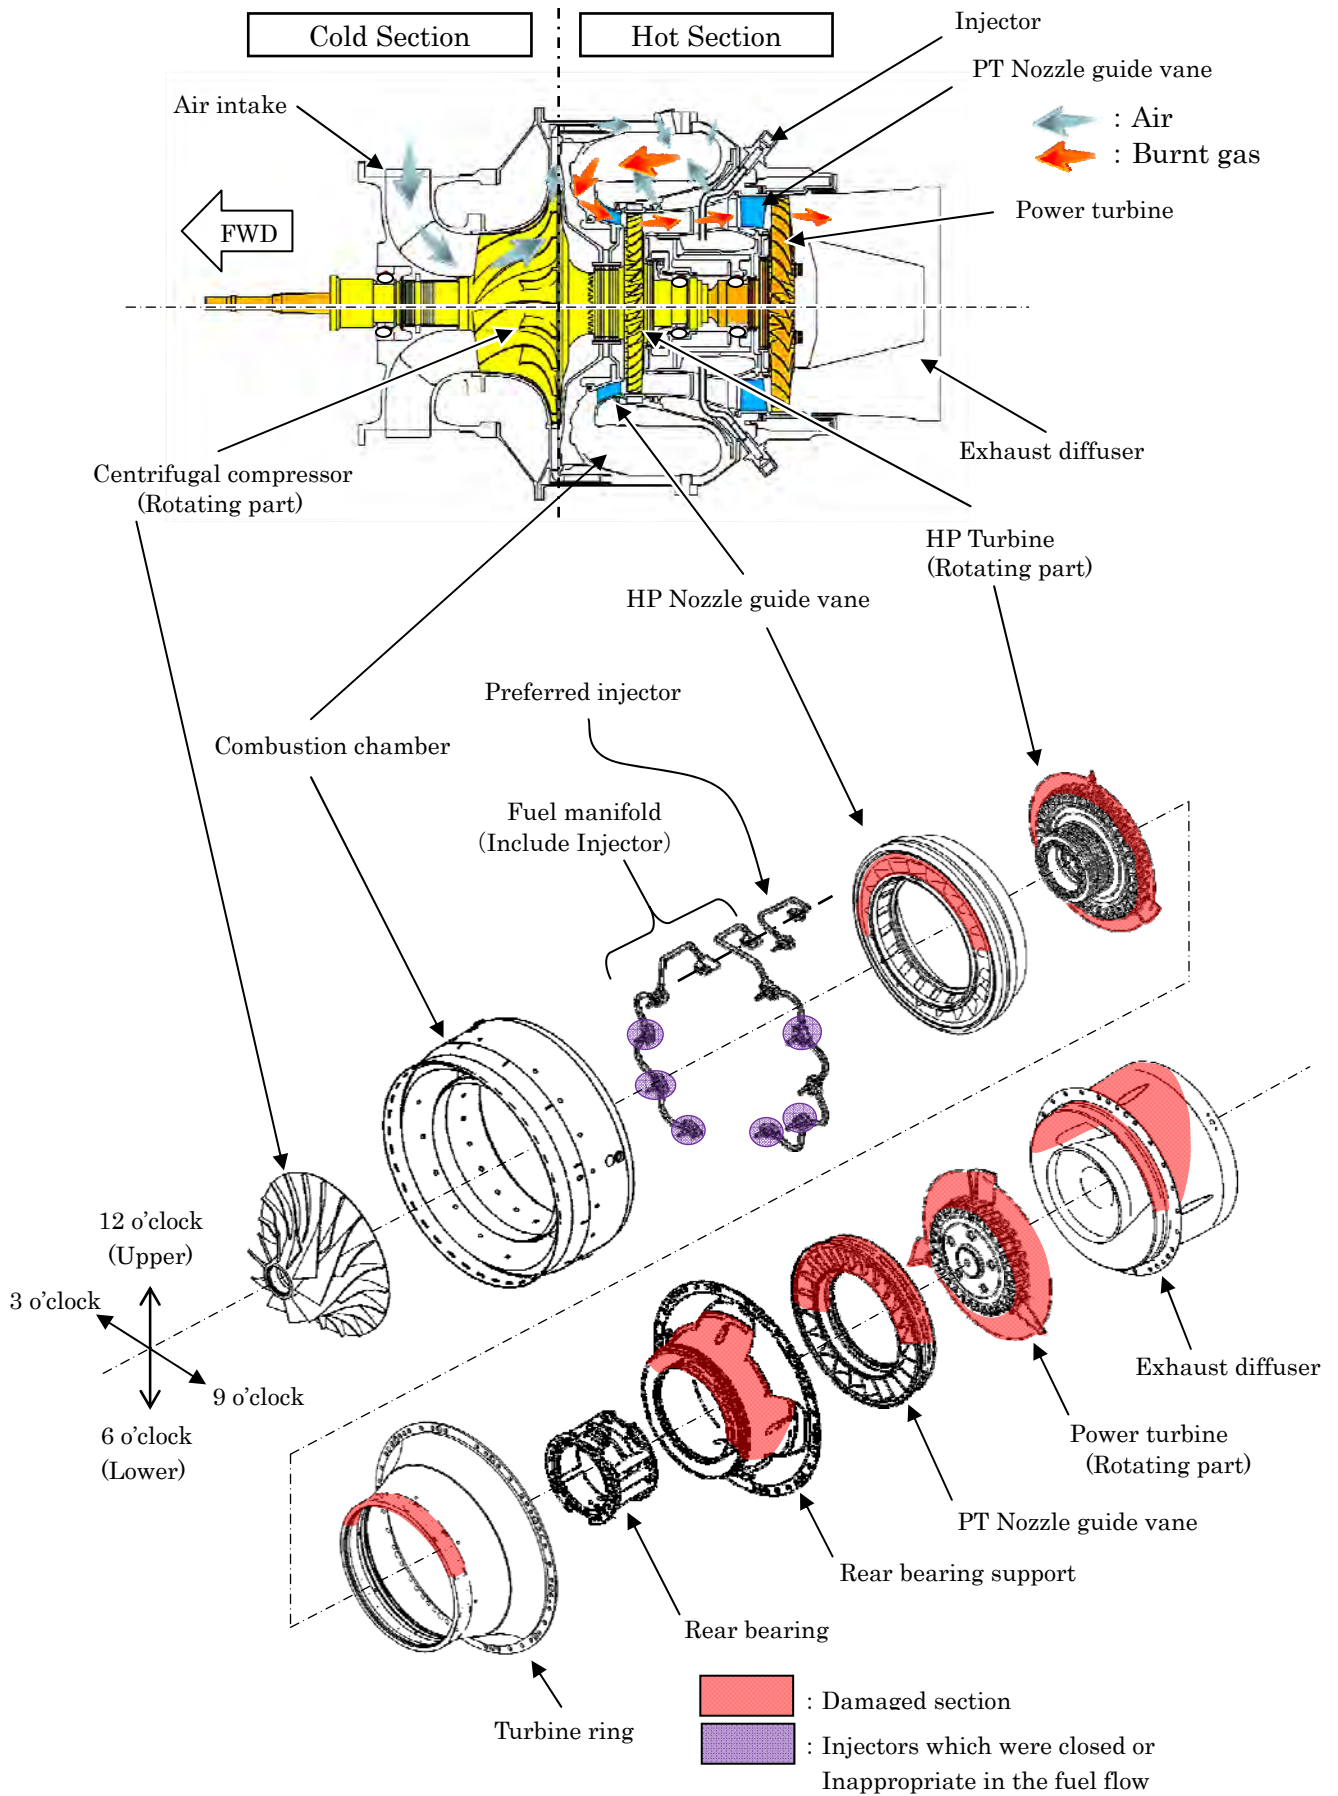
Figure 3 The Structure of the Engine and Main Sections Damaged in the Left Engine Inside

- b. The high pressure (HP) nozzle guide vanes for smoothing the flow of combustion gas was discolored due to overheating toward the Upper Structure and the rear edges of the guide vanes were damaged.

- c. All the HP turbine blades, which rotate the compressor, were fractured from the middle section, while the turbine ring and the rear bearing support, which form the flow path of combustion gas was damaged toward the Upper Structure.

- d. The pressure turbine (PT) nozzle guide vanes were damaged toward the Upper Structure, while all the blades of power turbine were fractured.
- e. The exhaust diffuser and its struts were fractured toward the Upper Structure, and the fractured sections were melted.

The accumulated material clogged six lower injectors allowing upper injectors to operate leading to overheated conditions in the upper interior, damaging the upper structure between the HP nozzle guide vanes and exhaust diffuser; this destruction resulted in fractures of downstream rotating parts – HP turbine blades and power turbine blades.

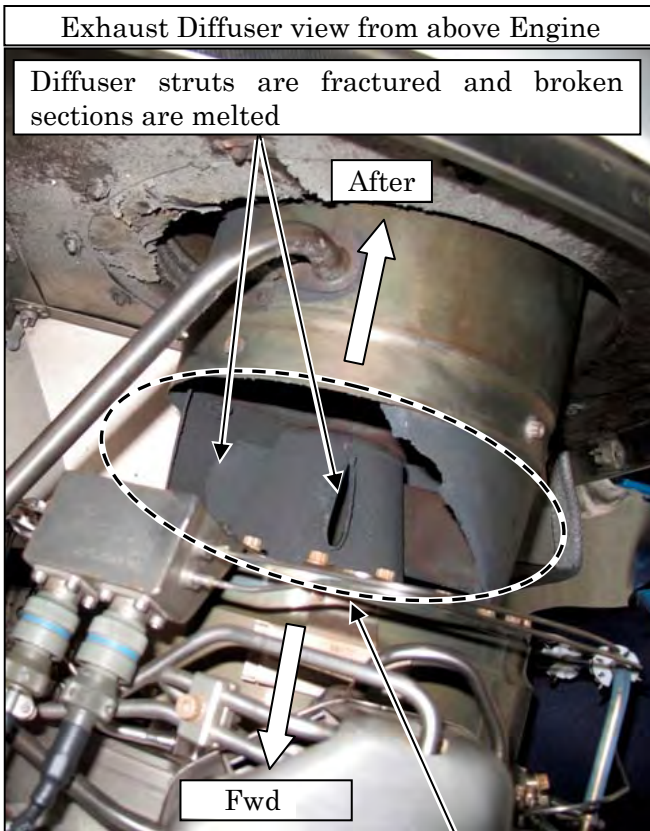
Exhaust Diffuser was damaged

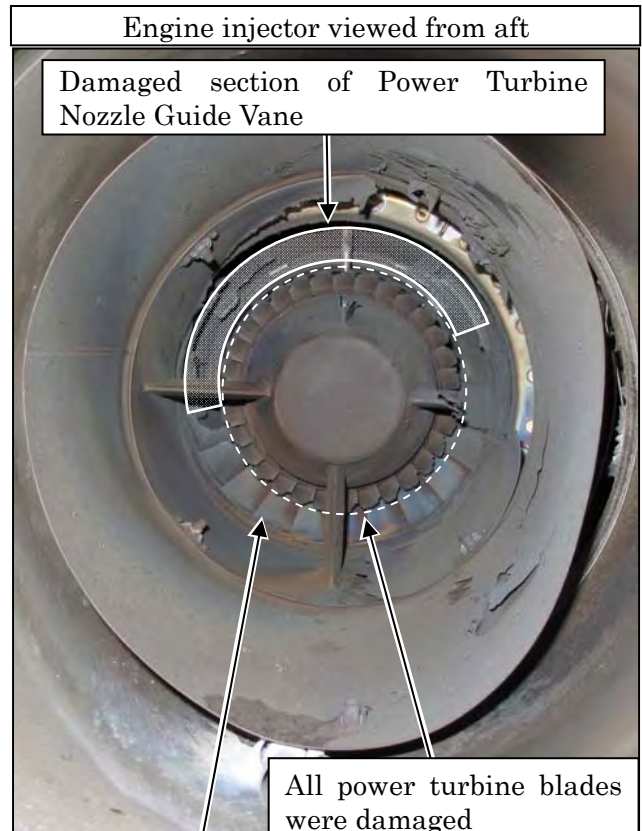
Exposed Power Turbine Nozzle Guide Vane

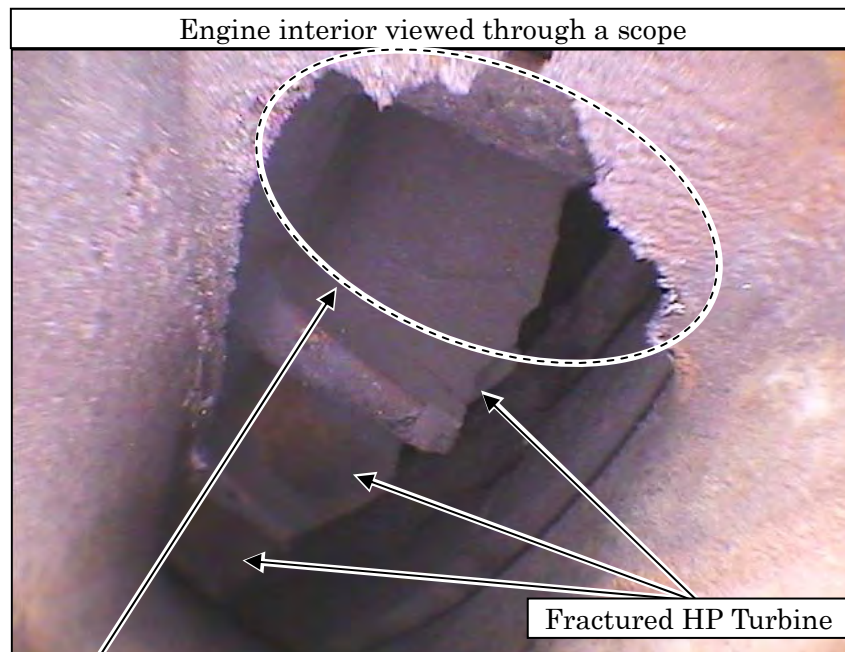
Fractured HP Nozzle Guide Vane

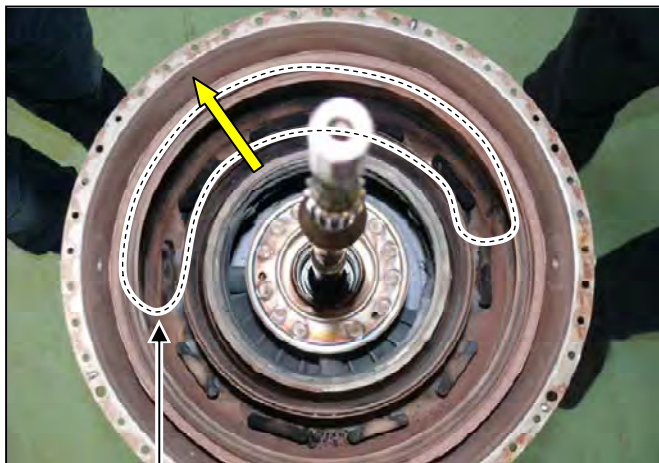
Combustion

Upper interior wall is discolored black indicating being over-heated

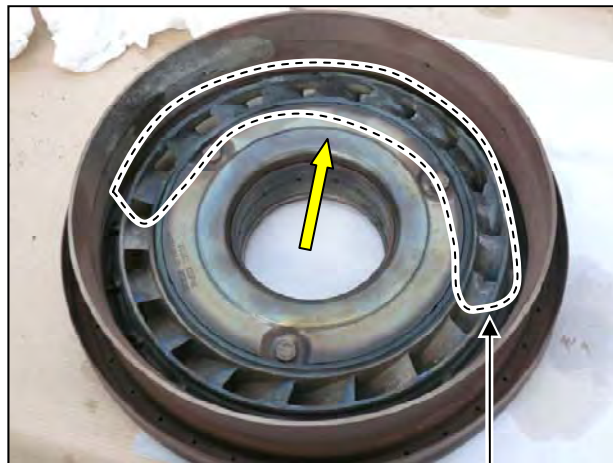
HP Nozzle Guide Vane

Upper structure is discolored by over-heating and trailing edges of vanes are damaged

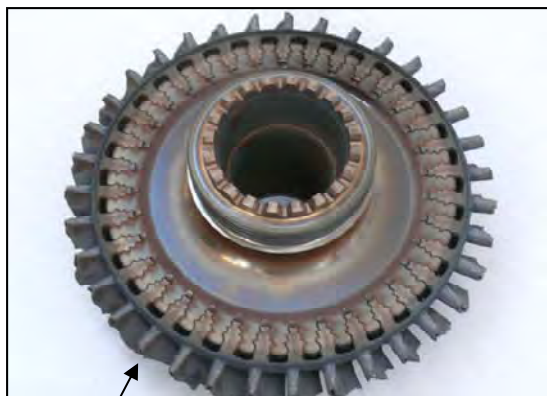
HP Turbine (rotating parts)

All blades are fractured at mid length

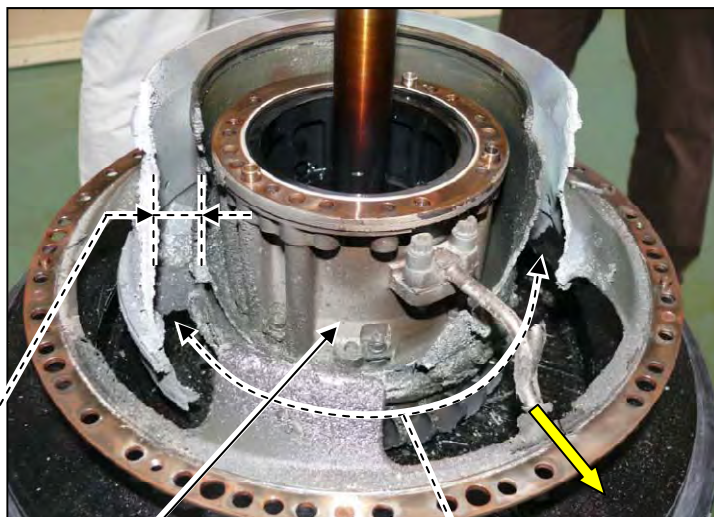
Rear Bearing  
Rear Bearing Support

Segment of damaged PT Nozzle Guide vane

Fractured Rear Bearing  
(Damage rear bearing support and Exposed rear bearing)

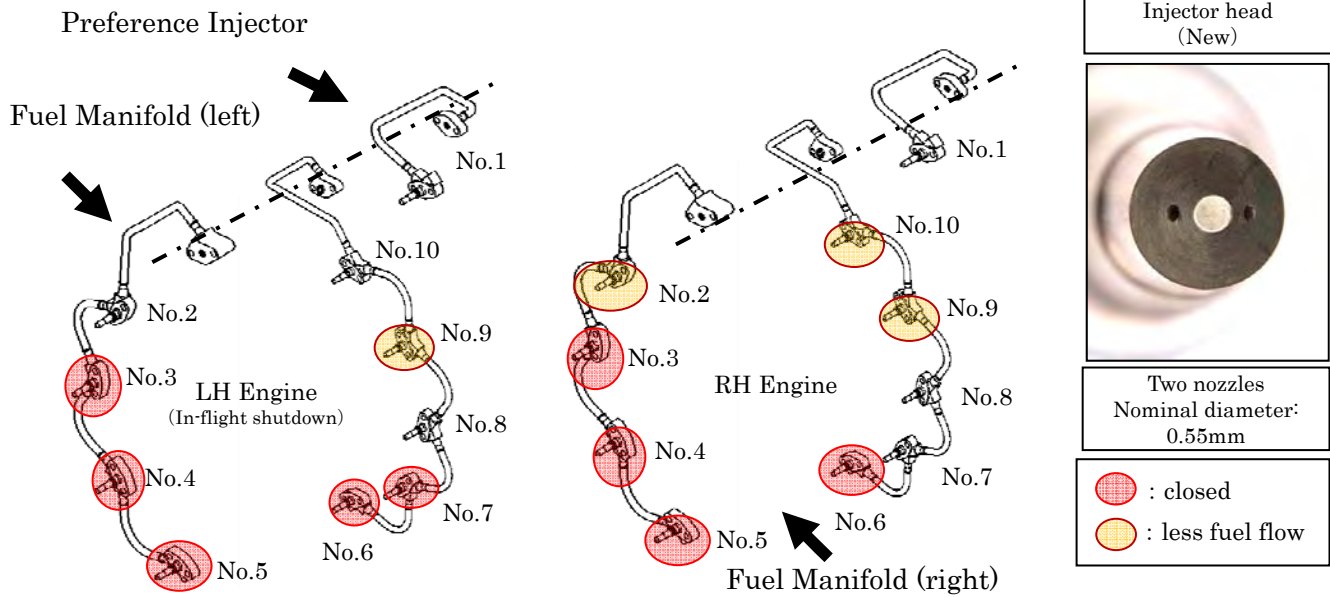
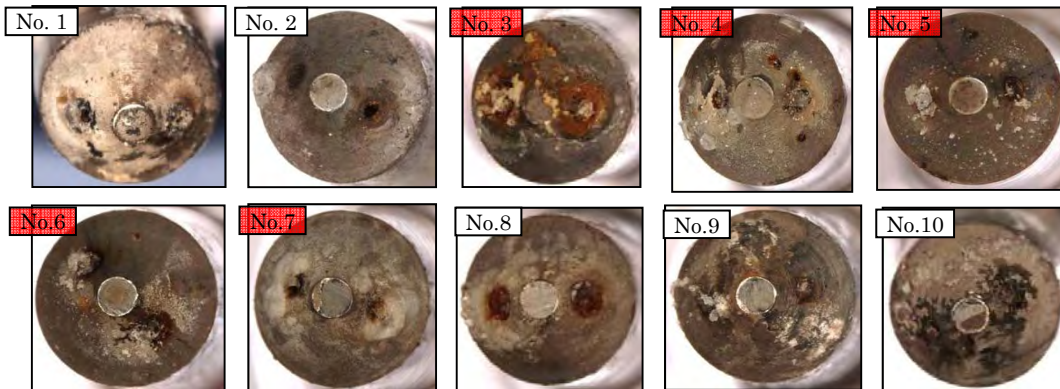
## 《Injector for Both Engines》

Accumulated white and brown foreign substances covered all of the 10 fuel injector outlets. A fuel flow test confirmed that five of them (No. 3 to No. 7) were clogged and one (No. 9 injector) demonstrated insufficient amount of flow. Accumulated foreign material was found near the inlet of the fuel filter upstream of fuel manifold.

Salt did not accumulate equally regardless of injector's location; the lower the injectors are, the more salt accumulation observed. This unequal accumulation was probably caused by gravity. There is also a possibility that differential pressures for fuel push-back were not necessarily equal due to clogged injectors

《Accumulated material on injector heads and clogged fuel nozzles for the left Engine which experienced in-flight shutdown (■ clogged)》

Injector heads are discolored in brown covered with accumulated with material (Analyzed to be NaCl)

1. Fungicide use was terminated.
2. Engine air inlets and exhaust pipes are plugged with covers when the helicopter is housed in the hanger.
3. Engine compressors are cleaned by cranking the engines (with the starter on without ignition) with cleaning water dosed with a cleaning agent authorized in the EMM. In case of post-flight EET exceeding 70 °C, another compressor cleaning is required next morning.
4. In-flight engine conditions are monitored.
5. Fuel filters and engine interiors are inspected with an endoscope at shorter intervals than prescribed in the EMM.

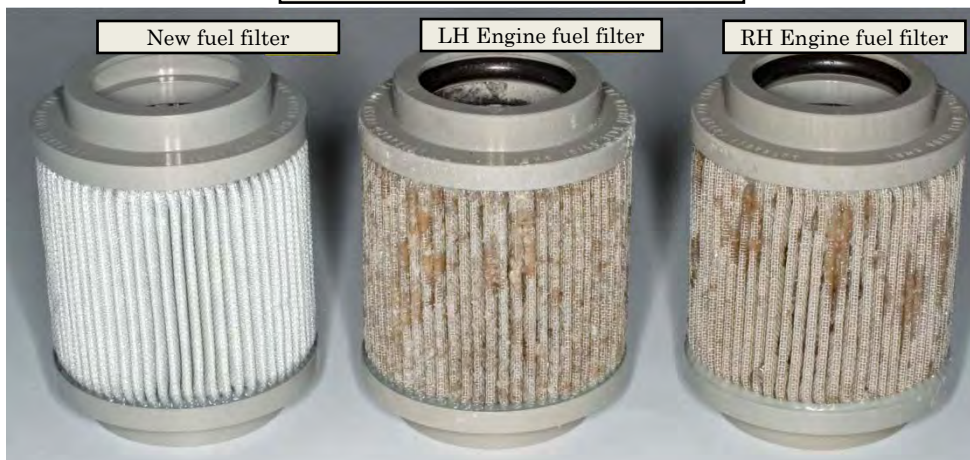
### Contaminated fuel filter

The fuel filter inlet was covered with accumulated materials. Analysis proved them to be NaCl

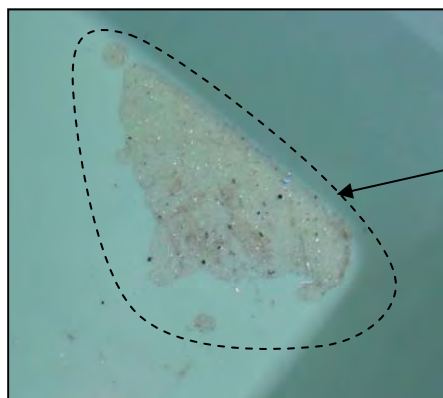
Photo 7: Transparent Liquid Taken from a Fuel Drain in Use

Transparent Liquid

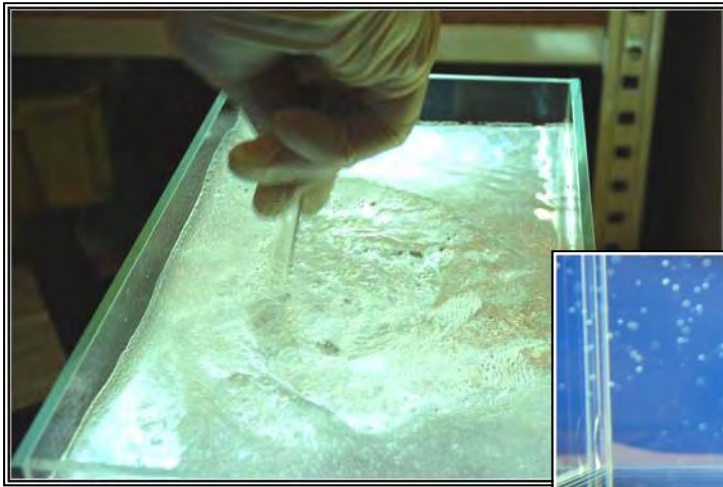
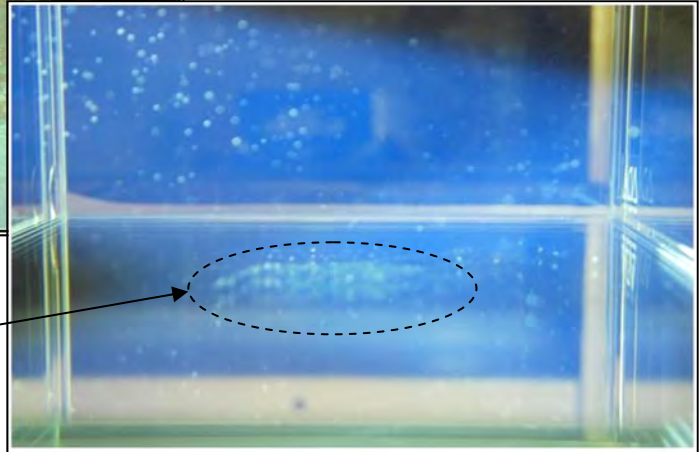
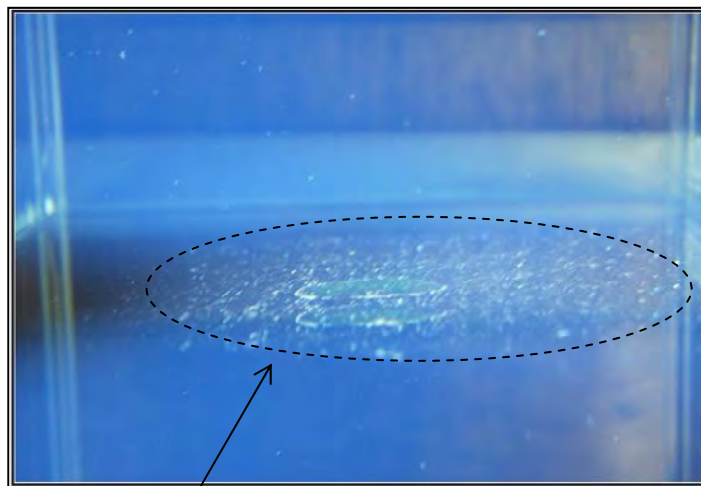
## Photo 8: Fungicide Dissolution in the Fuel

An amount of the fungicide, which creates a concentration of 50 ppm as specified in the EMM, was added to 10 l of fuel in a transparent container, stirred and left as it was for observation. After the stirring the fungicide became invisible dissolving into the fuel. After about 20 min of stationary condition, transparent substance precipitated at the bottom of the container. The condition of the mixture was observed for seven days stirring it once a day, but the precipitated transparent substance remained on the bottom.

When being left stationary, the fungicide deposited

The fungicide remains deposited

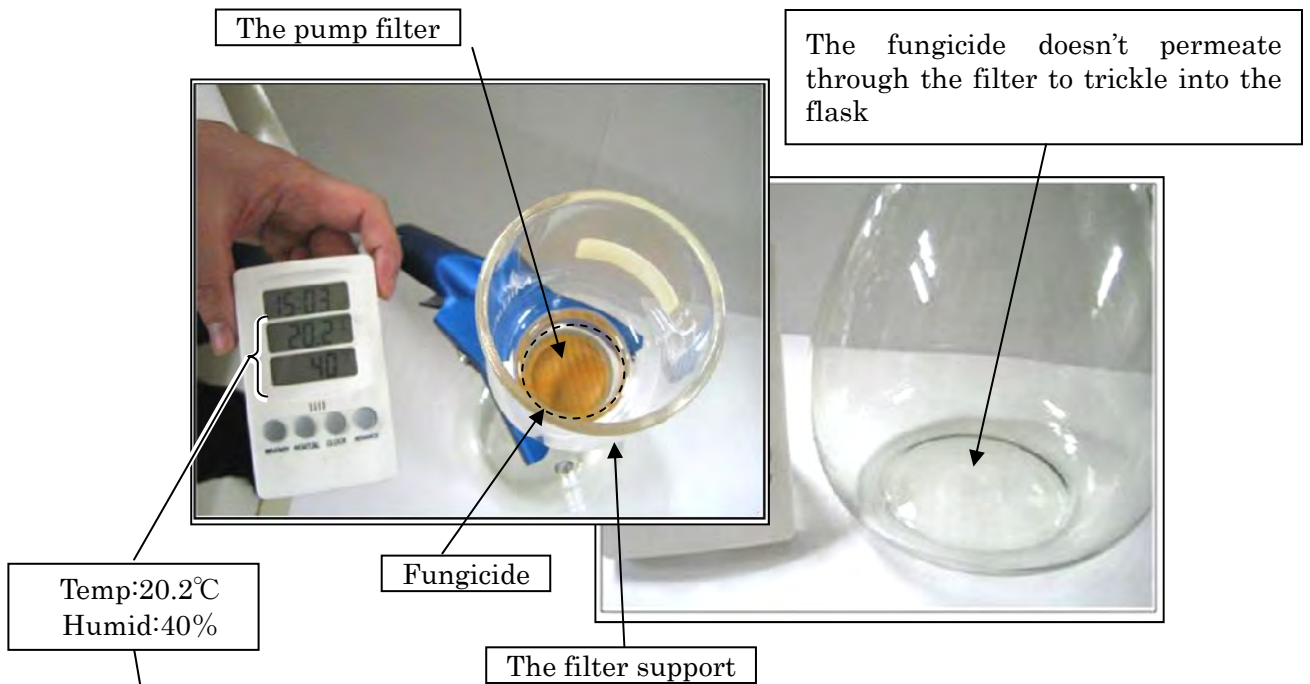
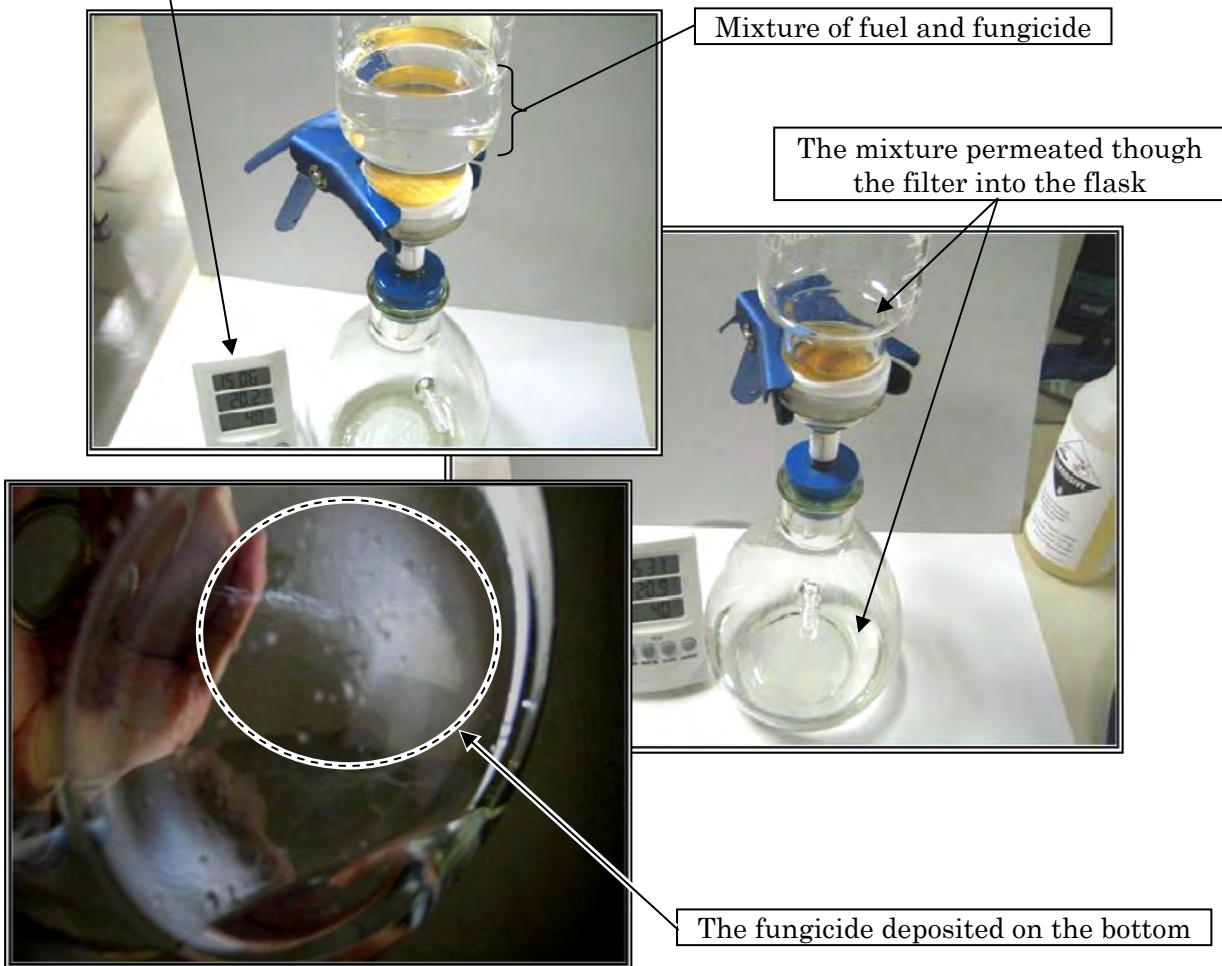
# Photo 9: Permeation of the Fungicide Through the Pump Filter

«1. The fuel filter stops the fungicide»

«2. The mixture of fungicide and fuel permeates through the filter»

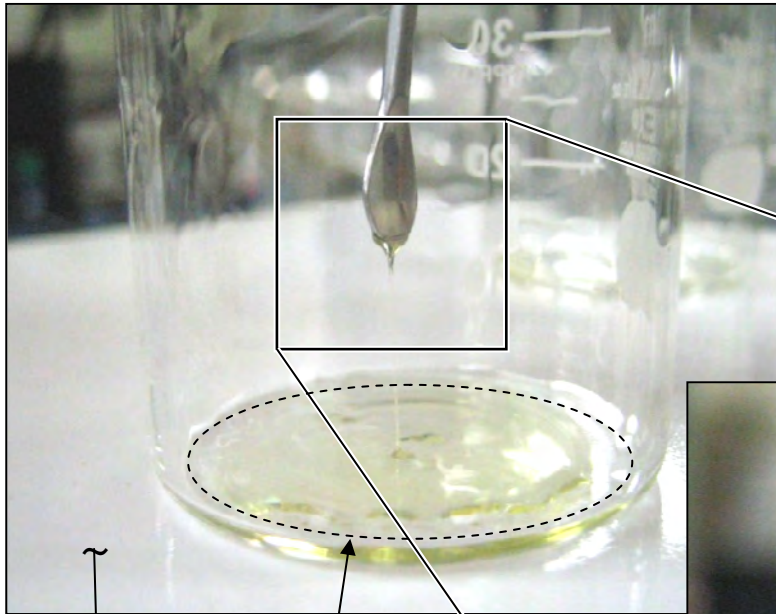
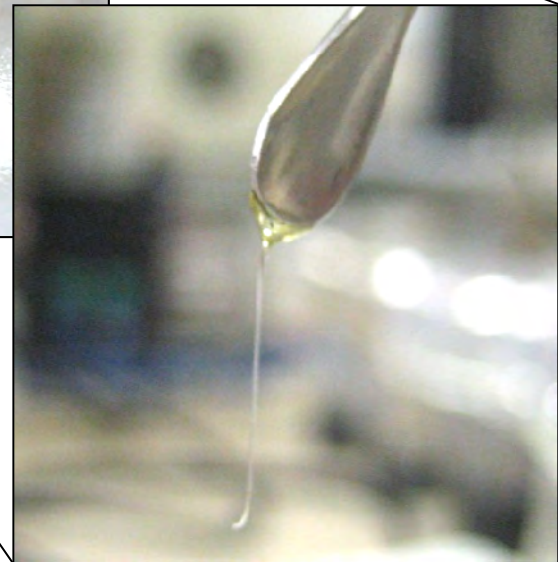
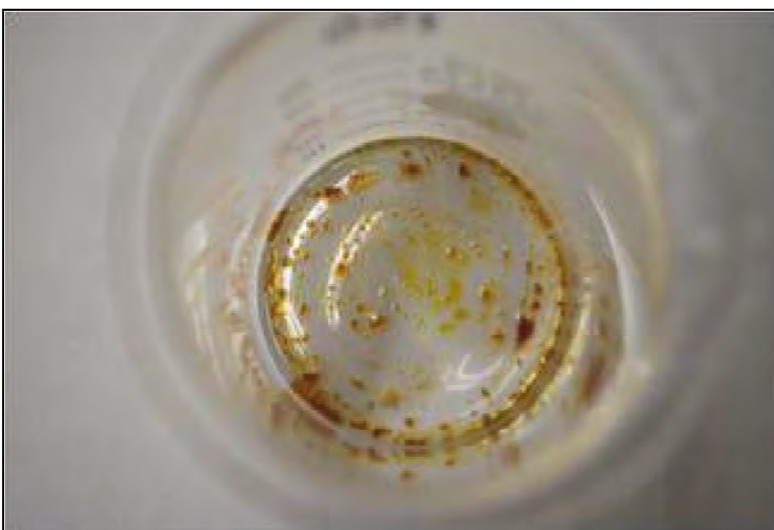
## Photo 10: Transformation of the Heated Fungicide

As the fungicide-dosed fuel is sprayed into the engine combustion chamber through hot injectors, heat influence on the fungicide was observed. When the fungicide in a beaker was heated, its viscosity gradually increased. When the applied temperature exceeded 200 °C, the fungicide transformed into dark brownish gum on the bottom.

When heated, the viscosity of the fungicide is increased

At more than 200°C, the fungicide was discolored to dark brown and left on the bottom
