AA2019-4

**AIRCRAFT ACCIDENT
INVESTIGATION REPORT**

**VANILLA AIR INC.
JA14VA**

FLIGHT ATTENDANT INJURY
BY THE SHAKING OF THE AIRCRAFT
VANILLA AIR INC.
AIRBUS A320-214, JA14VA
AT AN ALTITUDE OF ABOUT 9,100 M (FL300)
OVER THE SEA ABOUT 45 KM EAST OF
MIYAZAKI AIRPORT, JAPAN
AT ABOUT 10:35 JST, AUGUST 27, 2018

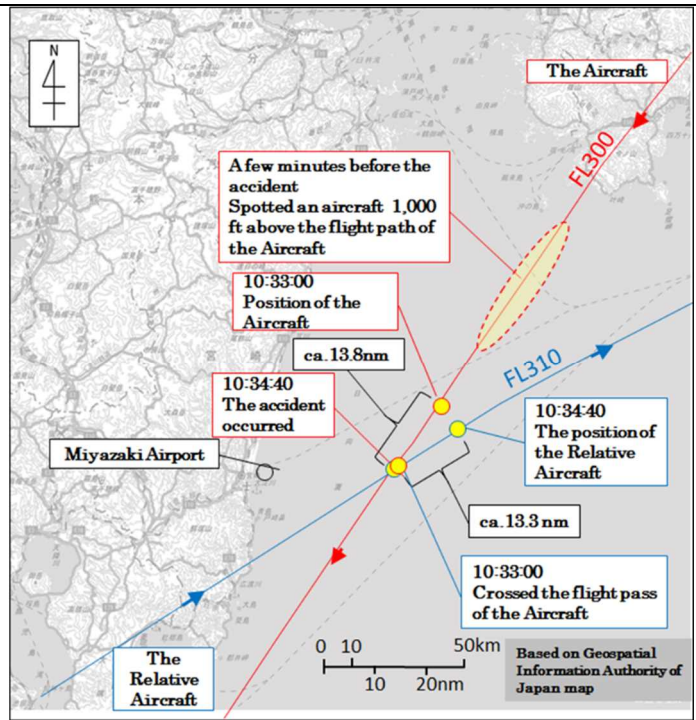
Figure 1: Estimated flight routes of the Aircraft and the Relevant Aircraft

According to the radar track records, about one minute 40 seconds before the accident, a Boeing 747-400F (CAL5254) was flying at FL310 from southwest to northeast in such a way as to cross the flight path of the Aircraft. The horizontal distance between the Aircraft and the Relevant Aircraft was about 13.3 nm when the accident occurred.

crossed 1,000 ft above the flight path of the Aircraft, and the Aircraft was flying 13.3 nm behind the Relevant Aircraft, when the Aircraft was shaken.

As described in the SIB issued by the European Aviation Safety Agency, on a flight at an altitude of 1,000 ft lower than the wake generating aircraft, it is possible to encounter wake turbulence up to 25 nm behind the wake generating aircraft, and the most significant encounters are reported within a distance of 15 nm. Judging from the fact that at the time of the accident, the winds were weak and the atmosphere was stable in the vicinity of the accident site, it is probable that wake turbulence from the Relevant Aircraft was not moved by wind but remained along the flight path of the Aircraft as it sank about 1,000 ft in about one minute and 40 seconds.

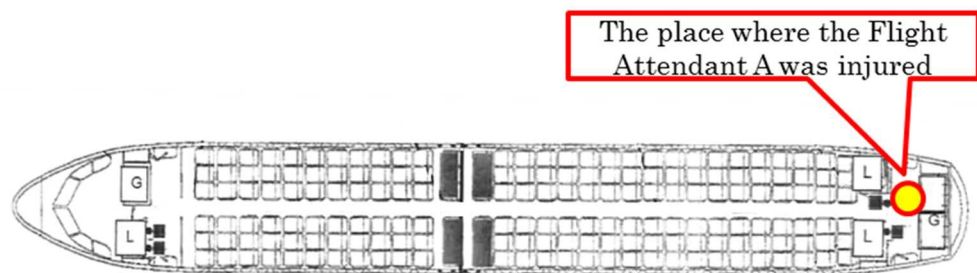
Figure 2: The place where the Flight Attendant A was injured

At 10:33:00, a few minutes after the PIC and the FO had spotted the Relevant Aircraft, it crossed in front of the Aircraft, and at 10:34:40, the Aircraft was suddenly shaken as if to be knocked up from below. At this time, the flight attendant (hereinafter referred to as “the Flight Attendant A”), who was preparing for cleaning in the aft galley after finishing in-flight services, had no time to grab something around her due to a sudden vertical shaking, fell down feeling as if her both feet floated in the air, and hit hard her buttock against the floor. The PIC and the FO felt that the shaking at this time was about the level of the light turbulence*3.

It is probable that because the winds were weak and the atmosphere was stable condition in the vicinity of the accident site, the weather conditions can be excluded from the factor that had triggered the shaking of the Aircraft that occurred only once; and the shaking of the Aircraft resulted from the Aircraft crossing through the Relevant Aircraft's wake turbulence which remained along the flight path of the Aircraft. It is also probable that the shaking of the Aircraft caused the Flight Attendant A to lose her balance, fall down and get injured in her buttock.

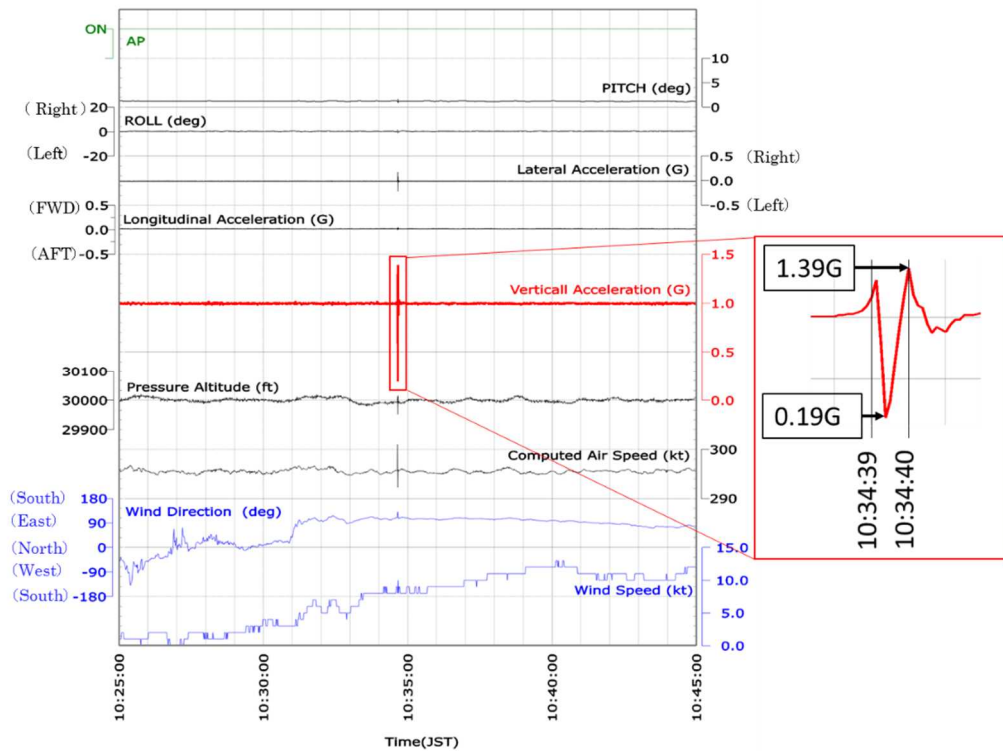
Figure 3: QAR records

According to the QAR records, from 10:34:39 to 10:32:40, the vertical acceleration fluctuated momentarily in the range between +0.19 G and +1.39 G. When the vertical acceleration fluctuated, there was little change in the attitude of the Aircraft.

It is probable that the timing of the Aircraft's shaking corresponded to the instantaneous fluctuation in vertical acceleration that was recorded on QAR.
