**AIRCRAFT SERIOUS INCIDENT  
INVESTIGATION REPORT**

## AIR PROXIMITY

1. KUMAMOTO PREFECTURE DISASTER PREVENTION FIRE  
FIGHTING AVIATION UNIT, EUROCOPTER AS365N3,  
JA15KM (ROTORCRAFT)

2. PRIVATELY OWNED, ROBINSON R44 II,  
JA344T (ROTORCRAFT)

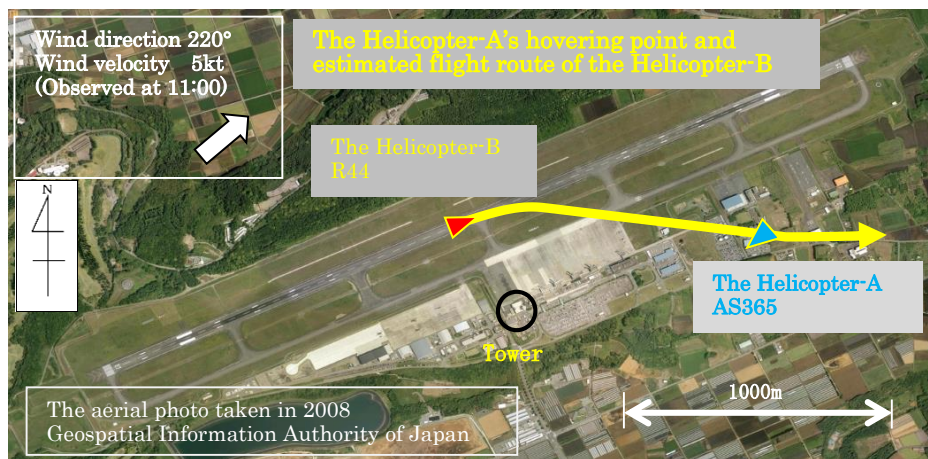
According to the captain of the Helicopter-B, in case of straight out departure, he usually flew straight until just before the end of runway, then turned right about 15 degrees, to which the Tower mentioned nothing particular. On the day the incident occurred, having thought it would be better to vacate the runway early for other arriving and departing aircraft, the Helicopter-B’s captain turned right immediately after takeoff without communicating his intention to the Tower.

Subsequently, the Helicopter-B flew just above the hovering Helicopter-A.

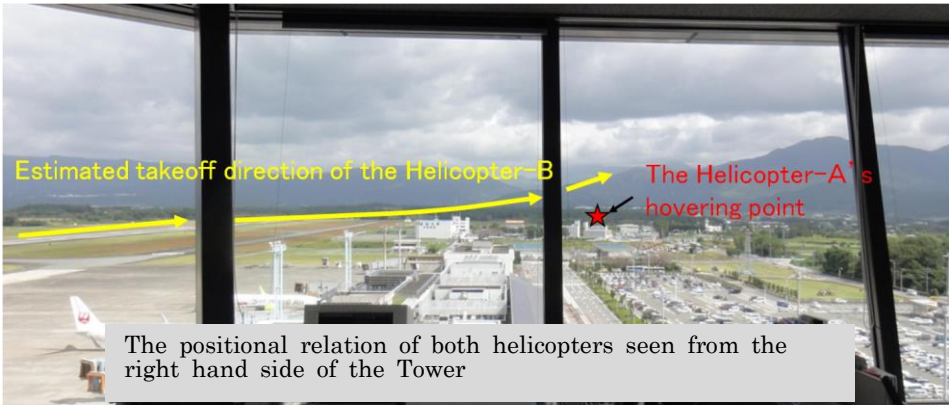
<p>Estimated takeoff direction of the Helicopter-B</p> <p>The Helicopter-A's hovering point</p> <p>The positional relation of both helicopters seen from the right hand side of the Tower</p> <p>Helicopter-B should fly almost in the direction of the runway extension and not fly in the direction of the Helicopter-A's training area. (ii) The altitude the Helicopter-A hovers is lower than the nearby buildings. Therefore, the Tower thought landing and takeoff aircraft at/from the airport would never get close to the Helicopter-A. (iii) At the time of the incident, the Tower was controlling three other aircraft's takeoff and landing and so on. (iv) The Tower had experiences that Helicopter-B's long transmission influenced other communications in the past and concerned a similar situation might happen.</p>
