**AIRCRAFT ACCIDENT
INVESTIGATION REPORT**

**JAPAN COAST GUARD SCHOOL MIYAGI BRANCH
J A 1 8 4 A**

DAMAGE TO AIRFRAME DUE TO HARD LANDING JAPAN COAST GUARD SCHOOL MIYAGI BRANCH BELL 505 (ROTORCRAFT), JA184A AT SENDAI AIRPORT, JAPAN AROUND 14:06 JST, FEBRUARY 27, 2019

August 30, 2019

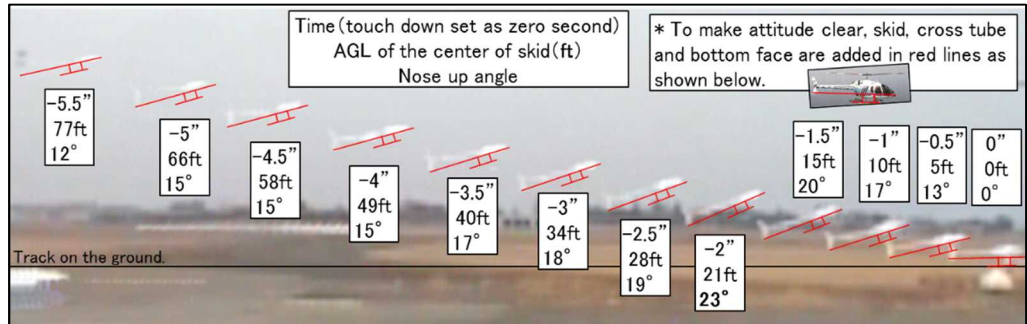
Figure 9: Monitor camera footage set at apron

Situation at the time of the accident was recorded in the monitor camera set at the apron, sequence photos of which are as shown in Figure 9. The helicopter had 12° nose up at 77 ft AGL 5.5 seconds before touchdown, 15° nose up at 49 ft AGL 4 seconds before touchdown and 23° maximum nose up at 21 ft 2 seconds before touchdown, and then, nose down was commencing followed by touched down in a horizontal attitude.
