**AIRCRAFT SERIOUS INCIDENT
INVESTIGATION REPORT**

**J-AIR CORPORATION
J A 2 0 2 J**

April 23, 2015

RUNWAY EXCURSION DURING LANDING J-AIR CORPORATION BOMBARDIER CL600-2B19, JA202J AT HANAMAKI AIRPORT, IWATE PREFECTURE, JAPAN AT AROUND 17:20 JST, DECEMBER 25, 2012

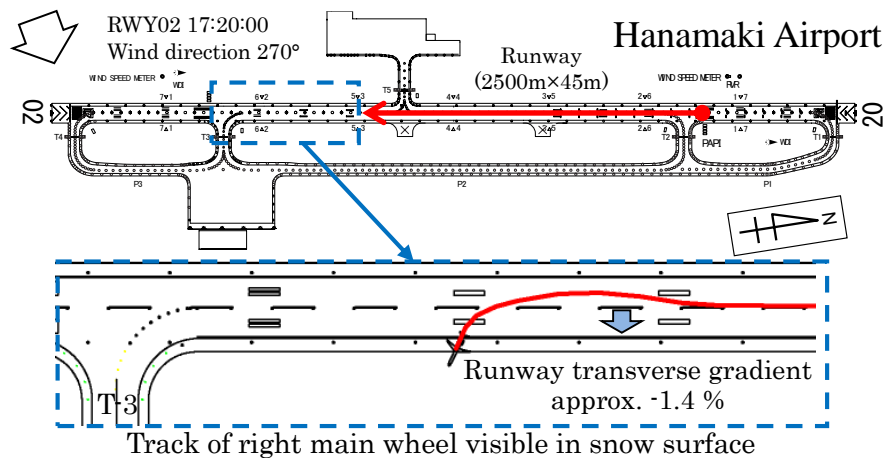
After this, the Captain again used idle reverse in an attempt to reduce speed, whereupon the deflection of the nose to the right stopped and it started deflecting significantly to the left. Then, from around the time the nose was aligned with the direction of the runway, the depression of the rudder pedals switched from maximum left to maximum right. However, the nose still continued to deflect to the left, the aircraft ran off the side of runway with the pitch angle of the aircraft decreased, and came to a halt in a state with the nose landing gear protruding approximately 7m outside the runway pavement surface. The nose wheel had sunk down; accordingly the aircraft was disabled to perform taxiing.

It is probable that this serious incident occurred, when the aircraft landed, it was unable to maintain the direction of movement on the runway after touching down, resulted in veering off the runway to the left side.

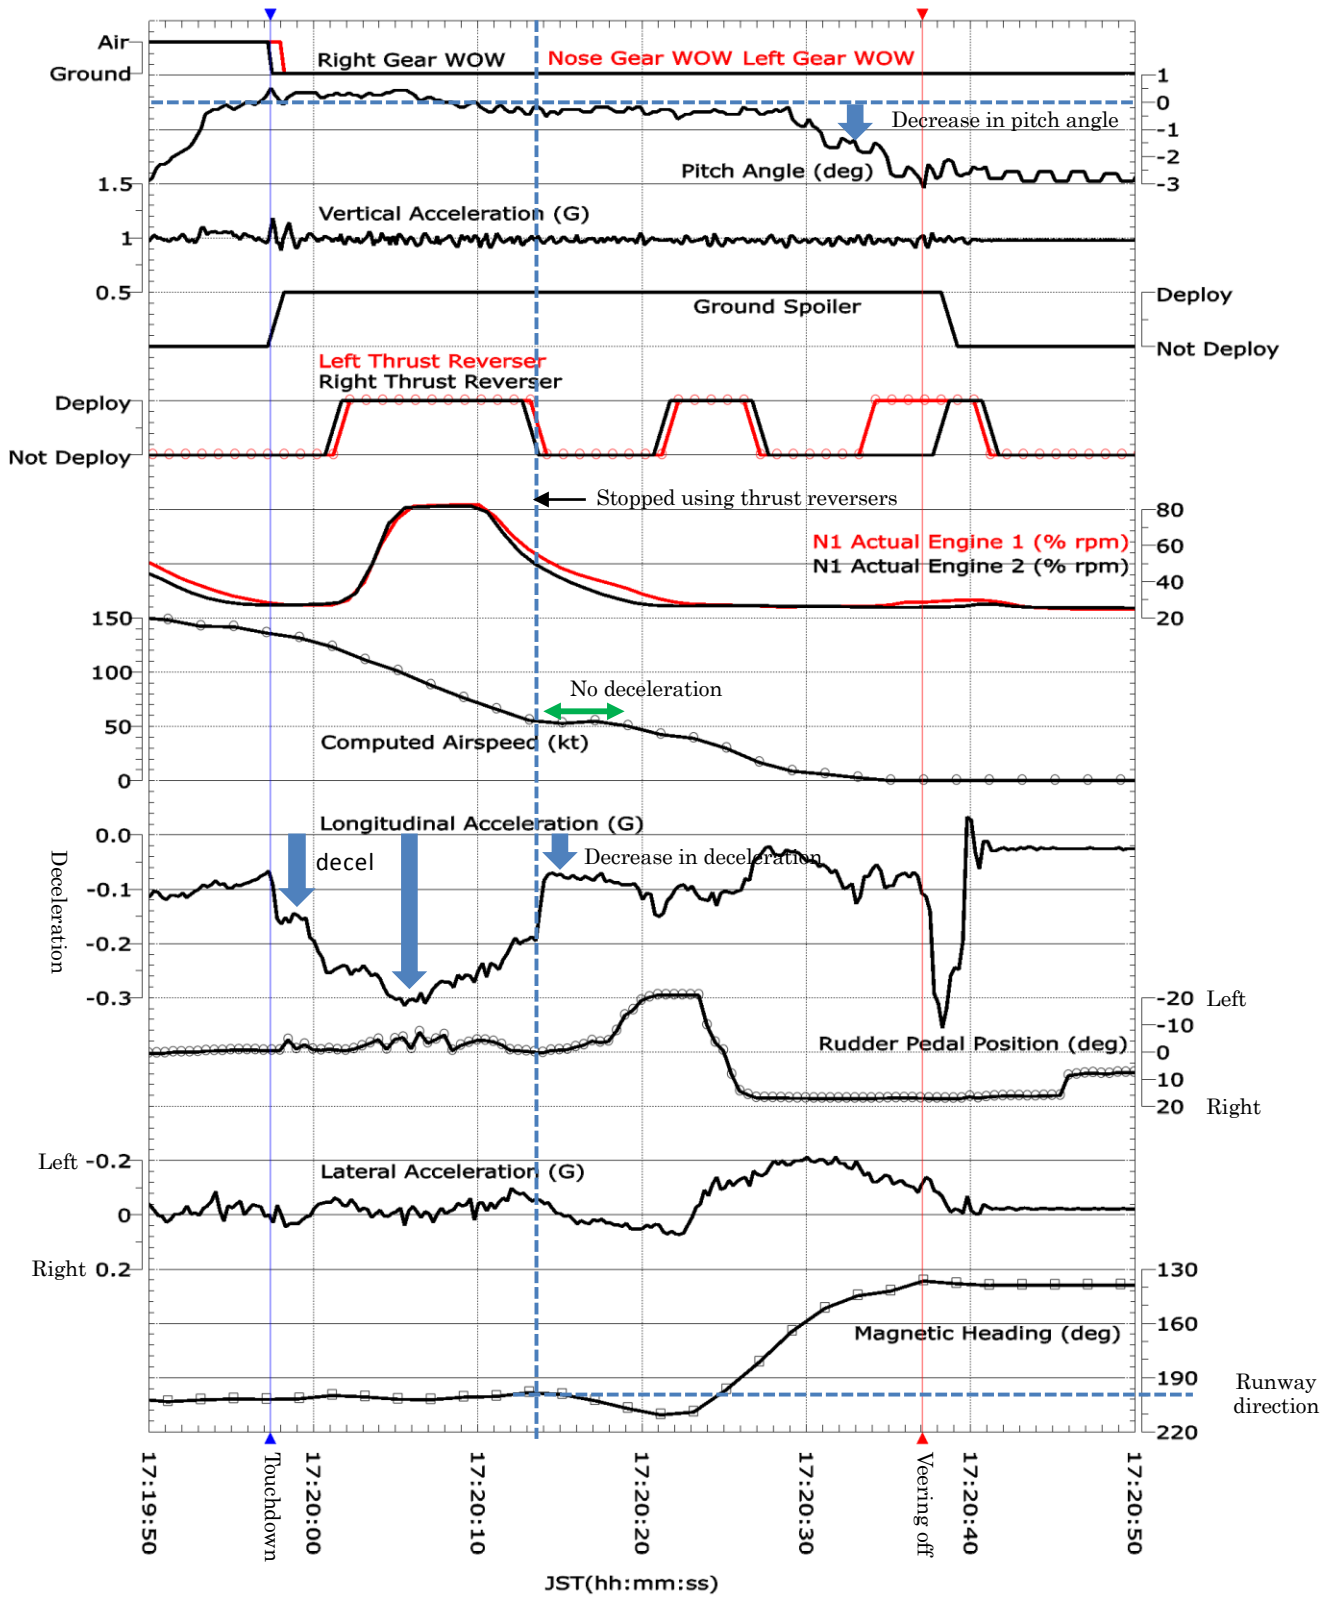
Figure DFDR Records

The Captain stated that the feeling of deceleration was lost from around the time the 60 kt call was heard, and it was also recorded in the DFDR that the deceleration rate decreased from around the time the Captain stopped using the thrust reversers. It is probable that the decrease in the deceleration rate occurred because the runway was more slippery than the Captain had anticipated, and he stopped using the thrust reversers in a situation where the brakes were not sufficiently effective.

The DFDR recorded that the nose deflected to the right as the deceleration rate decreased. It is probable that, with the runway in a slippery condition, the nose deflected to the right as a result of the weathercock effect, whereby the nose turns to windward, because a wind from the right direction of the aircraft blew stronger as the aircraft

<p>moved ahead the runway.</p> <p>(5) Subsequent aircraft deflection to the left and veered off the runway</p> <p>The DFDR recorded that after the nose deflected to the right, the rudder pedals were operated to maximum left and the nose deflected to the left. It is probable that the Captain operated the left rudder pedal in order to return the aircraft to the runway centerline after it had deflected to the right, but because the nose did not react, operated the rudder pedal to maximum left in the end. However, it is probable that a large deflection to the left started because the rudder pedal input was too large.</p> <p>The DFDR recorded that the operation of the rudder pedals changed from maximum left to maximum right from around the time when the nose deflected significantly to the left and the nose was aligned with the runway direction, and it is probable that the Captain suddenly operated the rudder pedals to the opposite direction in order to stop the large deflection to the left. It is probable that, because the Captain suddenly operated the rudder pedals to the opposite direction, the nose wheel slipped and the deflection of the aircraft did not stop, resulted in veering off the runway. In addition, it is probable that the decrease in the aircraft pitch angle was due to the effect of the runway's transverse gradient, and it is somewhat likely that the runway's downward transverse gradient towards the direction of movement of the aircraft also contributed to the aircraft veering off the runway.</p> <p>Concerning the operation of rudder pedals to maintain the direction on a slippery runway surface, it is probable that it would be effective to control the nose wheel while avoiding sudden operation, within a range in which the reaction of the nose direction can be confirmed, utilizing the width of the runway.</p> <p>(6) Provision of runway surface condition concerning snow and ice</p> <p>It is probable that the runway surface condition when the aircraft landed was worse than when the runway condition check was carried out. Therefore, it is desirable that airport administrators and operators should endeavor to grasp the runway surface condition at all times, while also conveying information closer to the actual runway surface condition to pilots, in order that they can achieve appropriate judgments and operation.</p>

- (i) Endeavor to obtain the latest information, because the runway surface condition can change in a short time.
- (ii) Avoid sudden operation of rudders when responding to nose deflection as best they can.
- (iii) When the braking action of the runway surface condition is poor, make positive use of idle reverse even below 60 kt, and use it until deceleration can be definitely confirmed.
