**AIRCRAFT SERIOUS INCIDENT
INVESTIGATION REPORT**

**J-AIR CORPORATION
J A 2 0 6 J**

February 26, 2015

FIRE WITHIN THE ENGINE FIRE ZONE
J-AIR CORPORATION
BOMBARDIER CL-600-2B19, JA206J
ON THE TAXIWAY A4 AT OSAKA INTERNATIONAL AIRPORT
AT AROUND 12:15 JST, MAY 6, 2013

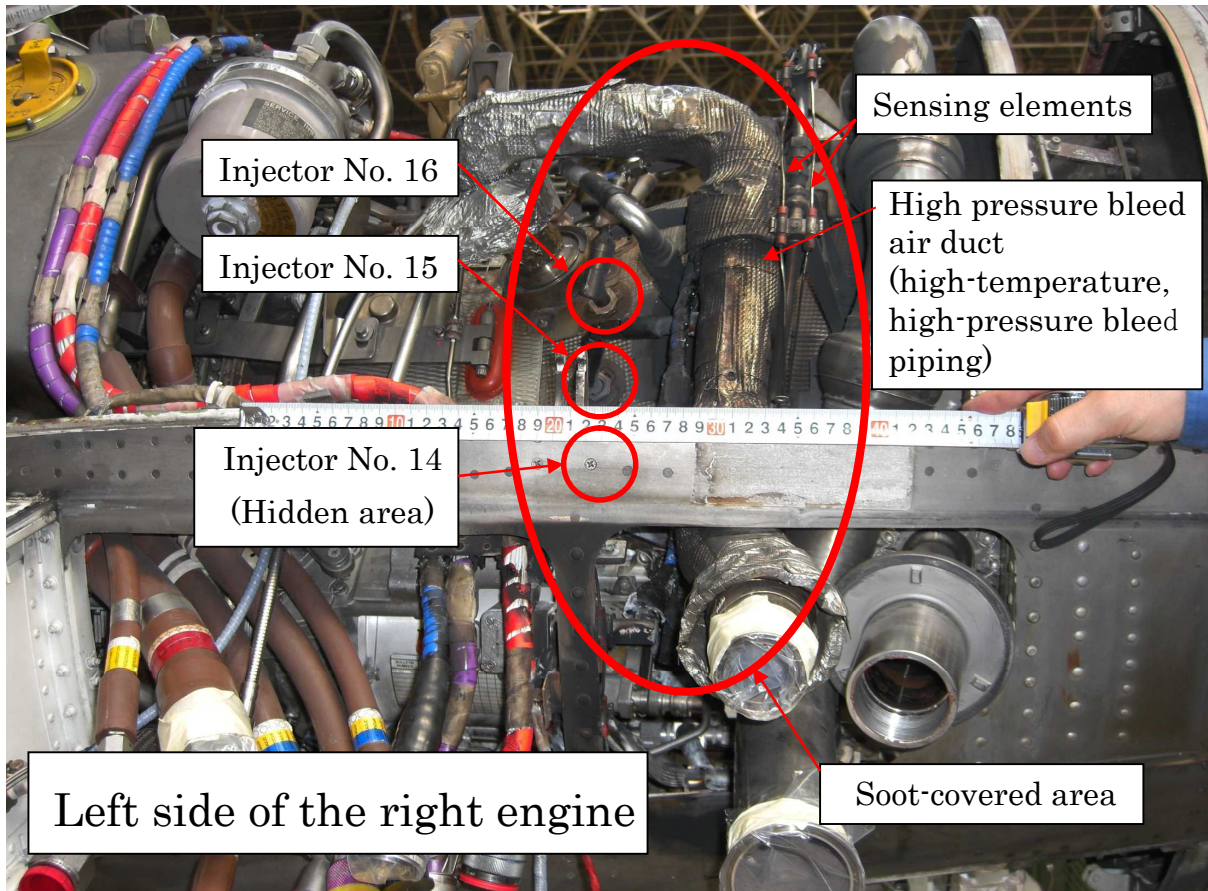
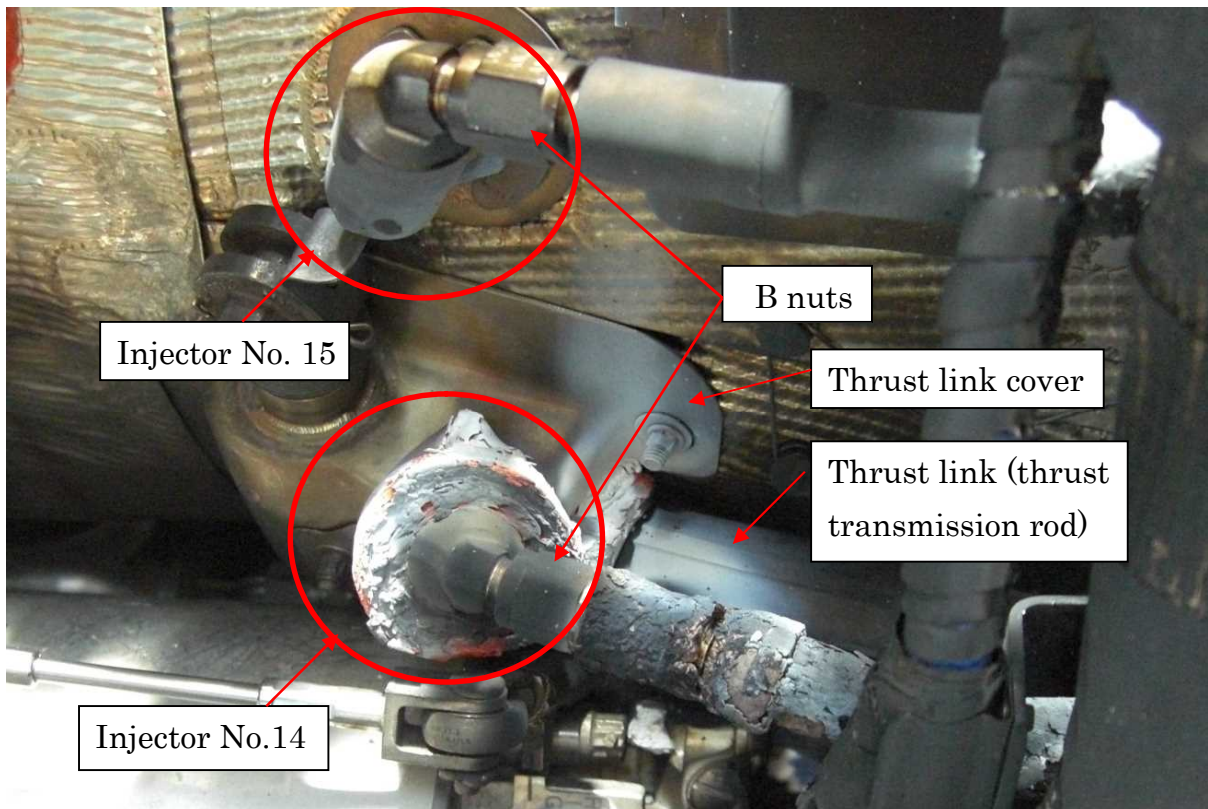
Photo 2: Evidence of the Fire 1

There were partial burn out and some soot deposits on the surface of the fuel manifold (hereinafter referred to as the “manifold”) connected to the fuel injectors (hereinafter referred to as the “injectors”) from No. 12 to No. 14 of the right engine. There was also soot deposits to the inside of the cowling directly above the manifold surface with burn out. In addition, there were discoloration marks suggesting that a liquid had burned on the surface of the hoses and the fuel/oil heat exchanger (the heat exchanger for fuel and oil) below injector No. 14. Below this area, there were no fire traces, nor were there any traces within the lower cowling. Moreover, there was no evidence of fire or smoke occurring outside of the engine.

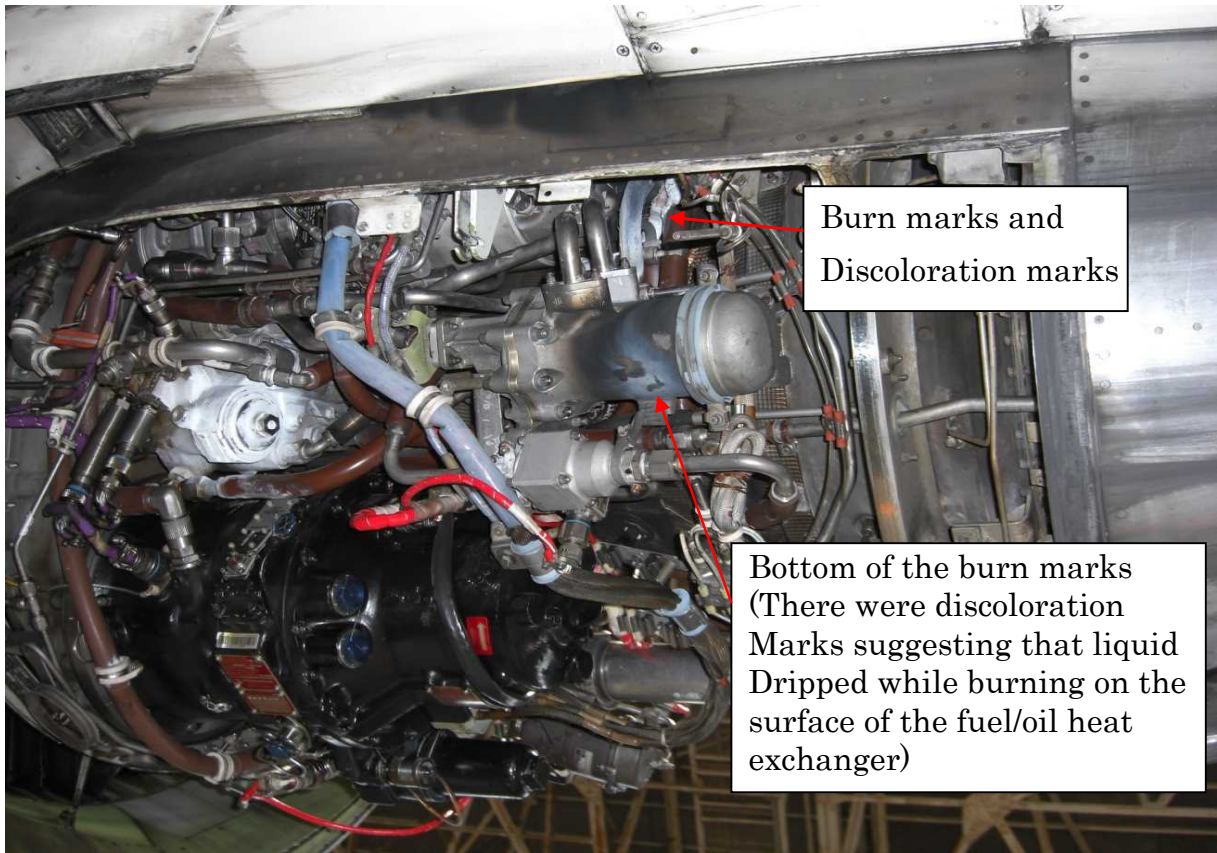
Photo 3: Evidence of the Fire 2

Burn marks and Discoloration marks

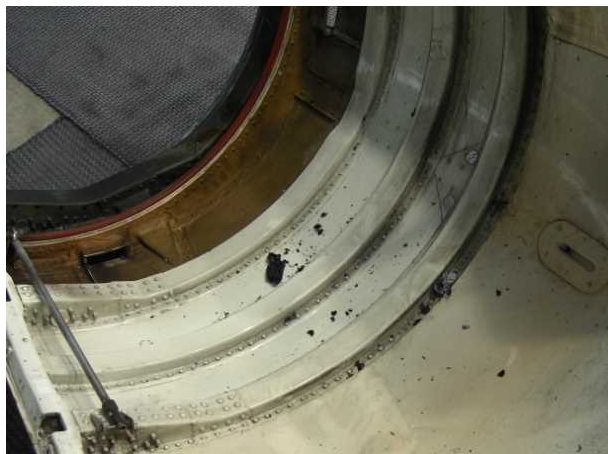
As described in 2.3.2, because the liquid burn marks did not reach to the lower cowling, it is somewhat likely that the quantity of leaked fuel was small. In addition, the JTSA couldn't determine the time at which the fuel began to leak.

There was soot on the upper cowling directly above where the the fire occurred.

There were no burn marks on the lower cowling

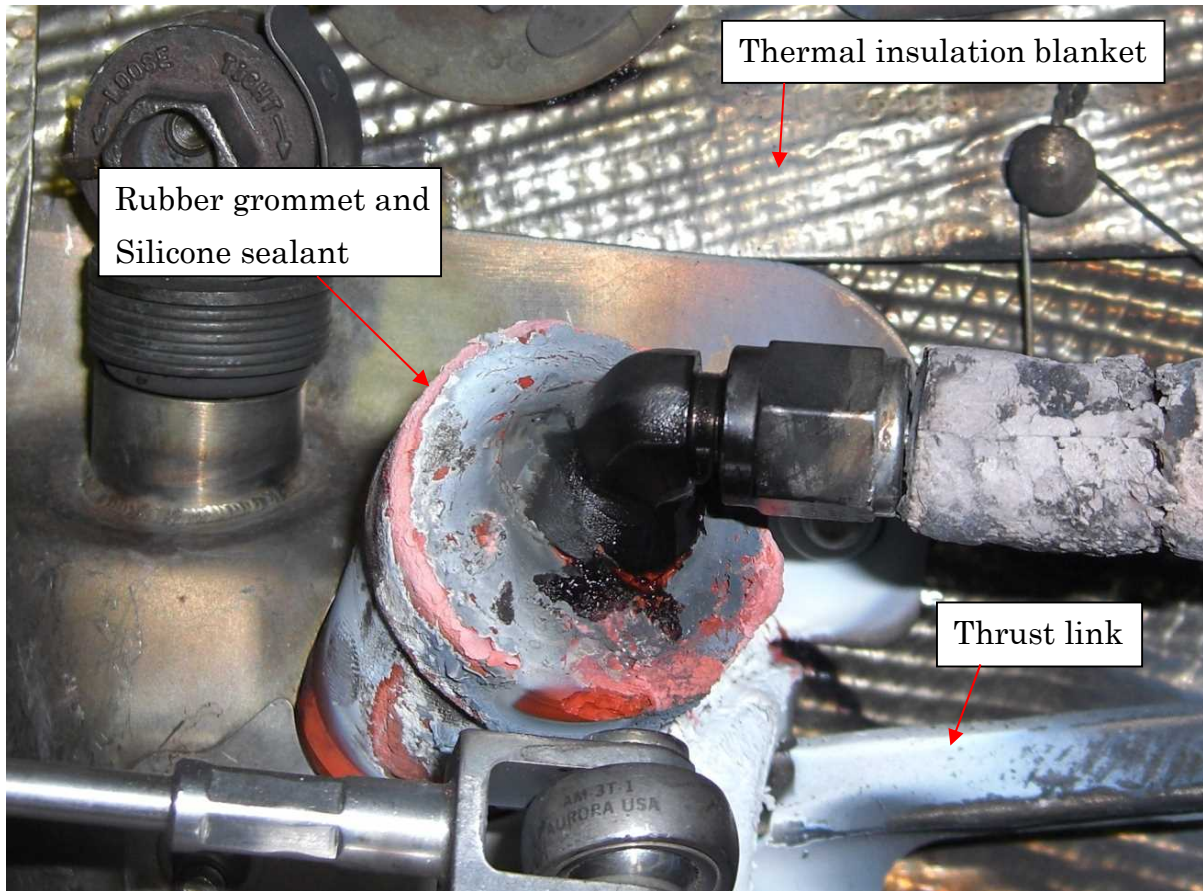
Photo 4: Confirmation of Fuel Leaks

When the right engine was brought into IHI, the factory designated by the engine manufacturer, for wet motoring^{*15} on the test cell, the leakage of small quantities of fuel was found near the coupling nut (hereinafter referred to as “B nut”) connecting injector No. 14 and the manifold.

The tightened torque value for the B nut connecting injector No. 14 was too loose to be measured with the torque wrench, and the screw could be turned by hand. By tightening the B nut connecting injector No. 14 to the minimum specified torque value of 135 lb-in, it was found to move approximately 3 mm on the circumference of the circle. When fuel was injected under pressure after re-tightening, no fuel leakage was found.

As described in 2.8.1, it is certain that in this serious incident, there was loosening in the B nut connecting injector No. 14 and the manifold, which caused fuel leakage to occur.

The wet motoring in the test cell revealed that fuel had leaked from the B nut connecting the injector No. 14 and the manifold. In addition, it was confirmed that the B nut was loose.

Because the starter is used for wet motoring, the RPM was approximately 30 % (approximately half of idle RPM), the time was approximately 30 seconds, and the fuel pressure was approximately 30 psi.

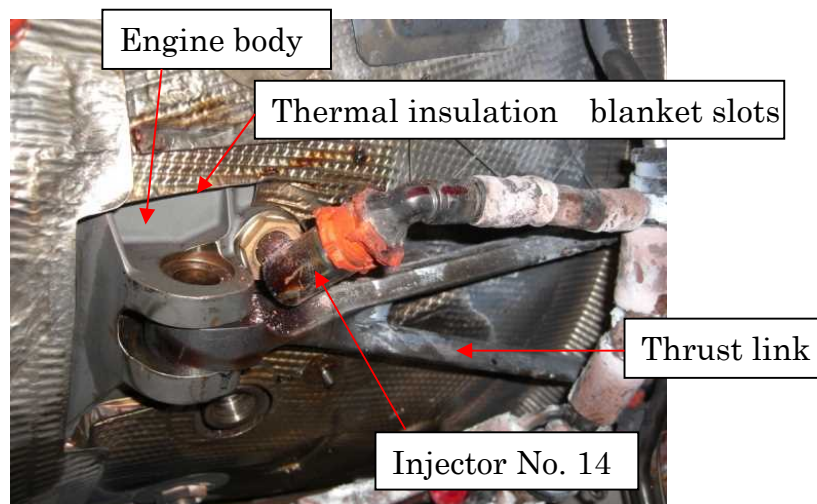
Photo 5: Thermal Insulation Blanket Slots

The engine surface where there were remarkable burn marks is covered with thermal insulation blankets. According to the documentation on the engine surface temperature provided by the engine manufacturer, the surface temperature of the blankets may be higher than the fuel auto-ignition point depending on operating conditions.

There are large slots in these blankets for structural reasons near injector No. 14 where fuel leakage was discovered. For this reason, there is no heat insulation near injector No. 14.
