# **AIRCRAFT ACCIDENT INVESTIGATION REPORT**

**The General Incorporated Association Tokai/Kansai Student Aviation League  
J A 2 1 5 1**

**February 16, 2023**

<b>Company</b>	The General Incorporated Association Tokai/Kansai Student Aviation League
<b>Type, Registration Mark</b>	Alexander Schleicher ASK13 (Glider, Two-Seater), JA2151
<b>Incident Class</b>	Injury to a person on board upon landing
<b>Date and Time of the Occurrence</b>	At about 09:58 Japan Standard Time (JST: UTC+9 hours), March 21, 2022
<b>Site of the Accident</b>	Kisogawa Gliding Field, Kaizu City, Gifu Prefecture (35° 12' 22" N, 136° 40' 43" E)

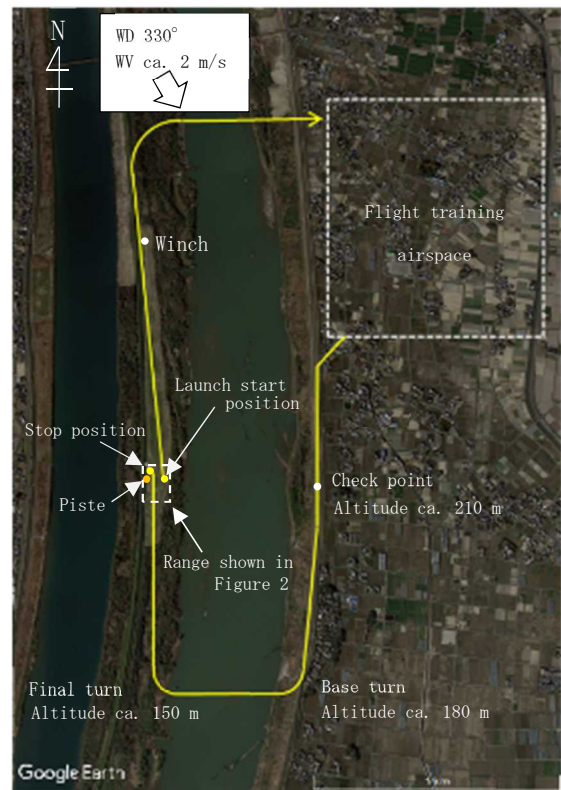
Figure 1: Estimated flight route

At about 09:51, the glider was launched from Runway 36 at Kiso-gawa Gliding Field with the trainee in the front seat for solo flight training. The flight instructor was standing next to the piste (command post), holding a microphone, and supervising the flight of the glider being able to communicate with the glider by radio. The glider released the tow line at an altitude of about 530 m, turned to the right to enter the flight training airspace, and conducted flight training such as a 360 degree-turn and others. After that, the glider passed the checkpoint\*1 at an altitude of about 210 m. The base turn was completed at an altitude of about 180 m, which was 30 m higher than the target of 150 m, therefore, the Trainee slightly extended the dive brakes.\*2 As the flight instructor believed that the Trainee could correct the altitude by themselves, the flight instructor did not give any specific instructions. As the final turn was completed at an altitude of about 150 m, which was still about 30 m higher than the target of 120 m, the Trainee fully extended the dive brakes and continued to approach the runway. The flight instructor instructed the Trainee to extend the dive brakes, feeling that the altitude was a little higher after the final turn. The trainee lowered the altitude as well as continued approaching

After that, the glider passed the checkpoint\*1 at an altitude of about 210 m. The base turn was completed at an altitude of about 180 m, which was 30 m higher than the target of 150 m, therefore, the Trainee slightly extended the dive brakes.\*2 As the flight instructor believed that the Trainee could correct the altitude by themselves, the flight instructor did not give any specific instructions. As the final turn was completed at an altitude of about 150 m, which was still about 30 m higher than the target of 120 m, the Trainee fully extended the dive brakes and continued to approach the runway. The flight instructor instructed the Trainee to extend the dive brakes, feeling that the altitude was a little higher after the final turn. The trainee lowered the altitude as well as continued approaching

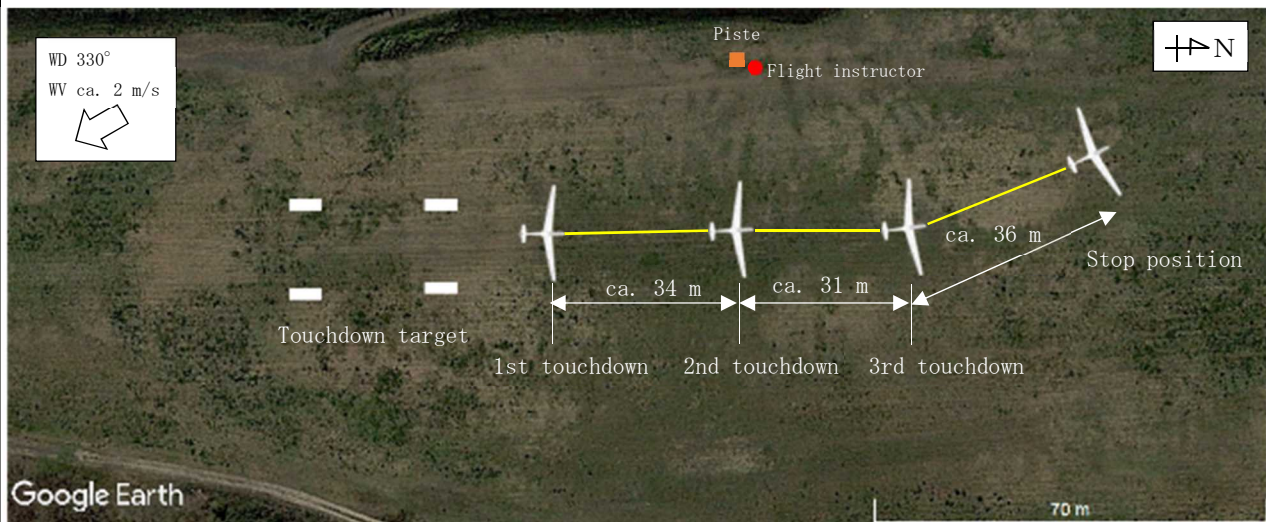
Figure 2: Estimated flight route (detail)

by the crab method.\*<sup>3</sup> After a while, the Trainee noticed that the approach path was deviated to the left from the touchdown target of the four white strips put on the runway. The Trainee was concentrated on correcting the speed and the approach path and continued to carefully watch the touchdown target, but when the trainee realized, the glider had passed 5 m in altitude, which is the reference for an operation to flare. Without reducing the descent rate, the glider made the first touchdown beyond the touchdown target and bounced. After the Trainee closed the dive brakes following the instruction from the flight instructor saying, “Close the dive”, the glider made the second touchdown at about 34 m forward, and the Trainee felt pain when their back was hit hard. After bouncing again and making the third touchdown at about 31 m forward from the second touchdown point, it ran on the ground. The Trainee extended the dive brakes to apply the brakes, and the glider stopped at about 36 m forward from the third touchdown point. (See Figure 2) Post-flight inspection found cracks in the cut-off places of the left aileron and a part of the trailing-edge of both the right and left main wings. The Trainee was diagnosed with a fracture on March 27, 2022.

a. The JTSB concludes that the Trainee commenced landing approach while not being able to lower the altitude sufficiently, and fully extended the dive brakes until the landing, thus the descent rate became higher than usual, and the flare operation was delayed due to the Trainee concentrating on correcting the speed and approach path, which was highly probable in resulting in the failure to reduce the descent rate of the glider. Therefore, the glider made a hard landing and bounced several times. The Trainee was most likely injured due to the impact of the second touchdown when the speed became slower than that in the first touchdown and the lift decreased.

The JTSTB concludes that the probable cause of this accident was that the Trainee made a landing approach on the path higher than usual with the dive brakes fully extended, thus the descent rate became higher than usual, and the flare operation was delayed due to the Trainee concentrating on correcting the speed and approach path, which was highly probable in the cause of the glider to make a hard landing and bounce and the Trainee to be seriously injured due to the impact of the second touchdown.

<p><b>5.1 Safety Actions Considered Necessary</b></p>	<p>As described in “3. ANALYSIS”, it is necessary that when granting solo flight to the trainee, their flight skills be confirmed according to the procedures as stipulated by making the stipulated procedures known to all concerned again. In addition, it is desirable to consider the methods for flight instructors to give appropriate instructions depending on the situation.</p>
<p><b>5.2 Safety Actions Taken after the Accident</b></p>	<p>The Japan Students Aviation League, of which the Tokai/Kansai Student Aviation League is a member, took the following safety actions after the accident.</p> <p>(1) Dissemination of notices, regulations and others related to solo flight</p> <p>They disseminated the regulations related to solo flight, which were based on the “Safety criteria relating to solo flight (glider)” issued by the Civil Aviation Bureau of Japan and the “Training Manual for Glider Sports” of the Japan Students Aviation League, to instructors and students. In addition, they held safety seminars.</p> <p>(2) Confirmation of the requirements for solo flight planners</p> <p>They decided that the instructor and the student manager should confirm the status of the solo flight planner and the requirements of the regulations at the start of the flight training.</p>
