**AIRCRAFT ACCIDENT
INVESTIGATION REPORT**

**GAKUSHUIN SCHOOL CORPORATION
J A 2 1 5 2**

HARD LANDING AFTER ABORTING WINCH LAUNCHING

ALEXANDER SCHLEICHER ASK13
(GLIDER, TWO-SEATER), JA2152
AT MENUMA GLIDING FIELD,
KUMAGAYA CITY, SAITAMA PREFECTURE, JAPAN
AROUND 15:10 JST, DECEMBER 9, 2018

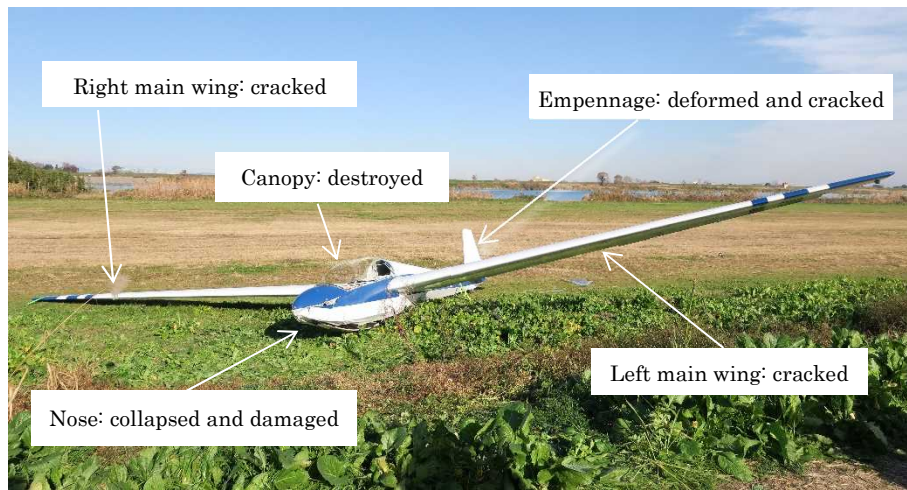
Figure 2: Accident glider

Substantially damaged

- Nose fuselage: collapsed and damaged
- Canopy: destroyed
- Empennage: deformed and cracked
- Main wing: cracked
- Frame: deformed
- Flight control system (elevator, rudder and aileron): stuck

stuck due to collapsing at the time of the collision, which resulted in disabled maneuvering of the aircraft.

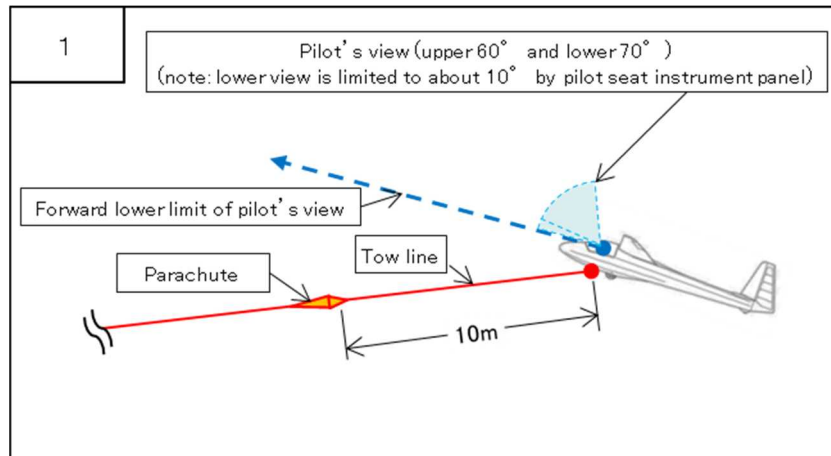
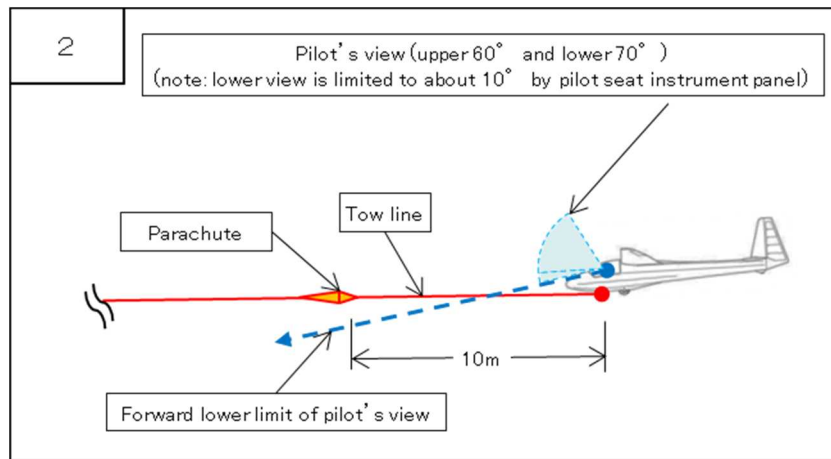
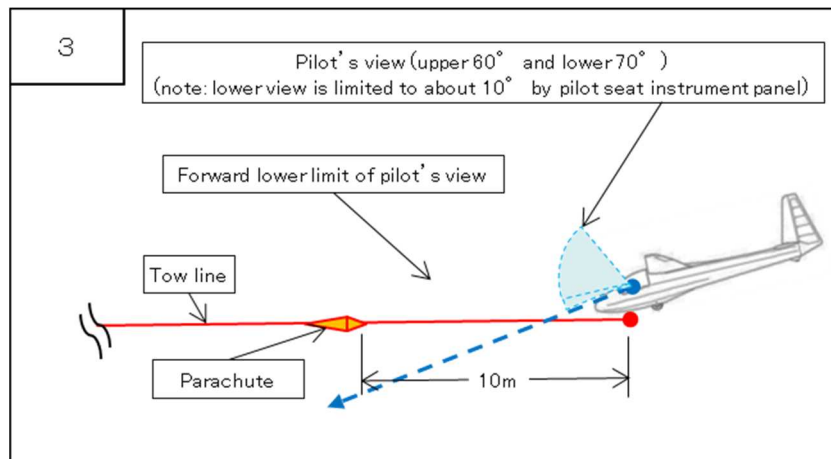
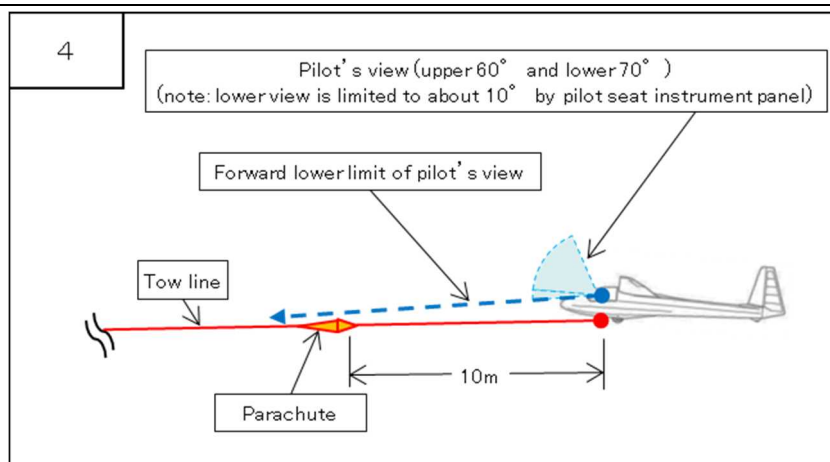
Figure 3: Attitude of airframe and pilot's view

- (ii) It is probable that the reason the Trainee had seen the parachute was that the aircraft had passed over tow line and had been in nose down attitude (attitude in Figure 3-2). Because coping procedures to be taken in case of passing over tow line is same as the case of tow line cut, it is probable that the Trainee attempted to follow the coping procedures for the case of tow line cut. From training experiences in the past, it is probable that the Trainee held knowledge on coping procedures to be taken in case of tow line cut. However, due to lack of experience of practical training simulating tow line cut immediately after take-off and at a low altitude of 10 m or lower, it is probable that the Trainee could not conduct an appropriate maneuvering and pushed the control stick forward too excessively, which caused the aircraft to become too excessive nose down attitude (attitude in Figure 3-3). And it is probable that the glider increased the sink speed, and collided with the ground without deceleration and flare. Besides, it is probable that the Trainee, as a result of having confronted different situation from normal, could not hear the voice of the flight instructor who instructed to nose up with radio communication.

(iii) It is probable that the aircraft could safely touch down if it pitched down the nosed to landing attitude (attitude in Figure 3-4), released tow line, flew straight keeping horizontality and appropriately used dive brake confirming the speed of the aircraft, when it was brought to different condition from normal, in accordance with emergency operational procedures of “Theory manual for private practical examination”, which is used in ground school training of JASL for the case that tow line is cut immediately after take-off to an altitude of 10 m or lower.

(i) In consideration of possibility that the failure of the aircraft to shift to normal climb attitude (attitude in Figure 3-1) after lift-off was attributable to lack of proficiency of the Trainee to control the glider at an appropriate pitch angle during launching, it is desirable that the current way of evaluation of proficiency to permit trainees solo flight be reviewed. Besides, in view of the lack of experience of the Trainee of the practical training simulating such case as occurrence of tow line cut at a low altitude of 10 m or lower immediately after lift-off, which is considered to have resulted in the Trainee inability to cope with the emergency situation, it is necessary that JSAL review how practical trainings prior to solo flight should be.

In this accident, it is highly probable that the glider experienced a hard landing and damage to the airframe, and the Trainee was seriously injured, because it was unsuccessful shift to normal climb attitude during the launching with winch launching, excessive nose down attitude at a low altitude when the glider aborted launching.

Regarding the failure of the glider to shift to normal climb attitude during launching of the aircraft and excessive nose down attitude at a lower altitude, it is probable that because the maneuvering of pushing down of the control stick immediately after lift-off was excessive, and effect to limit the nose up attitude was largely acting.

Ground school training and practical training related to emergency maneuvering simulating mal-launching at a low altitude are clarified in the training syllabus and such trainings are conducted.

In addition to the establishment of effective training system including utilization of the footage of practical instruction of trainees and so on, proficiency and its stability of trainees who have experienced a limited number of solo flight are confirmed by flight with multiple instructors on board or multiple dual flights in case of one instructor on board prior to solo flight.
