**AIRCRAFT ACCIDENT
INVESTIGATION REPORT**

April 27, 2012

PRIVATELY OWNED
SPORTAVIA SF25C (MOTOR GLIDER, TWO-SEATER), JA2168
AT SHINSHINOTSU GLIDING FIELD,
SHINSHINOTSU-MURA, ISHIKARI-GUN, HOKKAIDO, JAPAN
AT ABOUT 10:41 JST, JUNE 12, 2011

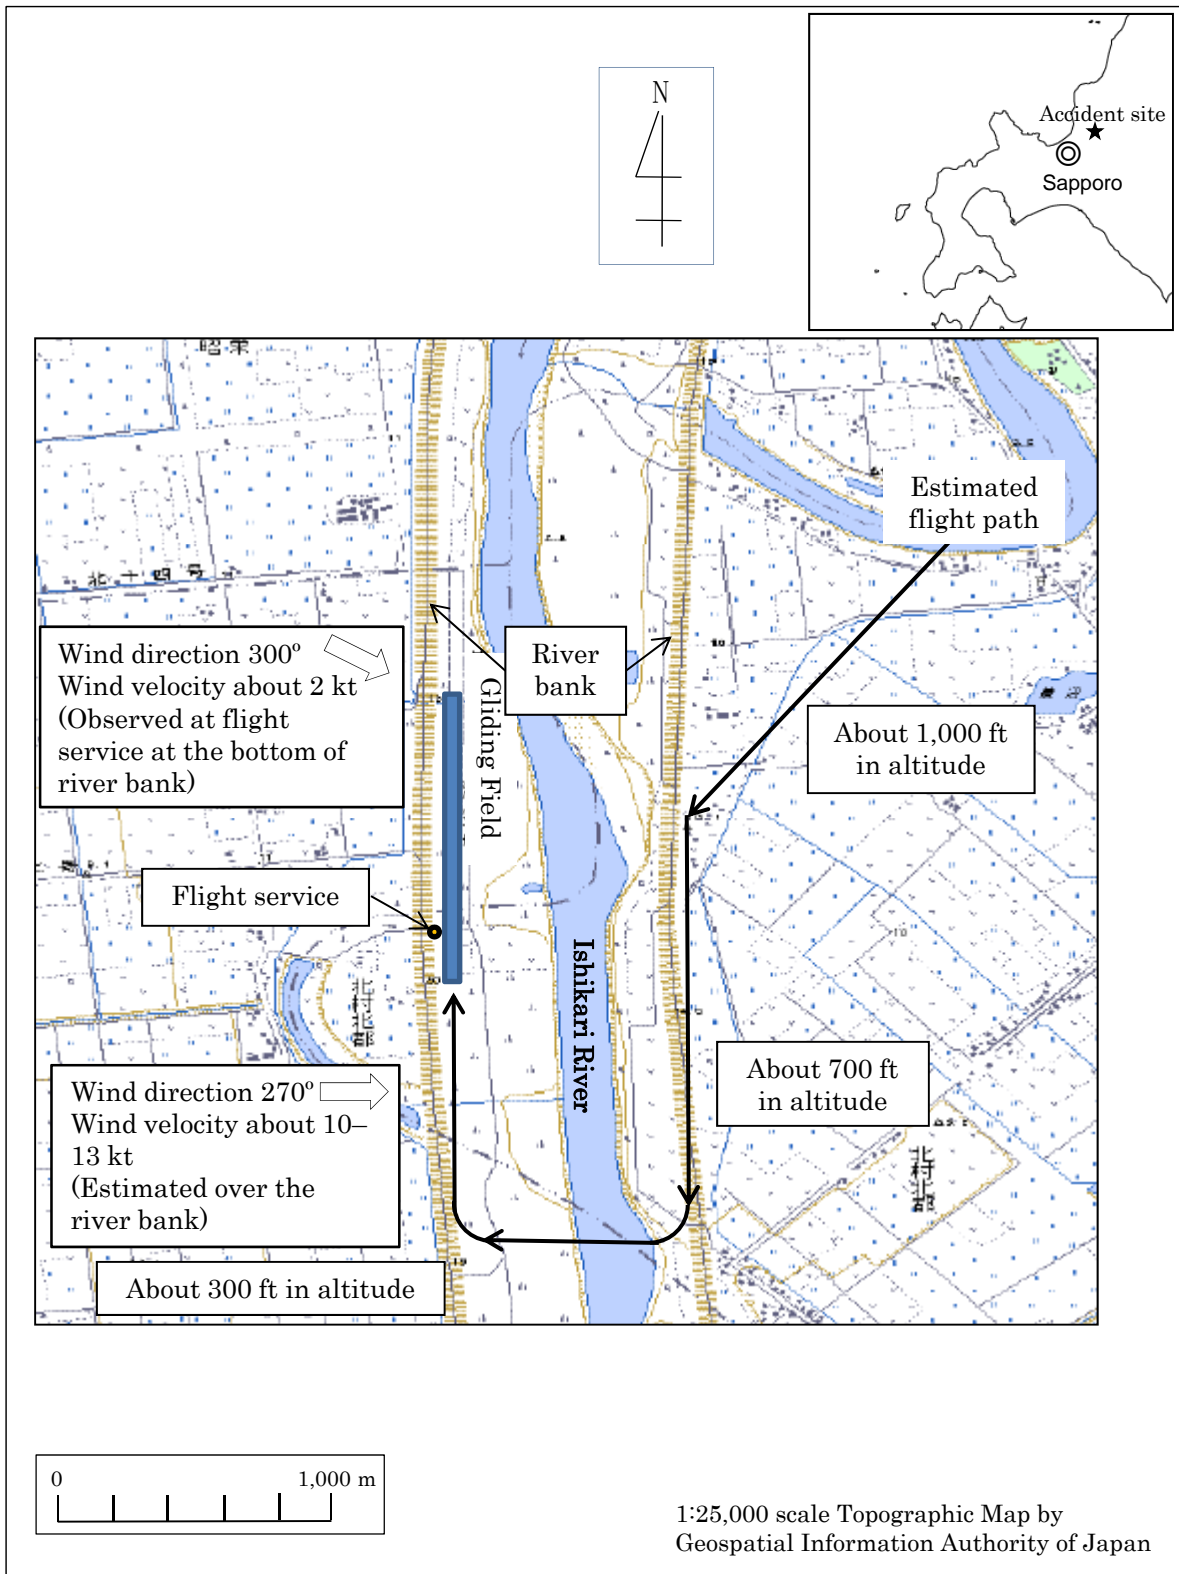
Figure 1 Estimated Flight Path

- (1) According to the statements described in 2.1 (1), having felt the Aircraft lifted by air currents at an altitude of about 100 ft on the latter half of the final approach leg, the captain pulled the spoiler lever with a slightly strong force, but this caused the nose of the Aircraft to go down more steeply than intended, and the Aircraft to descend at a greater rate, so he released the spoiler lever and pulled the control stick, during which he felt that the elevators were lighter to operate than usual and the rise in nose pitch was not as significant as expected, and eventually the Aircraft violently touched down on the runway with a nose-down attitude.

Therefore, it is probable that, as the Aircraft's rate of descent decreased at an altitude in the vicinity of 100 ft and the Aircraft deviated upward from the predetermined approach path, the spoilers were operated from a half-extended position toward the fully extended position in an attempt to correct the condition, but immediately after these actions were taken nose-down angle became greater and rate of descent became higher. It is probable that, just after the occurrence of this situation, the spoilers were fully retracted and the elevators were operated toward the nose-up direction as a corrective action, but the elevators were lighter to operate than usual and the Aircraft touched down on the runway surface due to an inadequate nose-up attitude.

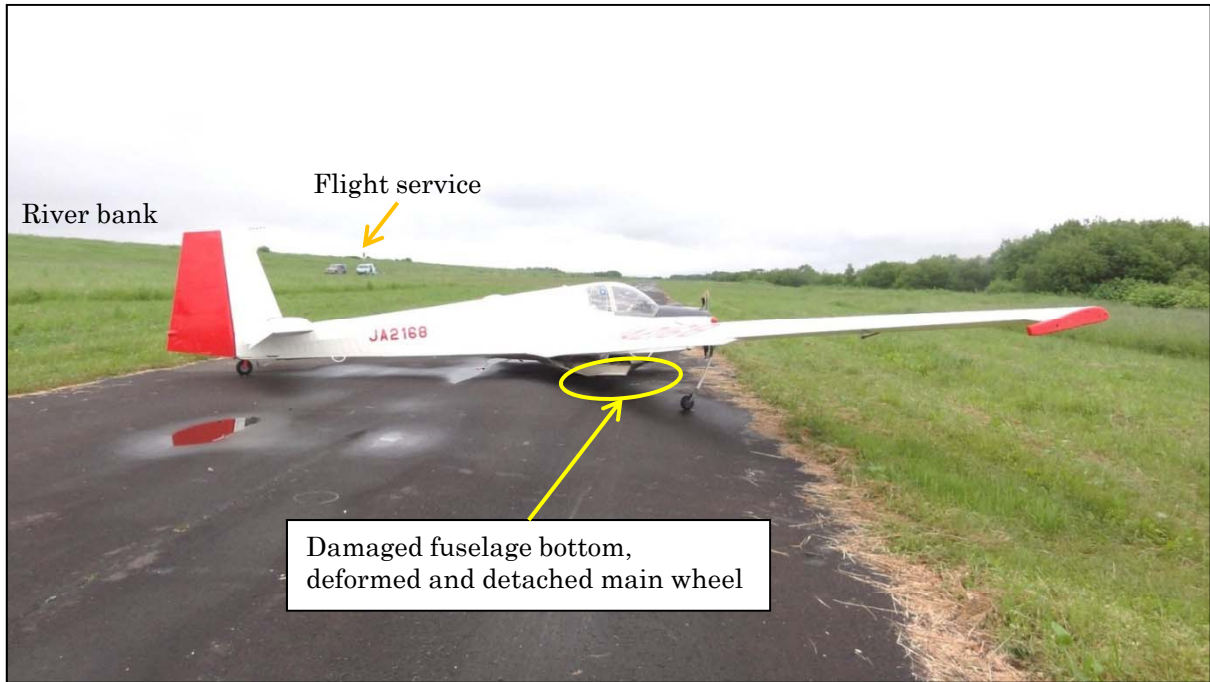
Photo 2 Accident Aircraft

- | | |

| (1) Propeller: | The blades were broken. |
| (2) Engine: | The intake and exhaust pipes were deformed. |
| (3) Fuselage: | The lower fuselage was damaged. |
| (4) Wings: | There were open cracks. |
| (5) Landing gear: | The main wheel was deformed and detached; the outriggers (wheels on the wing bottoms) were deformed. |

When judged from the damage to the Aircraft described in 2.3.2, it is highly probable that the every damage was caused by the external forces working at the time of the accident. It is also highly probable that there were no abnormality with the Aircraft before the accident when judged from the statement of the captain described in 2.1 (1).

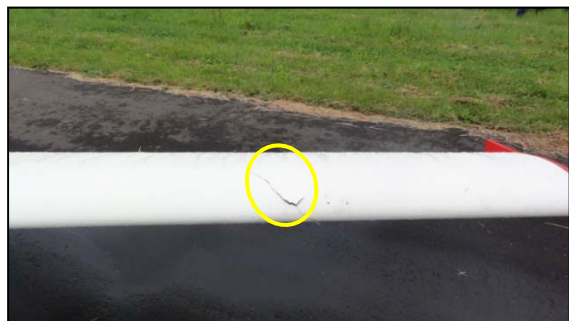
Cracked left wing
