AA2013-8

**AIRCRAFT ACCIDENT
INVESTIGATION REPORT**

**PRIVATELY OWNED
EXTRA EA300/200, JA22DB, CRASH INTO THE SEA
SURUGA BAY (THE WATERS OFF BETWEEN THE ESTUARIES
OF OKITSU RIVER AND FUJI RIVER)
SOMETIME BETWEEN 09:15 (LAST RADAR ACQUISITION)
AND 10:17 (EXPECTED TIME OF FUEL EXHAUSTION)
JULY 26, 2011**

September 27, 2013

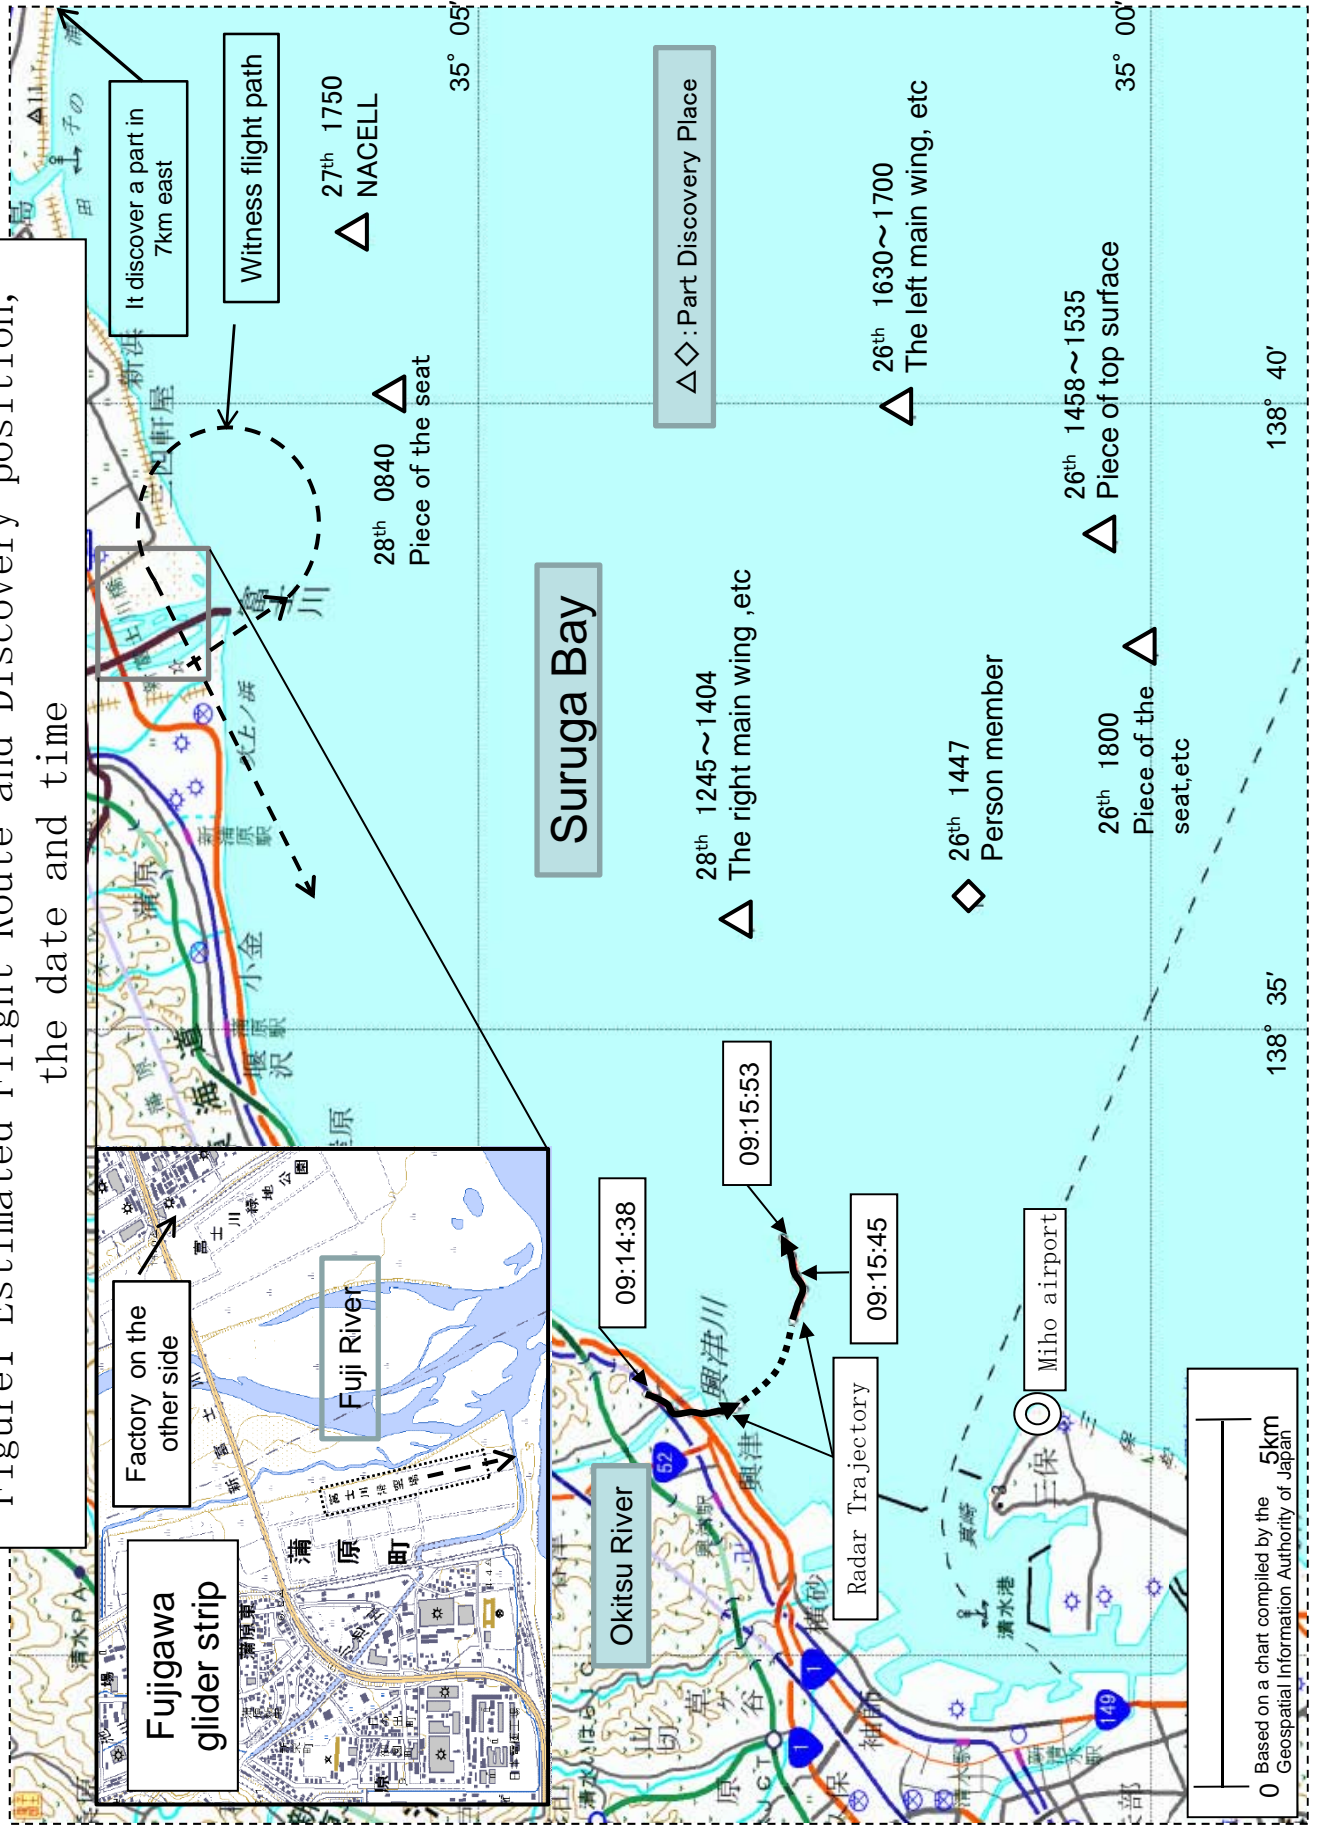
Figure1 Estimated Flight Route and Discovery position, the date and time

Judging from the dispersed debris the very likely accident site is the sea stretching off between the estuaries of Okitsu River and that of Fuji River, northern part of Suruga Bay—the air space above this area is referred to as “the accident airspace” in this report. The exact time of occurrence was not determined although it is short time after the loss of airplane’s radar detection at 09:15:53, July 26, 2011.

Pieces of recovered Objects originating from	Locations (Δ in Fig.1)		Date/Time of discovery
	Latitude	Longitude	
Upper surface, fuselage	35° 0.30'	138° 38.90'	14:58~15:35, Jul. 26
Upper surface, L wing	35° 1.80'	138° 39.90'	16:30~17:00, Jul. 26
Cockpit	35° 0.02'	138° 37.98'	18:00, Jul. 26
Nacelle	35° 5.90'	138° 41.30'	17:50, Jul. 27
Seat	35° 5.60'	138° 40.00'	08:40, Jul. 28
Right wing, etc	35° 3.00'	138° 35.80'	12:45~14:04, Jul. 28

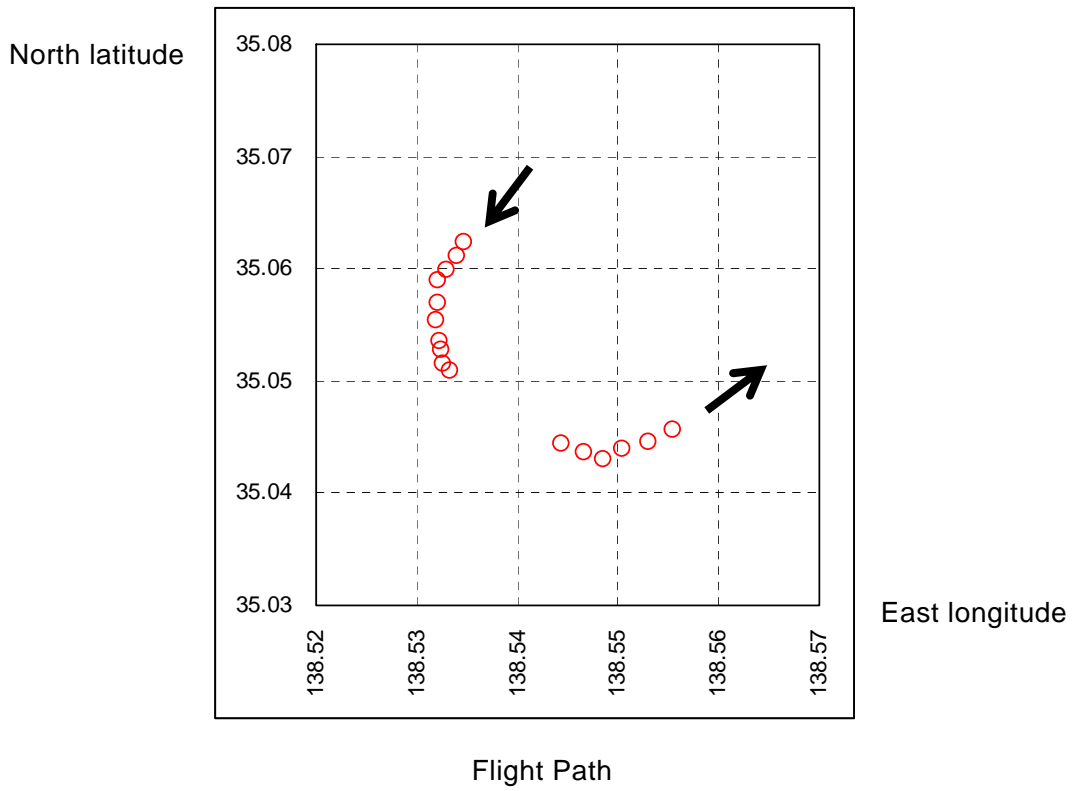
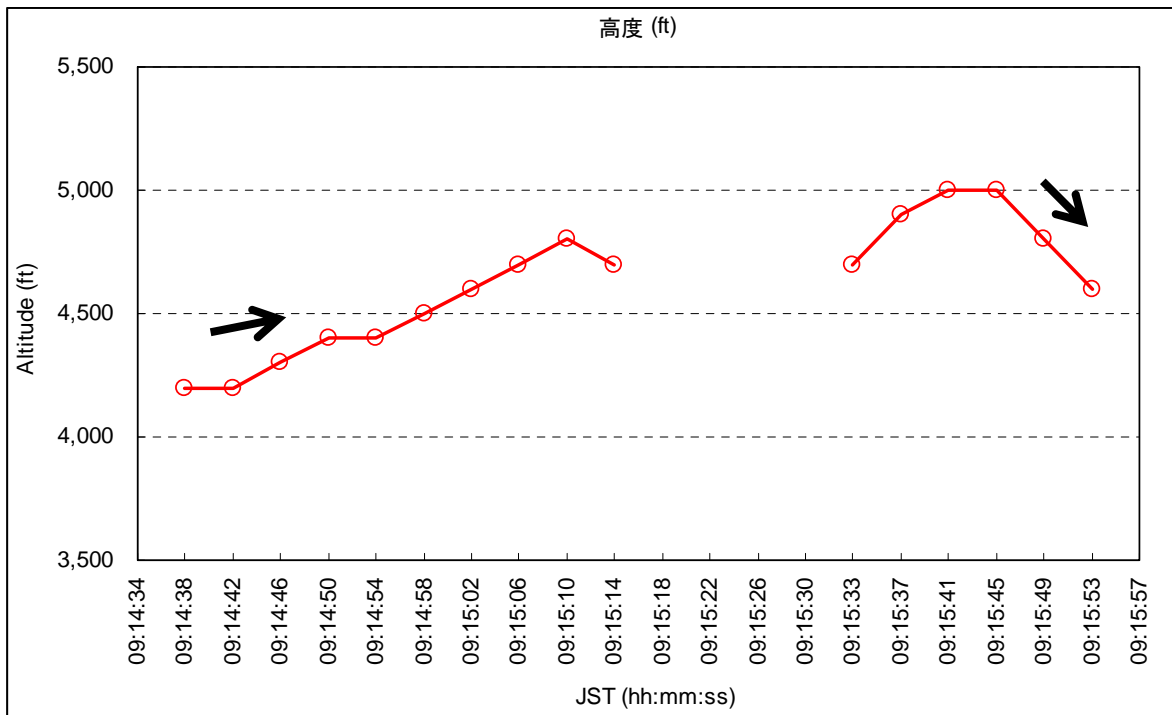
Figure 2 Rader Controller

The radar of the Hamamatsu Base, JASDF recorded the airplane's intermittent trajectories from 09:14:33 to 09:15:14 and from 09:15:33 to 09:15:53. These trajectories showed its left turn over the estuary of Okitsu River at 4,200 feet and roll-out to the general direction of the glider strip. Its altitude diminished from 5,000 feet to 4,600 feet within eight seconds (the rate of descent equals to as much as 3,000 fpm). The airplane was out of the radar detection from 09:15:14 to 09:15:33 and on and after 09:15:53.

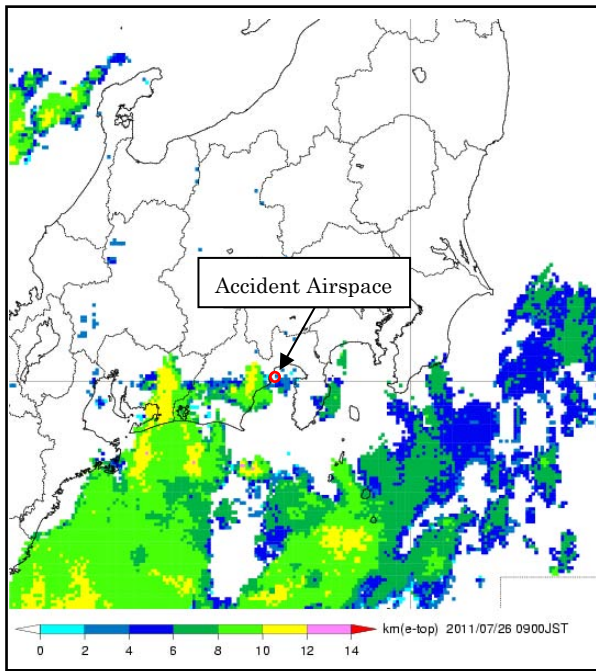
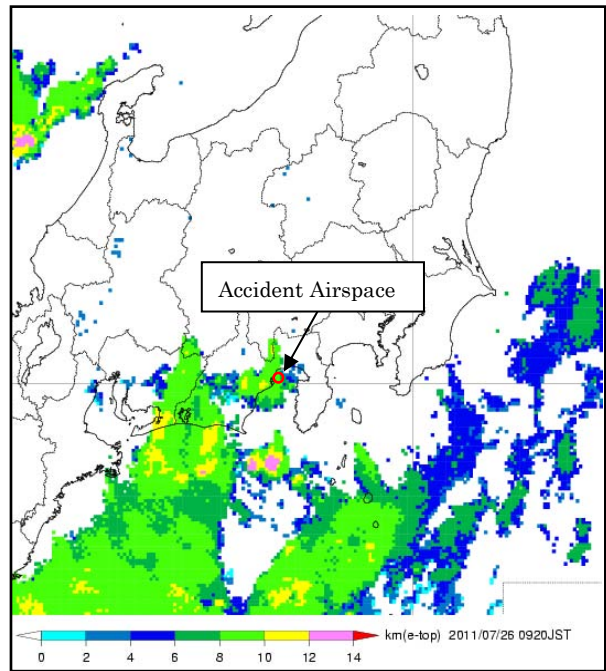
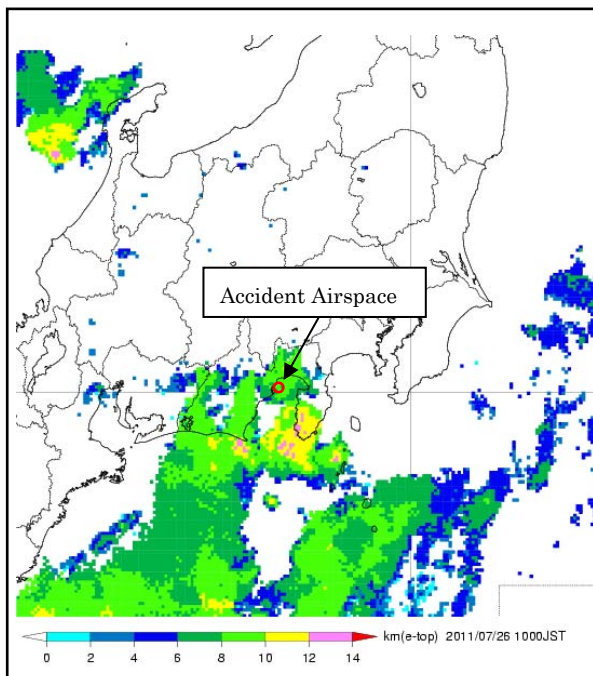
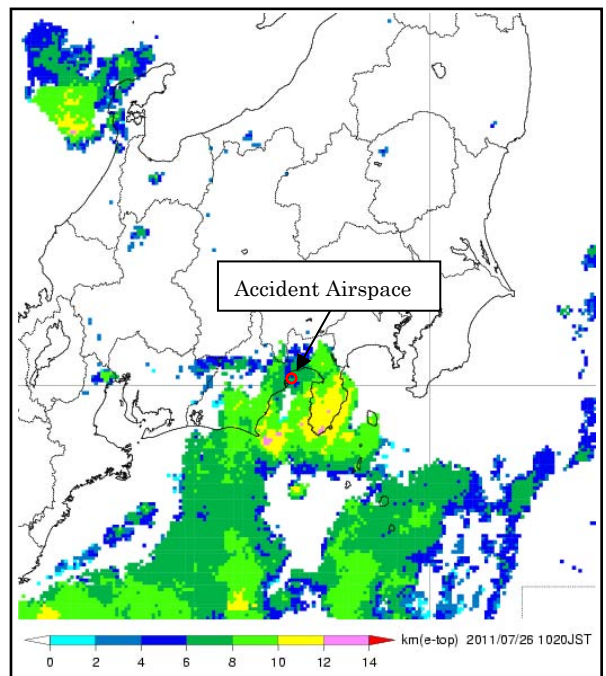
According to the Radar Echo Composite Chart (Precipitation) generated by Japan Meteorological Agency, northeastern part of Shizuoka Prefecture had precipitation of 6 mm/h when the airplane took off at 08:57. The chart also showed that the cloud of 8,000-meters cloud top height was over the estimated flight route at 09:20.

According to the METAR information as of 09:00 at Shizuoka Airport, the airport observed a mild thunderstorm, visibility of four kilometers with haze, nearly overcast with cumulus with its cloud base at 2,500 feet (762 meters). Figure 5 Echo Altitude (Cloud Top) Composite Chart showed 11,000-foot-high cumulonimbus at 10 kilometers north of the airport was traveling east.

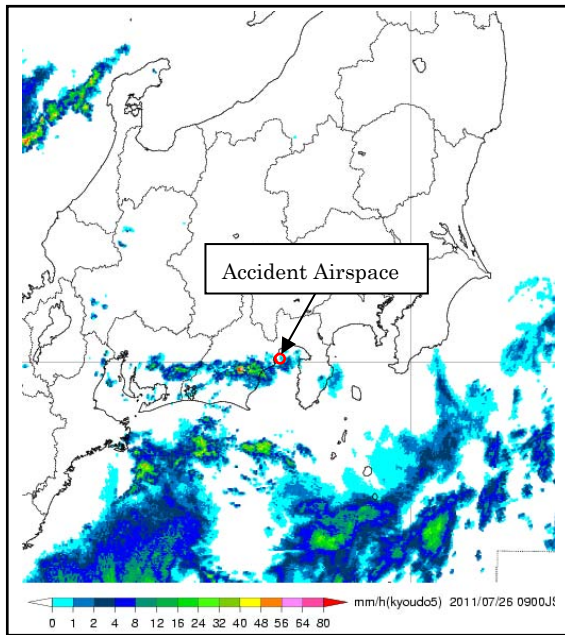
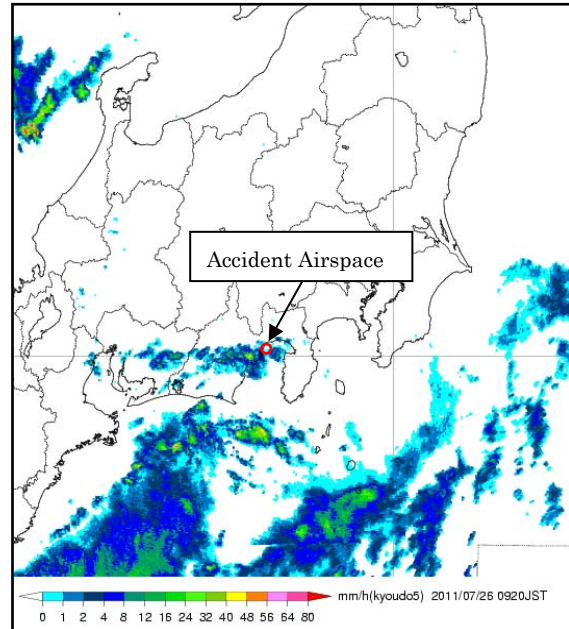
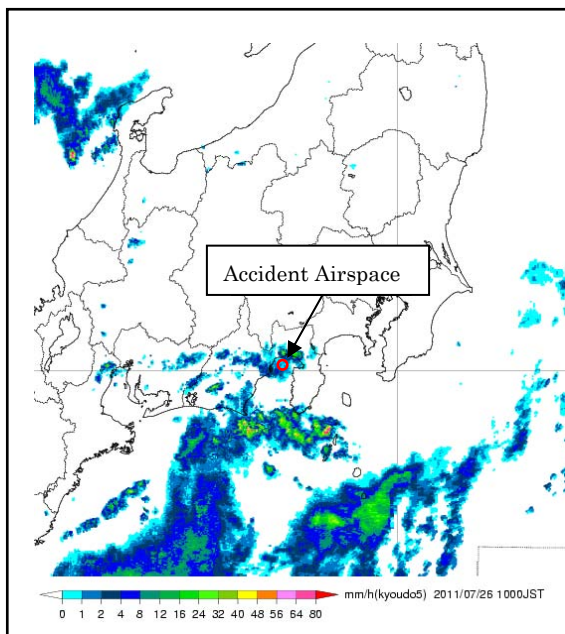
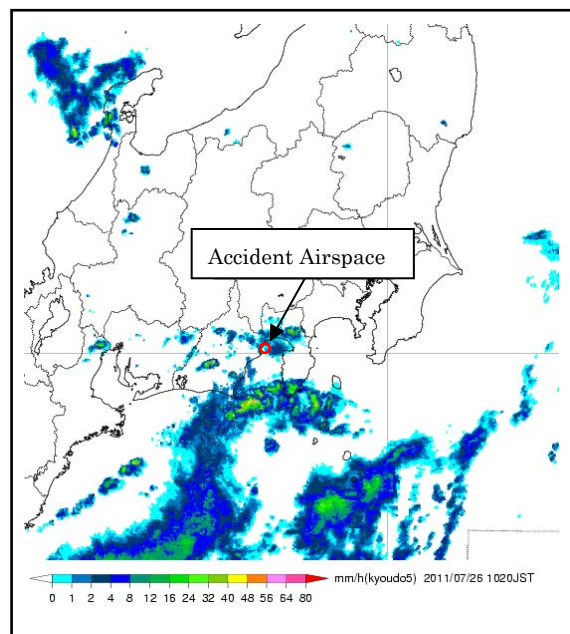
Along the airplane's estimated route which connects the estuary of Fuji River and Miho airstrip between 09:00 and 09:20, Figure 6 Echo Intensity (Precipitation) Composite Chart shows the precipitation of six millimeter per hour, while AMeDAS recorded precipitation of three millimeter per hour at Shimizu at 09:30. These facts suggest southerly wet warm air flowed into Shizuoka Prefecture generating unstable air conditions. The mechanic stated that he had heard rumbling of thunderstorm to the southwest of the glider strip at about 09:30.

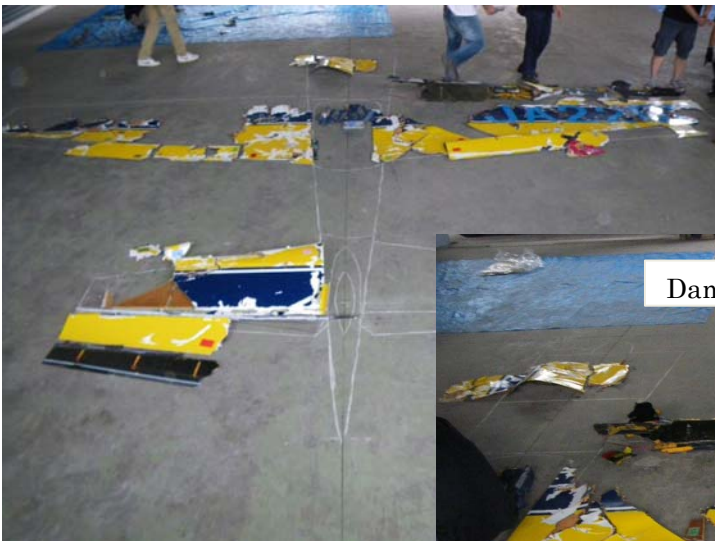
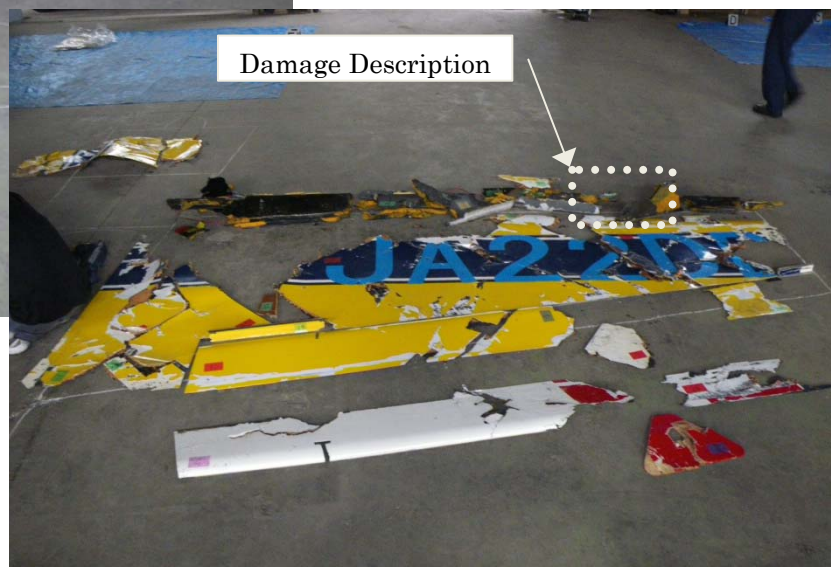
Picture 2 Recovered Debris

- a. Fuselage: Damaged
- b. Wings: Damaged
- c. The engine, propeller, instrument and other parts were not recovered.

Recovered debris included such as parts of wings, elevators, engine cowling, both main landing gear tires and wheels. The wheels were deformed and tires were punctured. The remaining major parts such as fuselage, vertical fin, engine and propellers were not recovered.

Burned and charred wing main spar was recovered on the beach about 16 kilometers east of the strip on March 3, 2011; other recovered right wing parts exhibited no fire damage.

As stated in the section 2.7.2, the portion of the right wing main spar was the only part that was damaged by fire. In-flight fire originated from the fuel tank should have damaged wider area; recovered peripheral parts exhibited no sign of fire. This fact suggests that the fire damage was caused upon the impact with the surface or sometime later, not in-flight.
