AA2015-8

**AIRCRAFT ACCIDENT  
INVESTIGATION REPORT**

## FUSELARGE DAMAGE DURING LANDING

SCHEMPP-HIRTH DISCUS b

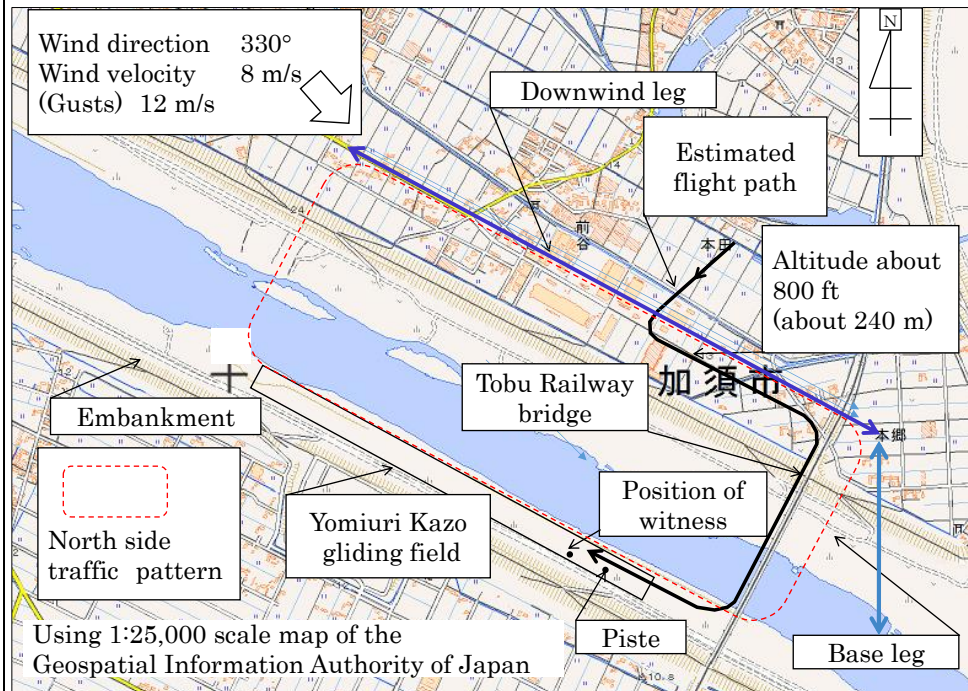
Figure 1 Estimated flight path

Privately-owned Schempp-Hirth Discus b registered as JA2531 launched from runway 31 of Yomiuri Kazo gliding field in Kazo City, Saitama Prefecture, at around 13:50 on February 1, 2015 (Sunday) for familiarization flight with only the pilot on board. After turning right and leaving the traffic pattern at an altitude of about 1,900 ft (about 580 m), the pilot flew northwards and looked for a vertical updraft but could not

Just before entering the downwind leg, the pilot received information concerning “Wind 330°, 8 m/s, gusts\*2 12 m/s” from the “Yomiuri Kazo Flight Service”\*1 then entered the downwind leg at an altitude of about 800 ft (about 240 m). The glider maintained a speed of 130 km/h allowing for the gusts, and flew over the Tobu Railway Bridge as the base leg, then started approach to runway 31.

The glider was approaching smoothly while using half of the dive brake\*3, then suddenly, the glider shook violently and sank with the same attitude at around an altitude of about 46-66 ft (about 5-20 m). The pilot had a momentary sensation of floating due to inertial force, but because the glider immediately settled down with hardly any change in its attitude, after quickly confirming the speedometer he thought he could land without problem because the speed was 130 km/h.

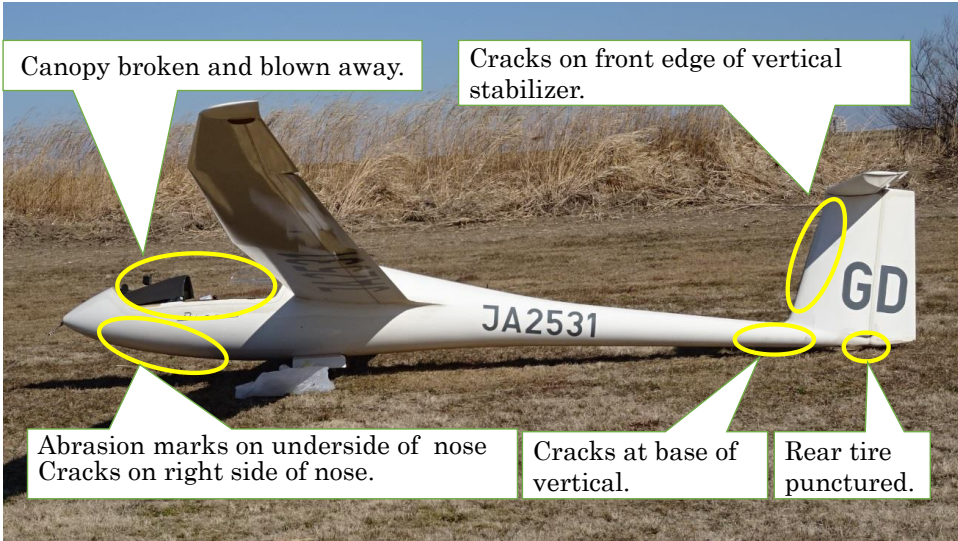
<p><b>2.3 Damage</b></p>	<p>Extent of damage Substantial</p> <ul style="list-style-type: none"> <li>• Canopy Broken</li> <li>• Fuselage Broken</li> <li>• Empennage Broken</li> </ul>

<p><b>Photo 1 State of damage to the airframe</b></p>
<p><b>2.4 Personnel Information</b></p>	<p>Pilot Male, Age 23</p> <p>Private pilot certificate (Glider) October 25, 2011</p> <p>Type rating for High-class glider October 25, 2011</p> <p>Class 2 aviation medical certificate Validity : November 13, 2015</p> <p>Total flight time 326 hours and 11 minutes</p> <p>Total flight time on the type of aircraft 22 hours and 20 minutes</p>
<p><b>2.5 Aircraft Information</b></p>	<p>Type: Schempp-Hirth Discus b</p> <p>Serial number: 526 Date of manufacture: September 29, 1994</p> <p>Certificate of Airworthiness No. 2014-11-05, Validity: March 21, 2015</p> <p>Category of airworthiness Glider, Utility U</p> <p>Total flight time 480 hours and 9 minutes</p> <p>Stall speed 69 km/h</p> <p>Approach speed with air brakes fully open and landing gear downed 95 km/h</p>

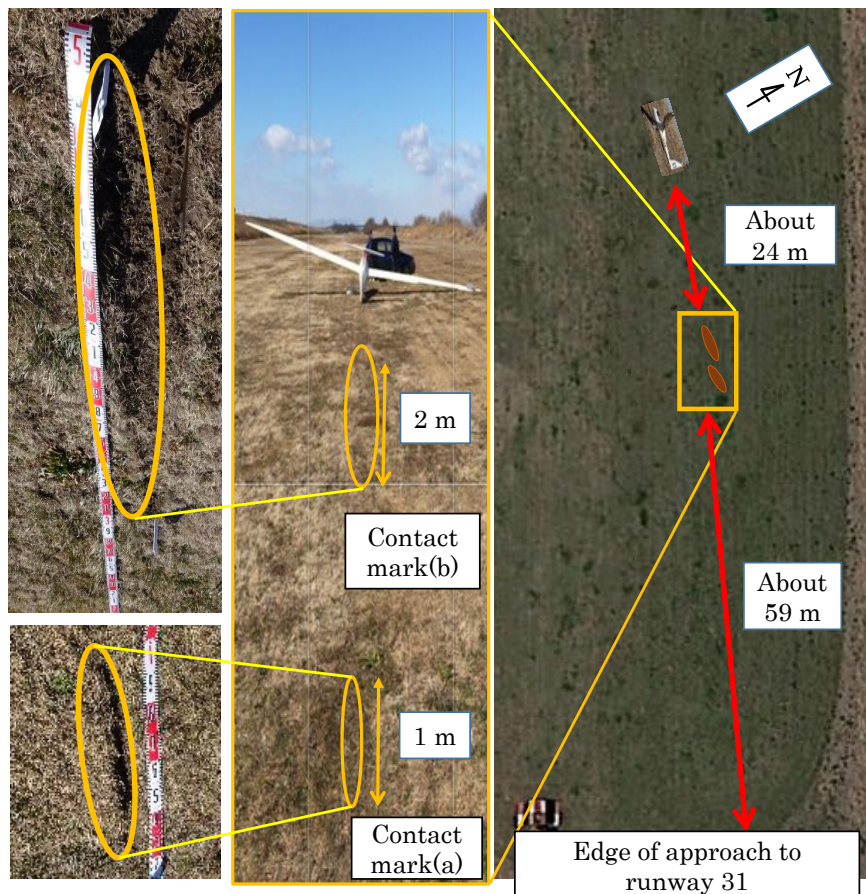
**Photo 2 Contact marks**

There was a 1 m-long contact mark (a) at the foreground when looking in the direction of travel of the Aircraft, and a 2 m-long contact mark (b) two meters forward of that. Contact mark (b) grew wider along its length. The glider had stopped about 24 m forward of contact mark (b). (see Photo 2, Figure 4)

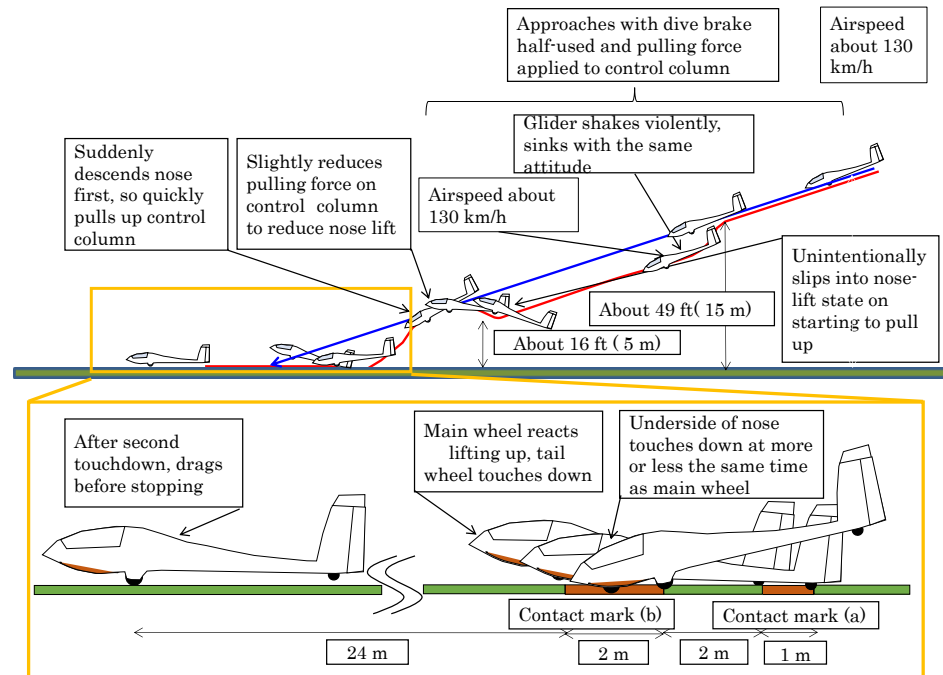
Figure 4 Estimated approach and touchdown situation

<b>3.1 Involvement of weather</b>	Yes
<b>3.2 Involvement of Pilot</b>	Yes
<b>3.3 Involvement of Aircraft</b>	No
<b>3.4 Analysis of Findings</b>	<p>(1) Sudden sink of the glider during approach</p> <p>Both average wind velocity and maximum wind velocity had intensified from about 13:50 in nearby Koga and Tatebayashi, and it is highly probable that wind had also intensified at the gliding field.</p> <p>The gliding field is skirted by an embankment about 9 m high on the south side and the Tobu Railway bridge on the east, and it is probable that when a northwest wind blows, air disturbance is topographically prone to occur. It is somewhat likely that topographical air disturbance caused the glider to suddenly sink at an altitude of about 49 ft (about 15 m) during its landing approach.</p> <p>(2) Condition of the glider at touchdown</p> <p>It is probable that the main wheel touched down before the tail wheel with the glider’s nose somewhat dropped. (Figure 4) Due to the large speed of descent, it is somewhat likely that the tire was compressed and the underside of the cockpit touched the ground, and the nose lifted in reaction to this, causing the tail wheel section to touch the ground and drag for about 24 meters.</p> <p>(3) Involvement of the pilot</p> <p>The pilot had received information concerning “Wind 330°, 8 m/s, gusts 12 m/s” from the Yomiuri Kazo Flight Service, and it is highly probable that it was generally appropriate to set the base leg and approach speed to 130 km/h.</p> <p>It is somewhat likely that the pilot, after starting the final approach, continued the same approach even when the glider suddenly sank, and performed the flare maneuver at an altitude of about 16 ft (about 5 m). Though the glider’s normal landing approach speed is 95 km/h, the pilot set the approach start speed at 130 km/h allowing for the gusts, and it is somewhat likely that his speed was about the same just before performing the flare maneuver.</p> <p>Although it is normal to reduce speed in stages and perform flare just before touchdown, it is probable that the pilot was somewhat late in starting to reduce speed, and that he applied somewhat large force in pulling up the control column, as a result of which the nose lifted so as to create a sensation of buoyancy. It is also somewhat likely that gusts had some influence at this time.</p> <p>After this, it is somewhat likely that the pilot eased his force in pulling up the control column and tried to reduce the nose lift, but as a result only succeeded in pushing down the control column.</p> <p>It is probable that the pilot’s action caused the angle of attack to reduce, lift to be suddenly lost and the glider to go into nose drop.</p>

Therefore, it is probable that the pilot again pulled up the control column in attempting nose lift, but because there was not enough altitude, could not lift the nose sufficiently, causing the glider to make a hard landing. (Figure 4)

It is probable that this accident occurred because the pilot, in attempting to control the nose of the glider, which had unintentionally gone into nose lift just before landing, eased his force in pulling up the control column, causing a state of sudden nose drop to occur and the glider to make a hard landing, resulting in the damage to the airframe.
