AA2011-10

**AIRCRAFT ACCIDENT
INVESTIGATION REPORT**

Japan Transport Safety Board

**PRIVATELY OWNED
VALENTINE TAIFUN 17EII
(MOTOR GLIDER, MULTIPLE SEATS), JA2553
TAKASU GLIDING FIELD
TAKASU-CHO, MATSUZAKA CITY, MIE PREFECTURE
AT ABOUT 14:45 JST, JUNE 12, 2010**

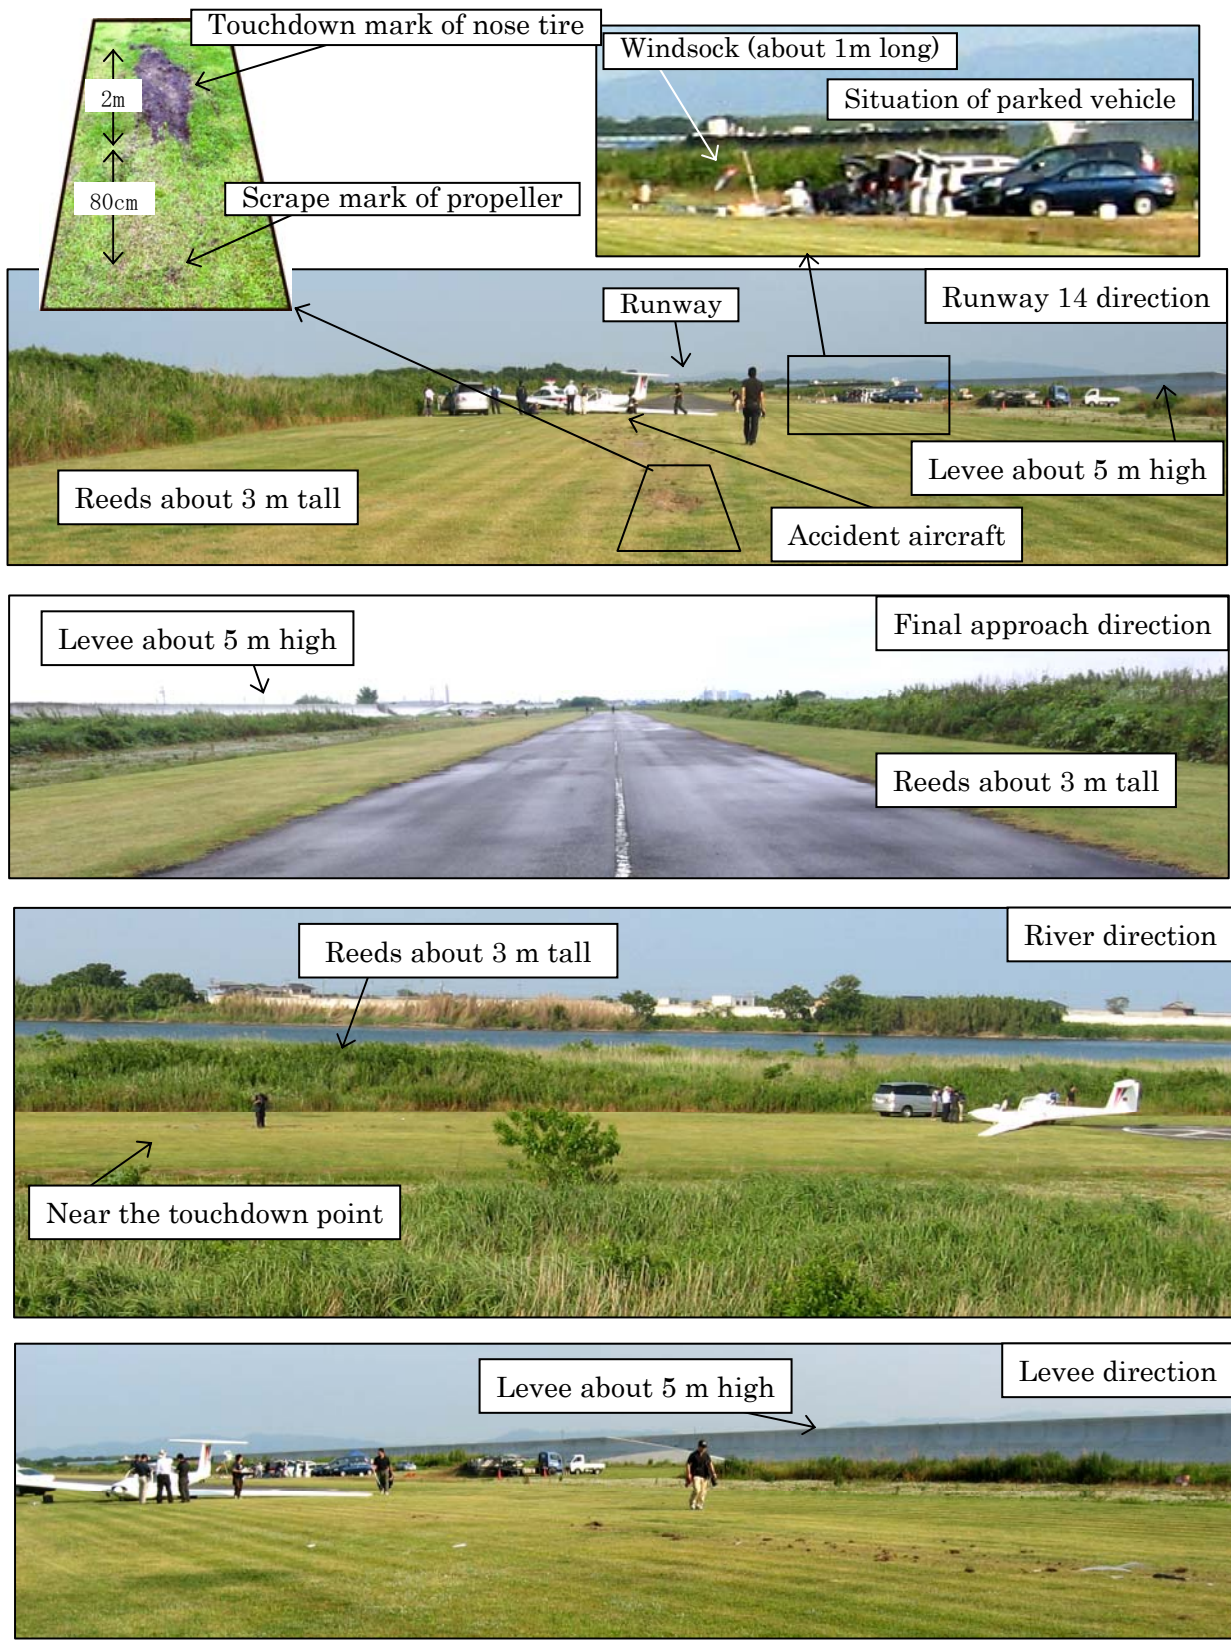
Photo 1: Accident Aircraft and Accident Site

The accident site was the grass in front of the threshold of Runway 14 of the Gliding Field on a riverbed, around the mouth of Kushida River. The Runway is paved with asphalt to the extent of 500 m in length and 10 m in width, the magnetic bearing is 140°/320°, and the elevation is about 2.5 m. Reeds about three m tall are growing in mass approximately 8.5 m ahead of the left shoulder of Runway 14, and the levee, which is about 75 m beyond the right shoulder, is approximately five m high.

The Aircraft was at a stop with its nose turned 005° and with its tail on top of the threshold of Runway 14. There was a scrape mark about five cm in width and ten cm in length across the entry direction about 59.3 m northwest of the spot where the Aircraft stopped. Further, there was a touchdown mark about 20 cm in width and about two m in length about 80 cm advanced from the scrape mark (equivalent to about 58.5 m northwest of where the Aircraft stopped) in the direction of the runway. In addition there were tire marks between the touchdown mark and where the Aircraft stopped, which had been left during landing roll, and propeller and windshield glass fragments were scattered around.

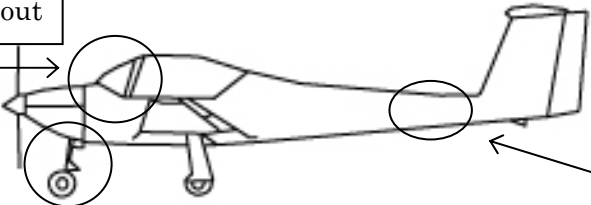
- (1) Fuselage: The front windshield glass in the cockpit was broken and fallen

Front windshield glass was broken and fallen out
