**AIRCRAFT ACCIDENT
INVESTIGATION REPORT**

December 21, 2017

**JAPAN AIRLINES CO., LTD.
BOEING 737-800, JA322J
PASSENGERS INJURIES
AT THE EMERGENCY EVACUAION
AT NEW CHITOSE AIRPORT, JAPAN
AT AROUND 15:10 JST, FEBRUARY 23, 2016**

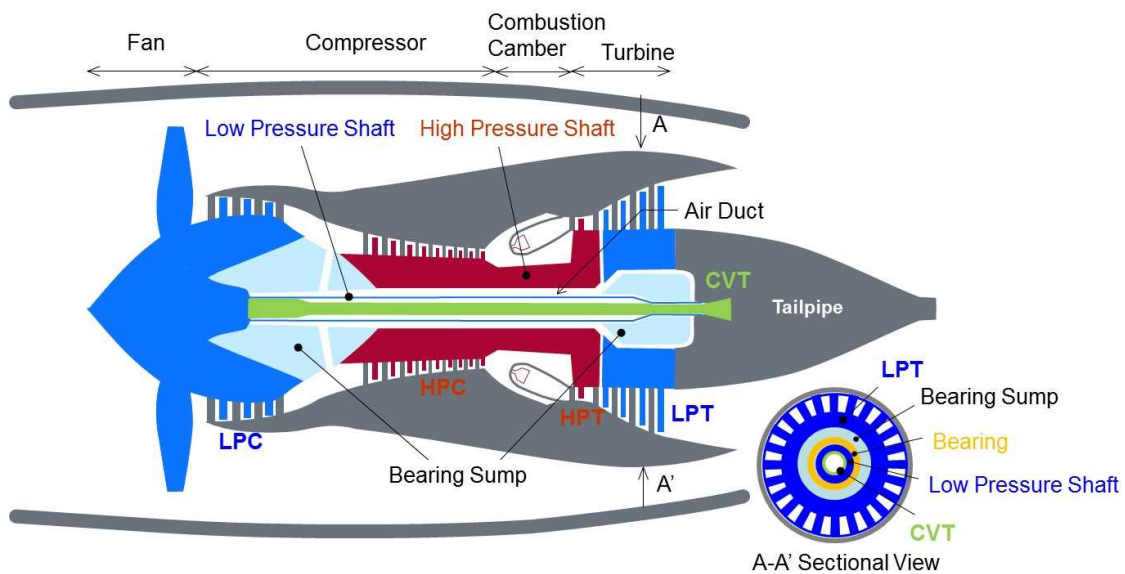
Figure 1 Schematic Diagram of the engine of the same type

with lubrication oils to mitigate rotation friction. The bearing sumps were installed respectively at the fore and aft. With installations of seals to the parts which axes and bearing sumps are touching, high pressured air from the compressor are used to increase pressure of air at outside of the seals (the side of bearing sump) and the pressure of air at inside of the seals are released through center vent tubes (hereinafter referred to as “CVT”) to the barometric pressure to keep an inner pressure low in order to prevent the oil leakage from the bearing sump through the seals. The high pressured air from the compressor was supplied to outside of the fore bearing sump and at the same time to outside of the aft bearing sump, via a duct at outside of the low pressure shaft.

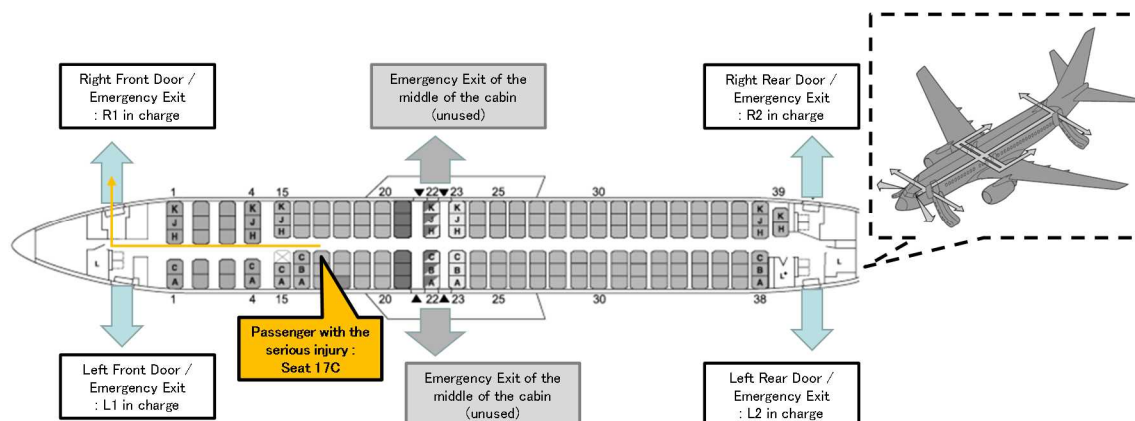
Figure 3 Location of Emergency exit and Allotments of cabin attendants

As shown in Figure 3, all emergency exits of the left front door, the right front door, the left rear door and the right rear door of the Aircraft were opened, the slides were inflated. Furthermore, the emergency exits of the both side near the middle of the cabin were not used.

L1 cabin attendant at the left front door, R1 cabin attendant at the right front door, L2 cabin attendant at the left rear door and R2 cabin attendant at the right rear door were deployed respectively and opened the door in charge. The passenger who suffered serious injury sat on the seat number 17C and evacuated from the right front door.

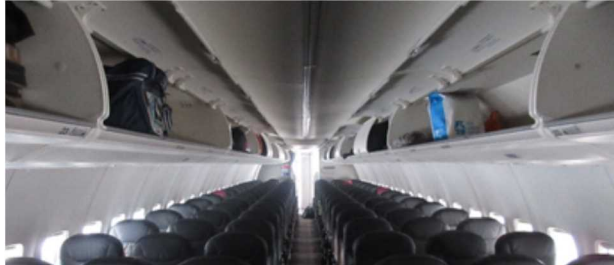
Photo A Cabin after the Emergency Evacuation

Furthermore, the overhead bin that stores the carry-in baggage had many of doors opened and were in state which the baggage had been carried out.

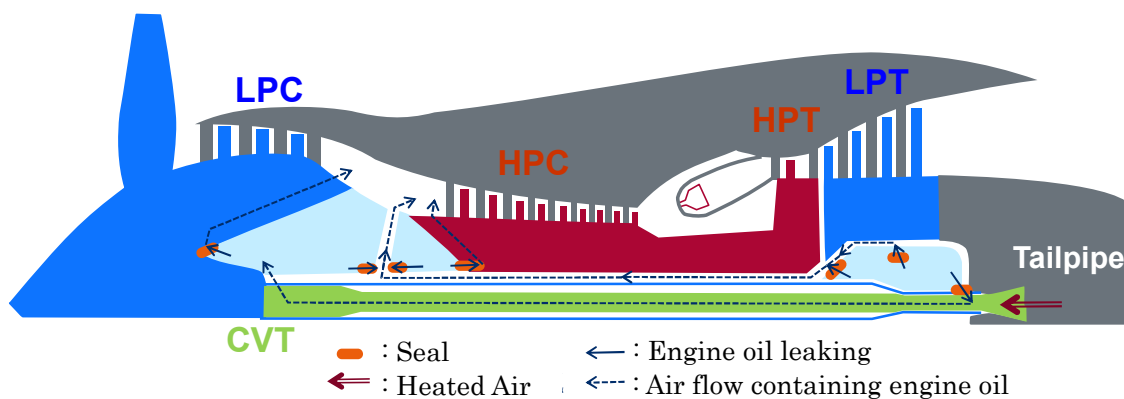
Figure 5 Flow chart of engine oil at the time of the accident

Furthermore, as described in 2.8.2 (2), traces of high temperature air flowing through inside of CVT from the rear to forward and soot and engine oil inside of air duct were confirmed. It is probable that these events were caused by the mixing with engine oil leaked from the bearing sump when the heated air from inside at rear of engine were sucked in and reversed from rear to front through the air duct and CVT described in 2.5.4, because the air inflow amount decreased from outside at front.

It is probable that because it is considered that the engine oil was leaked into LPC and as described in 2.8.2 (3), it is confirmed that the engine oil was attached to inside of the PACK duct, the engine oil leaked into LPC was mixing with the compressed air bled from HPC described in 2.5.2 and as via PRSOV and PACK it flew into the cabin in fog like condition, it generated the odd smells and it looked like smoke. Due to this, it is

(3) It is probable that because the airpressure at outside of the bearing sump could not be increased due to the icing on fan blades and LPC, and the decreased air inflow amount, the engine oil leaked from the bearing sump into inside of the engine and the oil vaporized into the cabin and caused to generate the odd smells and smoke. (3.4.1)

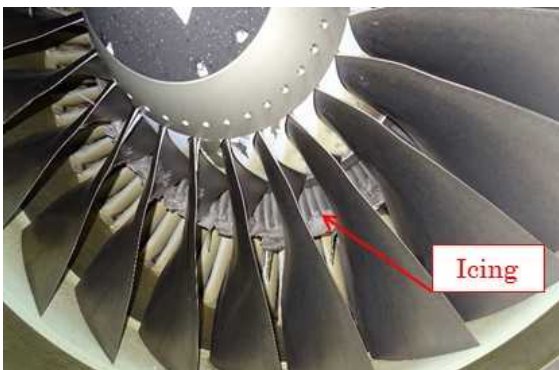
Fan blades of No.2 Engine

At the Aircraft investigation after the accident, as described in 2.8.2(1), it was confirmed that the icing were generated on fan blades and LPC of No.1 engine and No.2 engine of the Aircraft. Moreover, as described in 2.1.1, amounts of engine oil from both engines started to decrease at 14:56. It is probable that this decreases of engine oil amounts were caused by the leakage of the oil from inside of bearing sump to LPC, because the airpressure at outside of bearing sump seal could not be kept high due to the decreases of air inflow amount into engine by the icing on fan blades and LPC.

(4) The icing at the fan blades and LPC of the Aircraft engine caused the decreases in inflow amount of air into the engine and the engine was resulted in unstable condition. It is highly probable that because the thrust lever was operated, the air fuel ratio was deviated out of the combusting range and No.2 engine was stopped. (3.4.2)

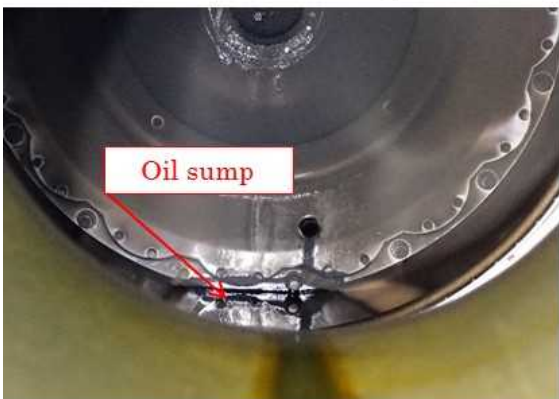
Inside of tailpipe of No.2 Engine

As described in 2.1.1, 2.1.2 (3) and (5), the cabin attendant could not confirm the flame at the engine prior to the No. 2 engine stopped, and confirmed the small red vertically long flame at the lower rear left of the No.2 engine after the No.2 engine stopped. Also, as described in 2.8.2 (2), as the accumulated oil was confirmed at the tailpipe, and the engine oil component was confirmed within the soot attached at the tailpipe. Based on these, it is probable that regarding the flame from the rear of the engine, as the part of leaked oil described in 3.4.1 was discharged via CVT into the tailpipe, because of the stop of the engine, the engine oil remained at inside of the tailpipe was ignited by its exposure to the heat of tailpipe.

(5) It is probable that a part of engine oil leaked into the engine drained into inside of the tailpipe and was ignited because of its exposure to the heat of tailpipe. (3.4.3)

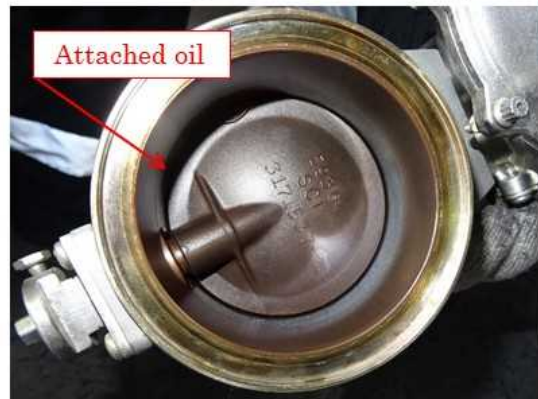
PRSOV(at side of No.2 Engine)

- Amount of oil recorded in EICAS
(No.1: 63%, No.2: 74%)
 - Attachment of engine oils inside of PACK duct
- (See Photo 2 Conditions of the Aircraft Components)
