**AIRCRAFT ACCIDENT
INVESTIGATION REPORT**

J A 3 2 C T

February 25, 2011

**PRIVATELY OWNED
ROBINSON R44 II (ROTORCRAFT), JA32CT
AT ABOUT 15 KILOMETERS SOUTHEAST OF TAJIMA AIRPORT,
JAPAN
AT ABOUT 09:30 JST, JULY 20, 2009**

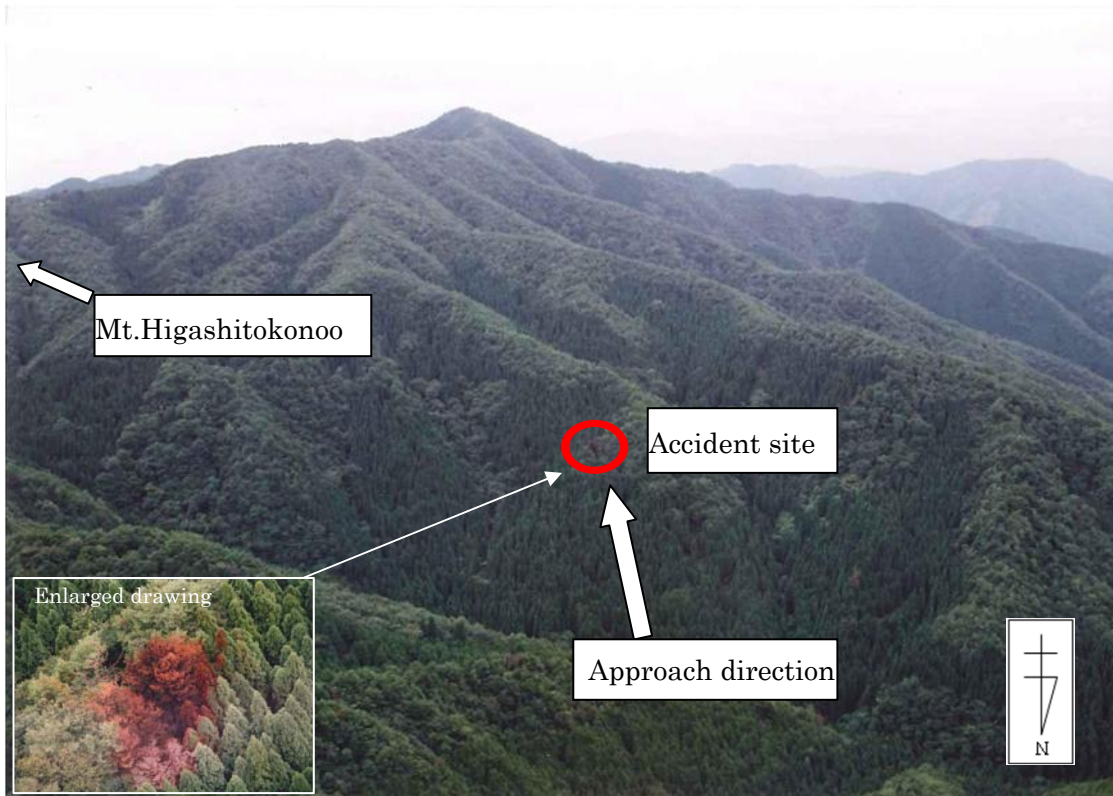
Photo 1 Accident Site

The Aircraft crashed into a slope beneath the peak of the ridge with its nose lying in the direction of south-southeast. The main rotor blades and the wreckage were found widely scattered around the ridge and on eastern and western slopes. The fuselage of the Aircraft was lying in the direction of southeast with its right side down on the ground. The front part of the Aircraft was destroyed that its original shape could not be observed. When the Aircraft crashed into the ground, it is believed that the nose broke down and flew ahead toward a pine tree, and the tree was found burned from the bottom of its trunk.

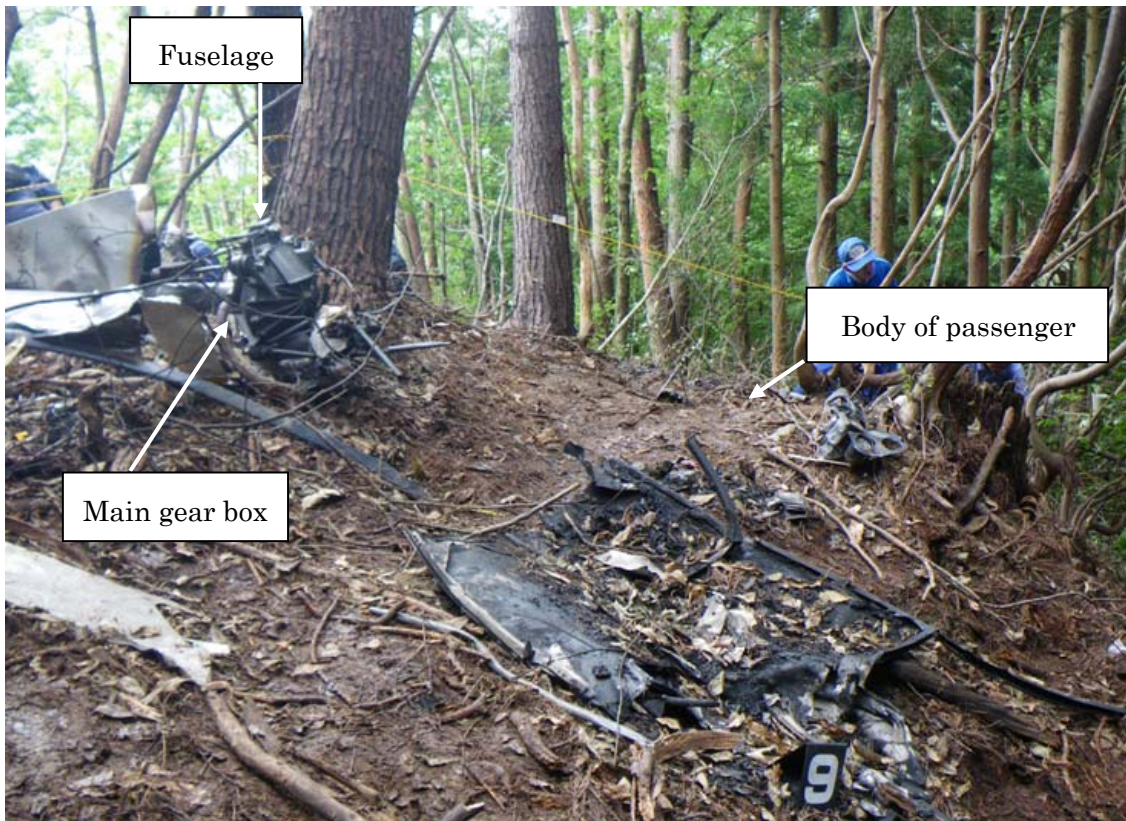
Photo 3 Crash Site

The shell plating of the tail cone barely remained connected to the fuselage, but the shaft of the inside was found broken. The tail rotor and the stabilizer were removed and scattered around. The main gearbox was detached from the fuselage and found at a place about 4 meters ahead of the fuselage with the mast lying in the direction of the west. The crash created a dent 2.7 meters in length, 1.8 meters in width and 0.5 meter in depth on the ground.

The nose section of the Aircraft and some trees in the surrounding areas were burned. Branches and leaves of trees were found to have turned red-brown in a broad area ahead of the fuselage. On the western slope, to which the Aircraft approached, about 20 trees with a diameter of 4 to 23 centimeters were found chopped at the top. A line linking the place of the chopped trees and the place where the blades hit the ground had an angle of about 25 degrees downward from the level surface.
