**AIRCRAFT SERIOUS INCIDENT
INVESTIGATION REPORT**

**PRIVATELY OWNED
JA 3 3 5 3**

**PRIVATELY OWNED
J X 0 1 5 7**

LANDING ON THE ENGAGED TEMPORARY RUNWAY
BY THE OTHER AIRCRAFT
AT TEMPORARY AIRFIELD OF AKENO SKY SPORTS CLUB,
CHIKUSEI CITY, IBARAKI PREFECTURE, JAPAN
AT AROUND 10:38 JST, AUGUST 13, 2017

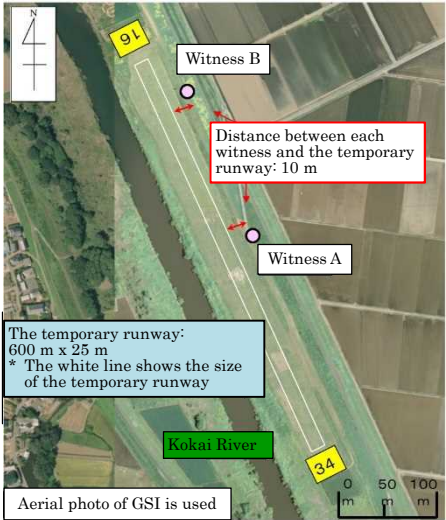
Figure 2: Situation of temporary airfield site and positions of witnesses

Witness A and witness B were watching the Aircraft A on the ground. When the Aircraft A first approached, Aircraft B suddenly appeared behind the Aircraft A, and when the Aircraft A landed, the Aircraft B flew low over the landed Aircraft A. After that, the Aircraft B flew via the west side of the temporary runway and returned to the Runway 16 side, and after commencing a turn at an extreme bank angle, it flew over the Aircraft A which was at the threshold of the temporary runway and landed in front of the Aircraft A. The witness B felt scared since the distance between the two aircrafts was only about 20 meters when the Aircraft B landed.

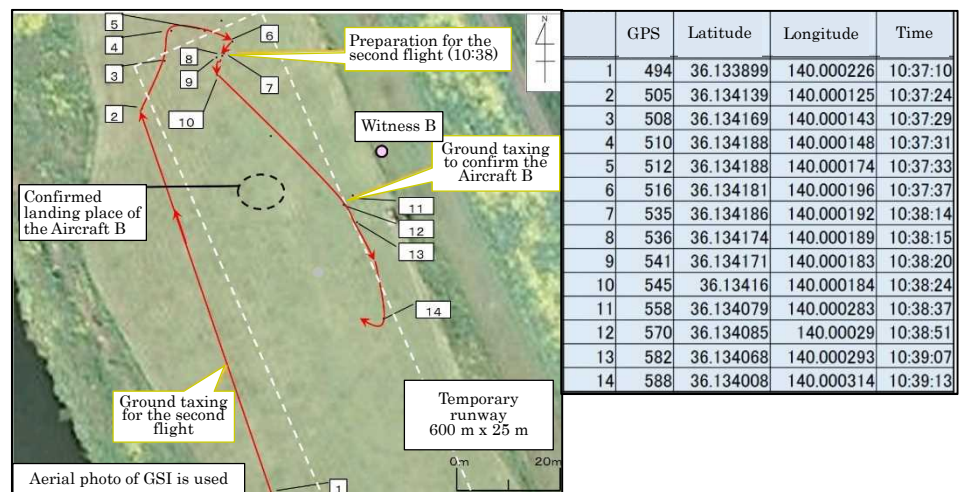
Figure 3: Estimated ground roll route by the GPS data of the Aircraft A (excerpt)

probable that the Aircraft A conducted its first landing at 10:36. After the landing, it is probable that the Aircraft A was taxiing on the outside of the temporary runway (west side) to move to the position to start the take-off roll again and at around 10:38, it arrived inside of the temporary runway shown as 7 and 8 in the Figure 3 and prepared for take-off with its nose orienting to the take-off direction. According to the statements of the Pilot B, the Aircraft B landed on the temporary runway because the Aircraft A stopped outside of the temporary runway with its nose aligning to the west. However, as mentioned above, it is probable that the Aircraft B landed on the temporary runway where the Aircraft A was preparing for the next flight and it is somewhat likely that the Pilot B visually confirmed the Aircraft A when the Aircraft A was facing the west in the vicinity of 6 and 7 in the Figure 3. Regarding with this, since the Pilot B was not a member of the club and did not have accurate understanding of the characteristics of the temporary airfield specified in the rules of the club, it is probable that the pilot considered that the position where the Aircraft A stopped was outside of the temporary runway. While the Pilot of the Aircraft B did not obtain permission from the club and did not understand the rules of the club, he conducted landing on the temporary airfield which was used by the Aircraft A and the landing was made very close to the Aircraft A, and since it was probable that depending on the movement of the Aircraft A the situation would have been more dangerous, the Aircraft B should not land on the runway.
