**AIRCRAFT ACCIDENT
INVESTIGATION REPORT**

HONDA AIRWAYS CO., LTD.

J A 3 3 U K

DAMAGE DURING LANDING
HONDA AIRWAYS CO., LTD.
CESSNA 172S, JA33UK
ON THE RUNWAY, KUMAMOTO AIRPORT
AT 13:14 LOCAL TIME, MARCH 24, 2011

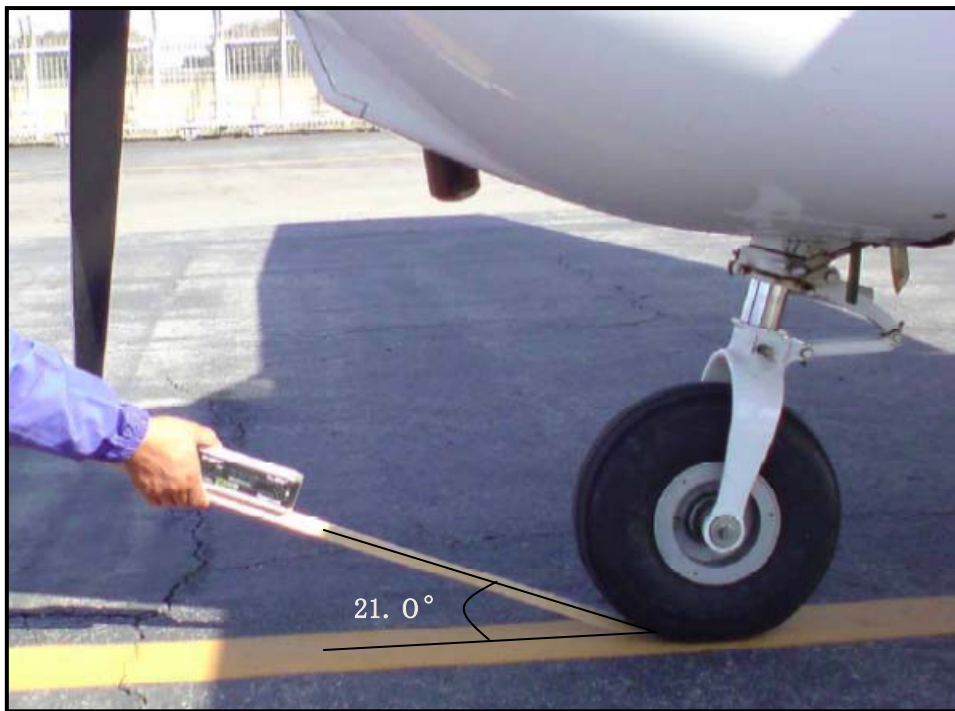
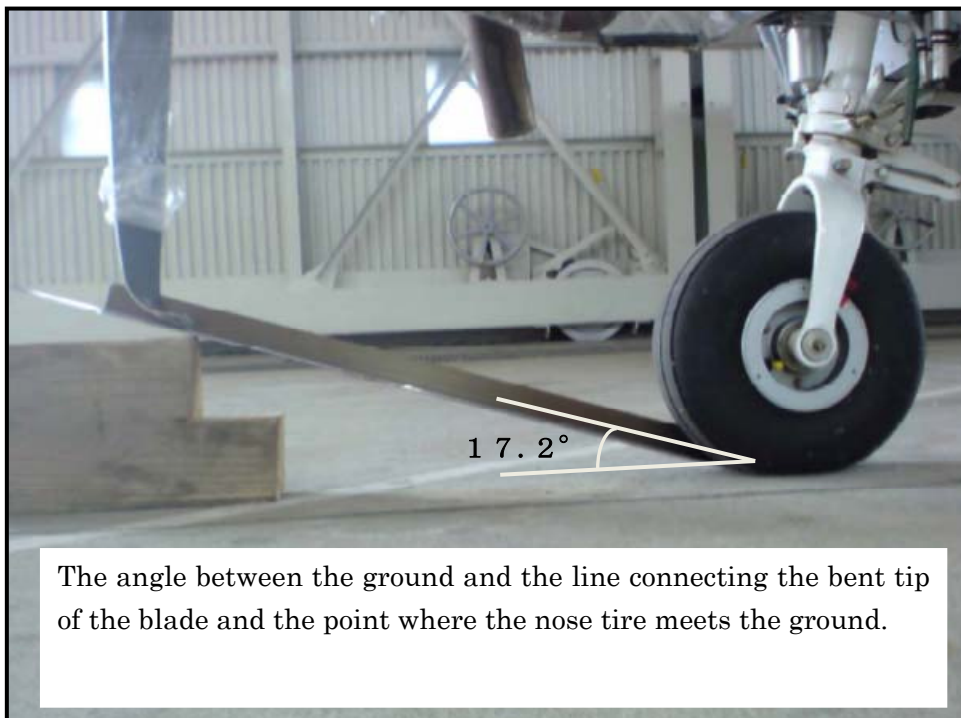
Figure 3: Nose-low Angle Needed for Propeller Blades to Touch the Runway Surface

With the nose oleo strut⁸ fully compressed, the angle between the ground and the line connecting the bent tip of the blade and the point where the nose tire meets the ground is 17.2°. This means that a nose-low attitude of 17.2° is necessary for the propeller blades to contact the runway.

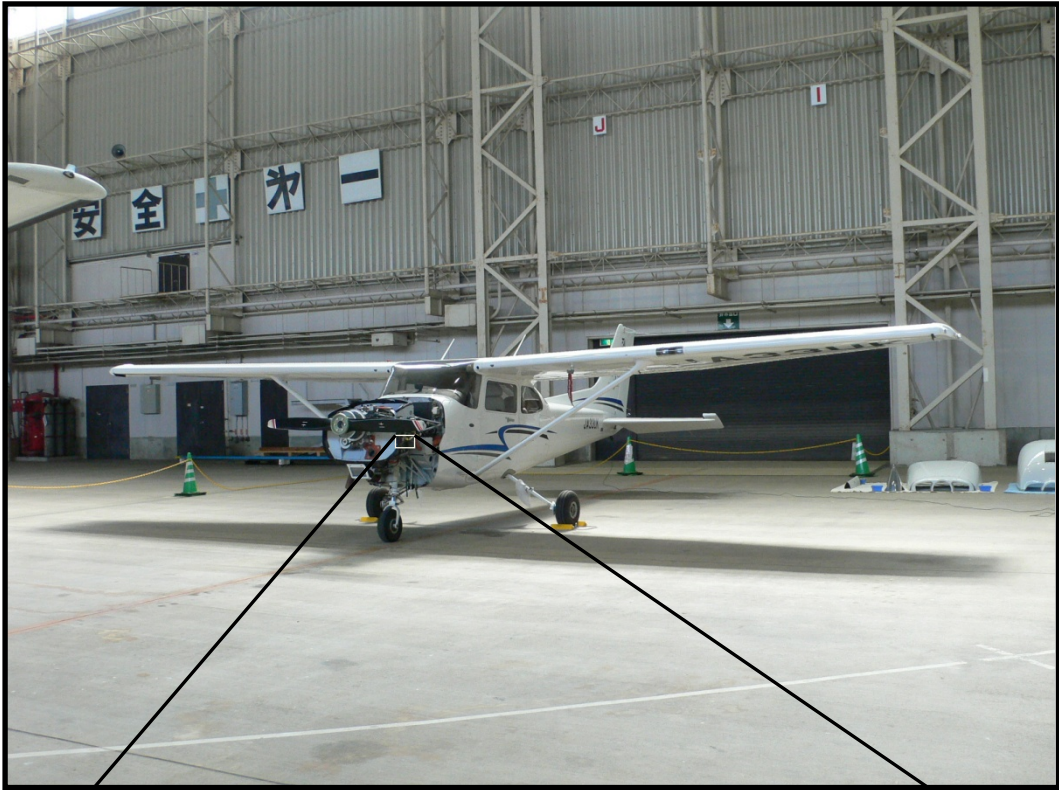
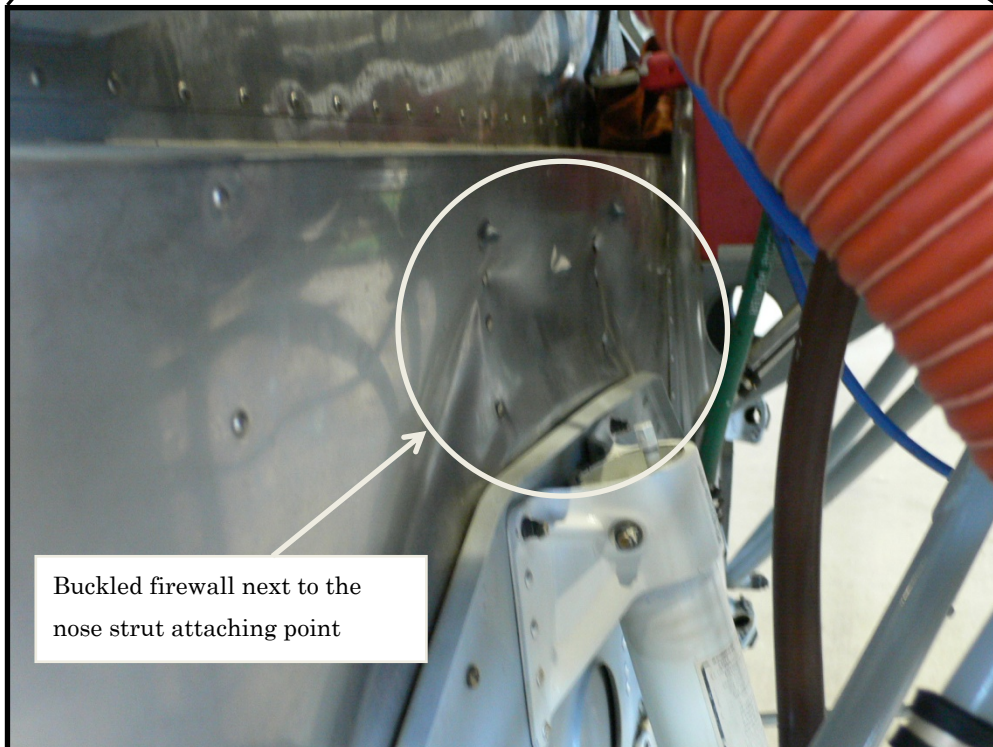
Photo 1 : The Accident Aircraft

a. Fuselage

The fire wall near the nose strut attaching points were buckled and distorted with loosened or uprooted rivets. The forward lower skin and forward portion of the cockpit floor were buckled and distorted.

Rearward shift of control wheel neutral point caused by the distortion of the fuselage lower portion restricted the elevator UP travel.

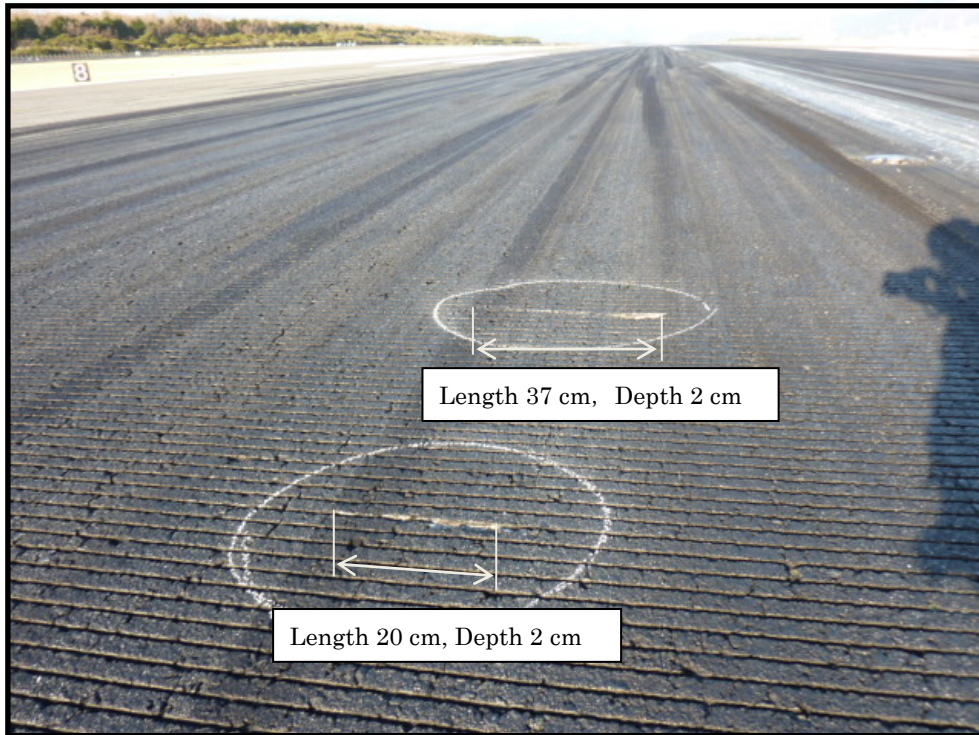
Photo 2: Propeller Contact Marks

Two propeller scratch marks (85 cm apart) were found at the point 625 m from the runway 07 end. The airplane tire marks (made at the first touchdown) were not identified due to countless tire marks made by other airplanes.

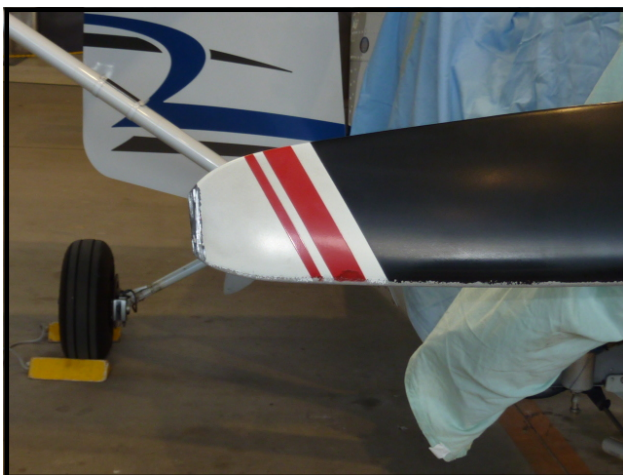
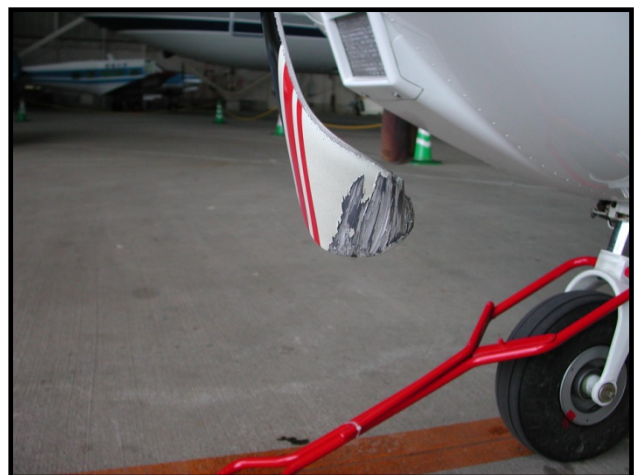
Photo 3: Damaged Propeller Blades

Of the two blades, one blade tip was bent rearward (70 mm from the tip), the other blade tip chipped away (10 mm from the tip).

Hard strikes of propeller blades very likely lead to the damage of fuselage structure.
