AA2014-6

**AIRCRAFT ACCIDENT  
INVESTIGATION REPORT**

October 30, 2014

## PRIVATELY OWNED CESSNA 172N RAM, JA3814 CONTACT WITH GROUND WORKER FOLLOWING DEVIATION FROM RUNWAY AT OTONE AIRFIELD, KAWACHI TOWN, INASHIKI-GUN, IBARAKI PREFECTURE, JAPAN AT ABOUT 15:55 JST, AUGUST 18, 2012

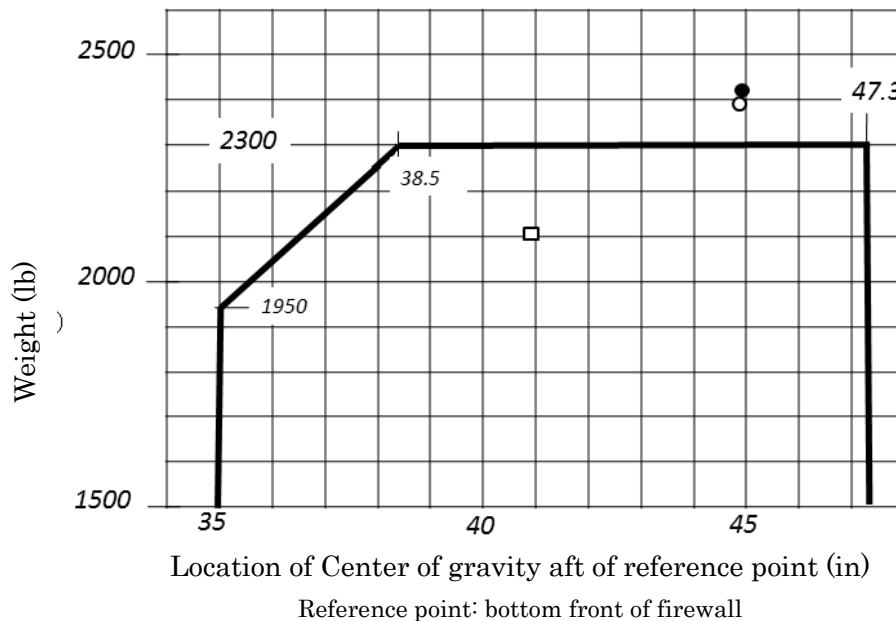
Figure A Weight and Balance Envelope

Moreover, it is somewhat likely that the weight and the location of the center of gravity, which were both beyond the operating limitations, had an adverse effect on the characteristic and maneuverability of the aircraft.

- 4 Passengers (Captain and Passenger A in the front seats, Passengers B and C in the rear seats) at landing ○ : 2,375 (lb) 44.9 (in)
- 4 Passengers (Captain and Passenger A in the front seats, Passengers B and C in the rear seats) at takeoff ● : 2,401 (lb) 45.0 (in)
- 2 Passengers (Captain and Passenger B in the front seats) at landing □ : 2,090 (lb) 41.0 (in)

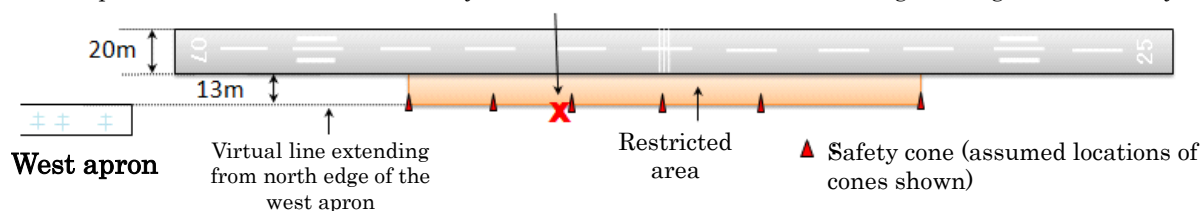
Figure C Restricted Area Set Up for Grass Mowting Operation

Assumed spot where Worker A was struck by the Aircraft (about 15 m from the long side edge of the runway)

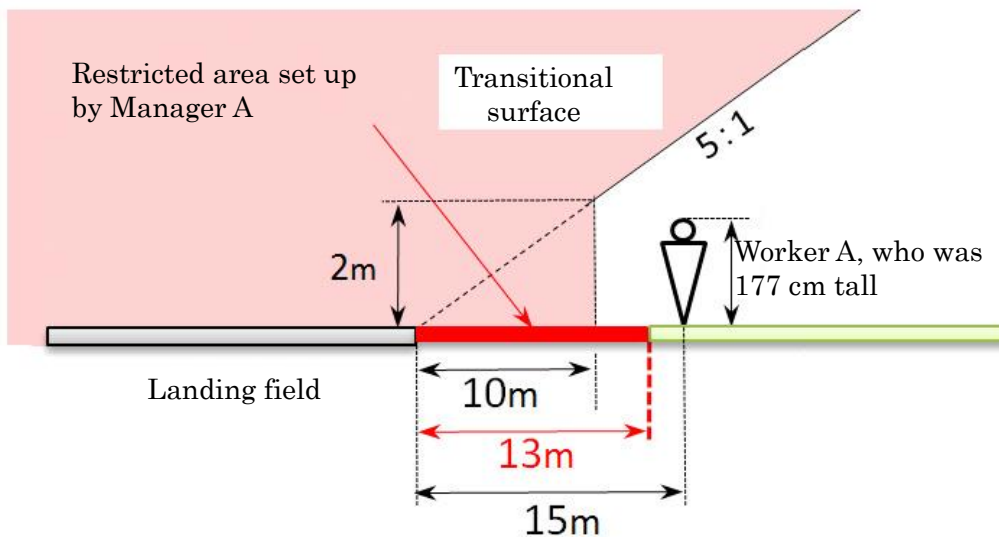
Figure D Restricted Area and Worker A's Position

Article 14 (Restricted area) of the Otone Field managing rules stipulates that no one shall enter any of the restricted area that the management may set up in the field. Article 17 (Prohibited Acts) of the rules stipulates that no person shall be permitted to enter landing strips, taxiways or aprons with no specific aim. It is probable that in order to secure the safety of the workers in conformity to the relevant standards in the Aeronautical Information Procedures Manual described in 2.10.8, Manager A established the restricted area stretching 13 m from the long sides of the runway as shown in Figure D so that the workers would not protrude above the transitional surfaces.

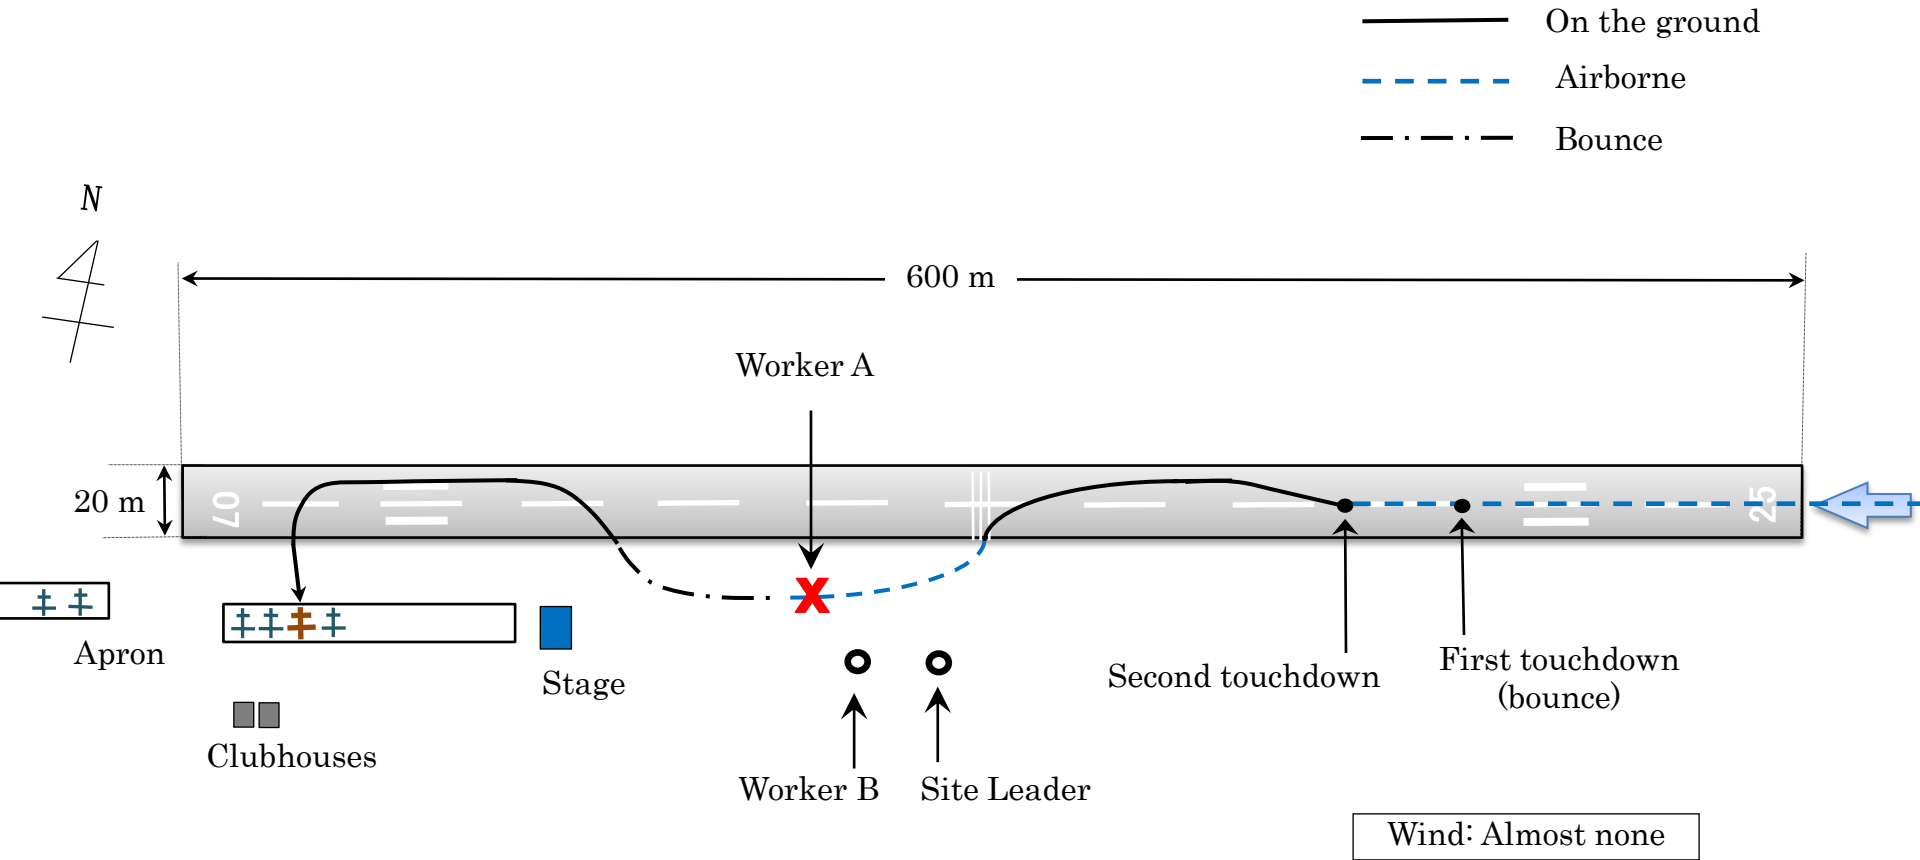
Figure 2 Estimated Flight Course and Ground Roll Track

The positions of Worker A, the Site Leader and Worker B are estimations. The figure is not to scale.

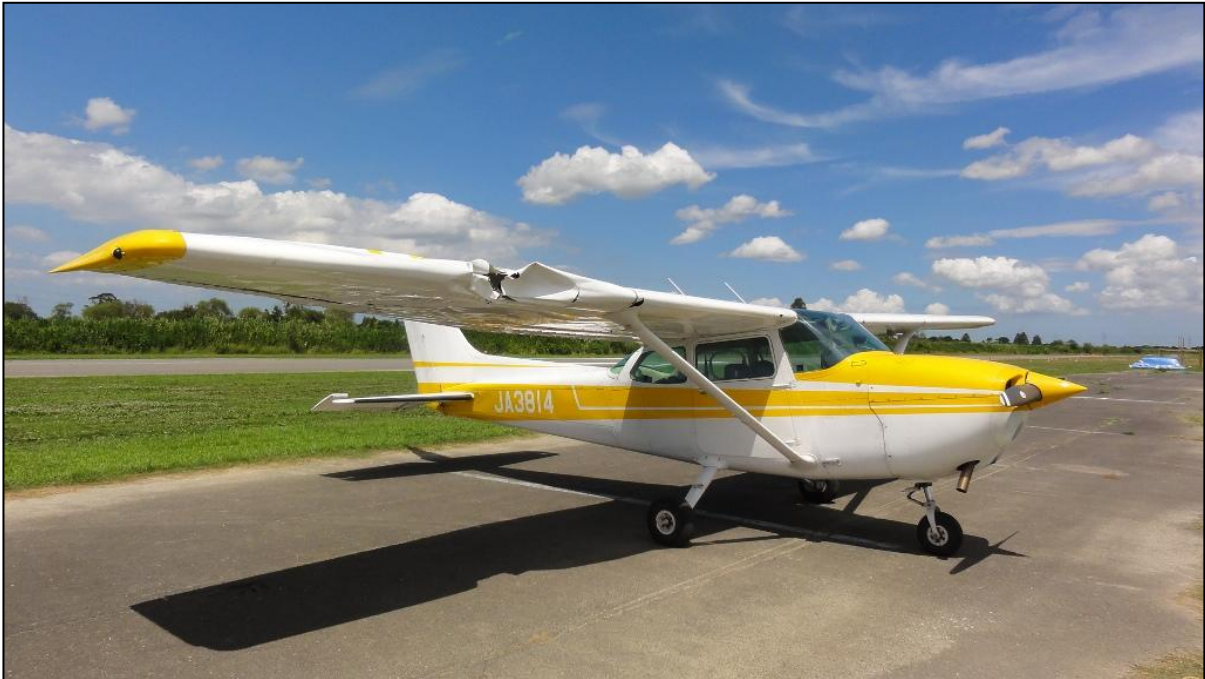
Photo 1 Accident Aircraft

(See Photo 1 – Accident Aircraft, Photo 2 – Scratch Marks on the Propeller Blades, Photo 3 – Damage to the Right Wing)

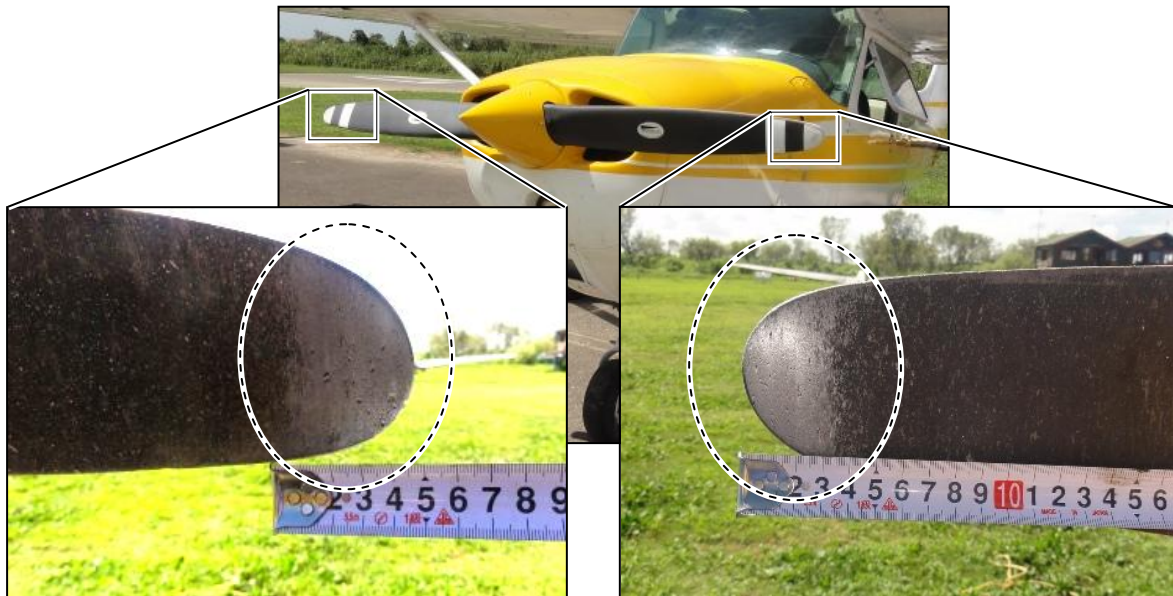
Photo 2 Scratch Marks on the Propeller Blades

- (1) Propeller      The two propeller blades had scratch marks at the tips and the paint there had been peeled off.
- (2) Wings          The left wing had no noticeable damage.  
The right wing tip had scratch marks caused by contact with the ground. The leading edge of the right wing had a large dent at around the middle of the wing, with the outer skin of the dented area cracked and the inside structural members there deformed. The trailing edge

(Rear sides of the blades)

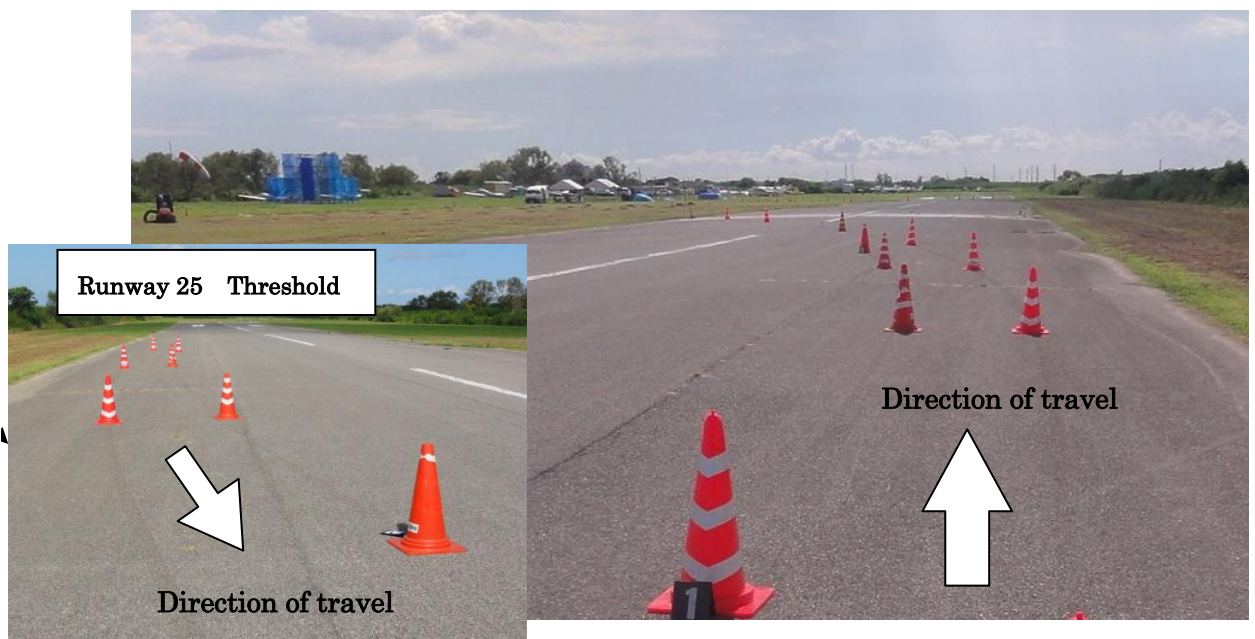
Photo 4 Tire Marks on the Runway

As described in 2.7, there were tire marks continuing until around the halfway marking on the runway but disappeared on the adjacent grass area and no trace of the Aircraft trajectory was found on it. According to the statements of the Captain described in 2.1.1 (1), the Captain did not have a clear recollection of how he operated the Aircraft after it veered off the runway; however, he remembered operating the right rudder in an attempt to bring the Aircraft back onto the runway. According to the statements of Club Member A described in 2.1.2 (2), the Aircraft, after veering off the runway, became airborne with extreme high pitch and rolled to the left but appeared unstable, and then suddenly pitched down and rolled to deep right, the tip of the right wing appeared to contact the ground. Also according to the statements of Passenger A described in 2.1.1 (2), the Aircraft, after
