AA2015-4

**AIRCRAFT ACCIDENT
INVESTIGATION REPORT**

**PRIVATELY OWNED
J A 3 8 5 3**

COLLISION WITH A TOWER FOR HIGH VOLTAGE POWER LINES
A PRIVATELY OWNED CESSNA 172M RAM, JA3853
SASAHARA-CHO, TOYOTA CITY, AICHI PREFECTURE, JAPAN
AROUND 11:47 JST, MARCH 5, 2014

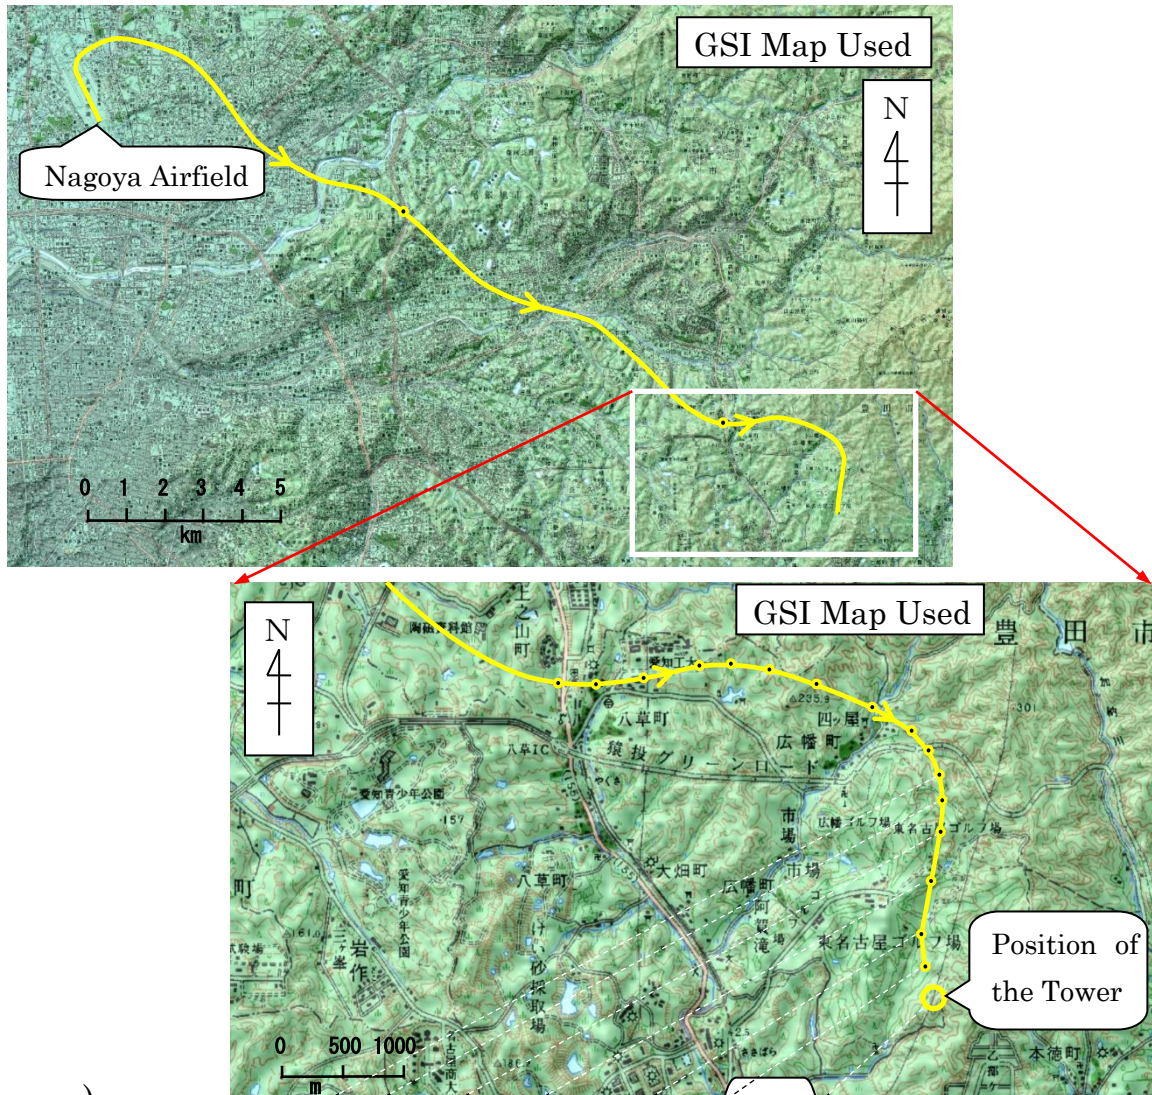
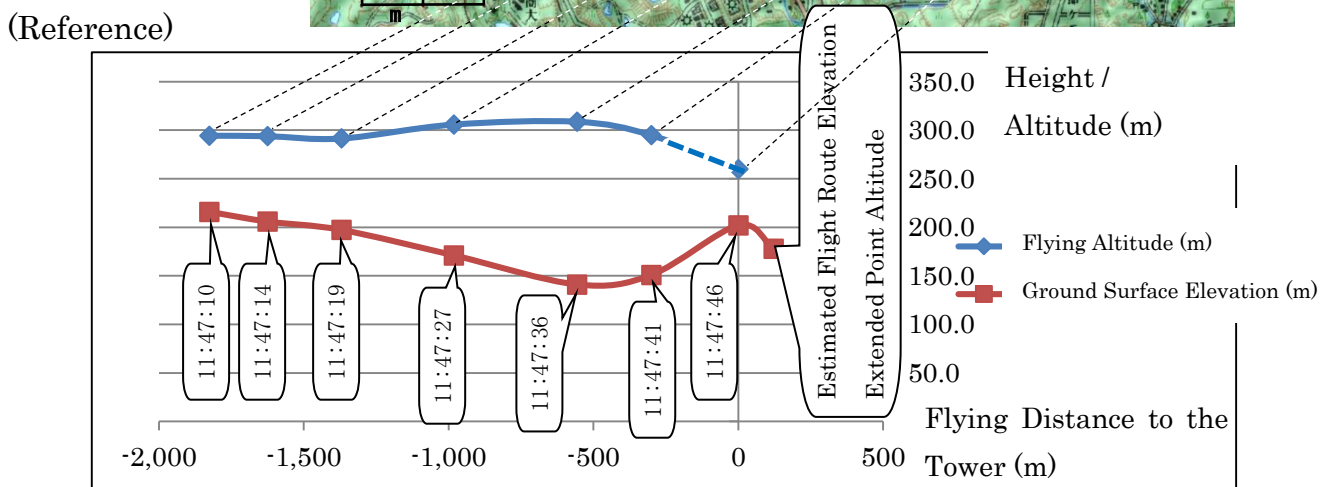
Figure 1: Estimated Flight Route Based on the Data of the GPS

According to the data retained by handhelds GPS navigation device (hereinafter referred to as “the GPS”), the Aircraft flew in the direction of the hilly area on the inland side instead of making the flight according on the route of the flight plan.

※ Height of the Tower: 63m / Elevation of Top of the Tower: 265m / Altitude of Collision: 259.7m

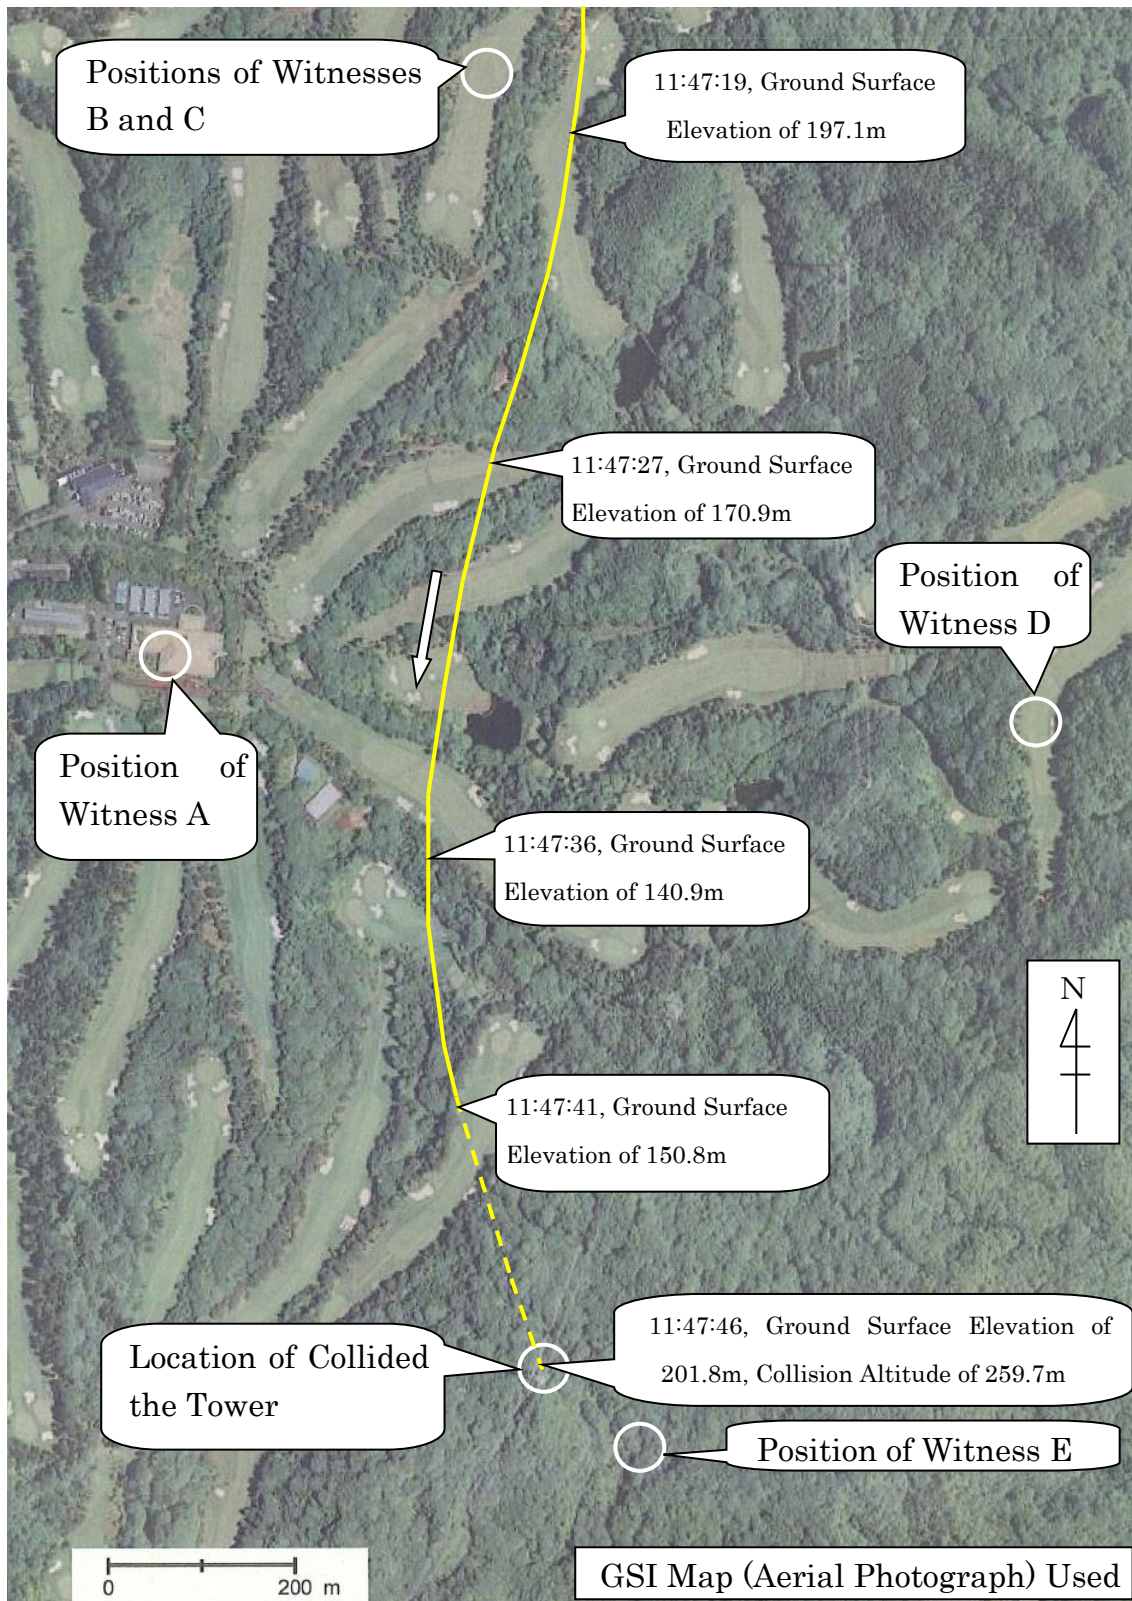
Figure 2: Estimated Flight Route (Immediately before Collision)

※ Time and Positions: GPS Records / Ground Surface Elevations: Altitude Values of GSI Map

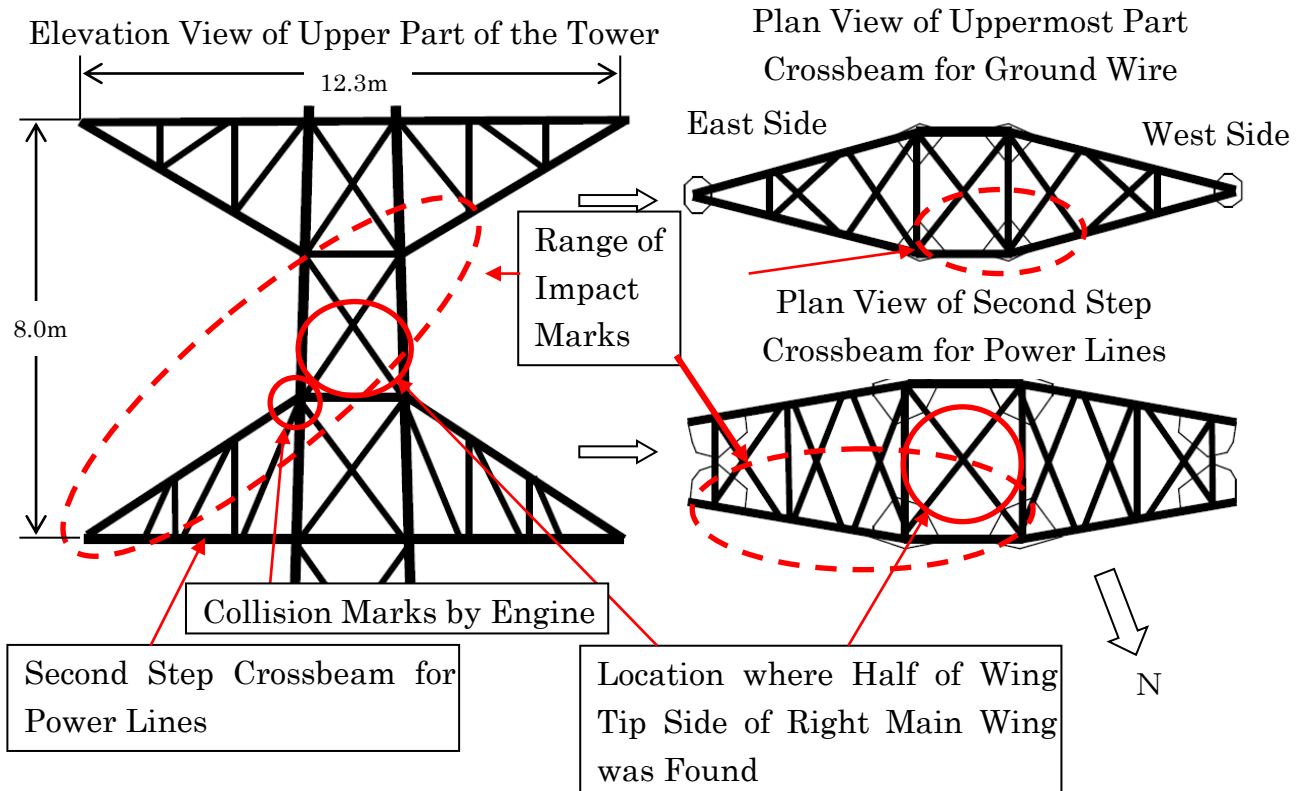
Figure 4: Range of Collision Marks of the Tower

On the upper part of the Tower have crossbeams projecting from east to west. The uppermost part crossbeam is for the ground wire (earth line) and the second level crossbeam is for the power transmission line. There were collision marks in the components including two columns located between the west side of the uppermost part crossbeam and the east side of the second level crossbeam. According to the matching of the actual parts of the Tower with the airframe wreckage, the column located in the east had a collision mark by the engine whose altitude was 259.7 m, 5.3 m below the Tower top. Moreover, there was a scratch mark in the guard of the upper part of the insulator of the power line connected from the north side of the second level east side crossbeam. There was soot from the east column with the collision mark to the east side crossbeam.

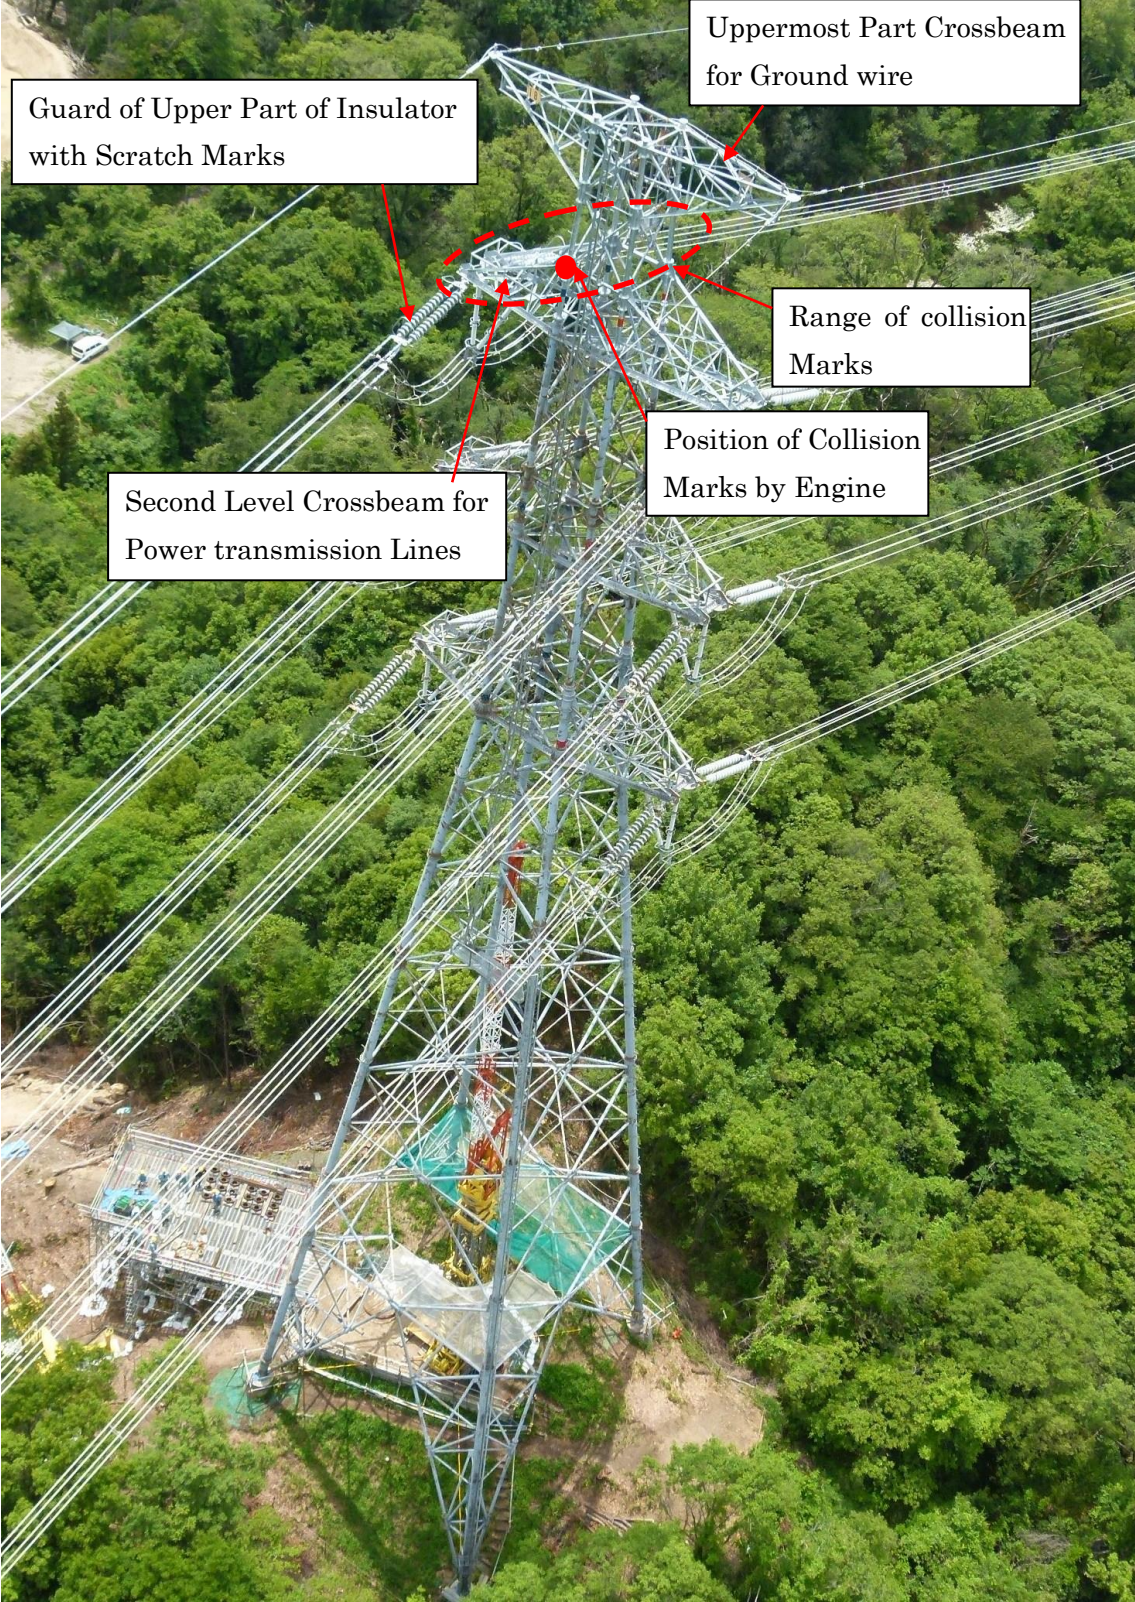
Photo 2: The Tower Struck by the Aircraft
(Immediately after Repair)

In addition, according to the electric power company, it was recorded a momentary power reduction in the vicinity of the accident site at 11:47:46.

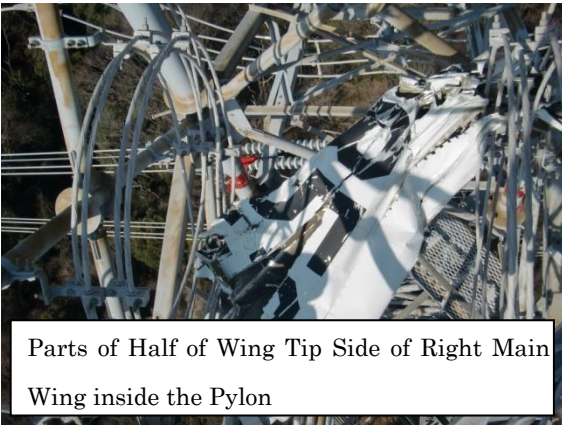
Falling off of the right main wing and fracture from vicinity of the right main wing

Parts of Half of Wing Tip Side of Right Main Wing inside the Pylon

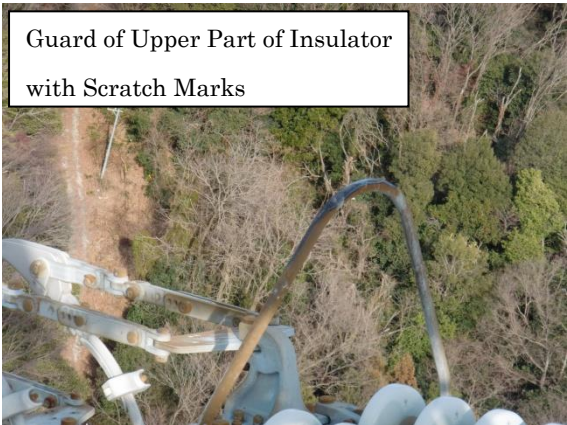
Guard of Upper Part of Insulator with Scratch Marks

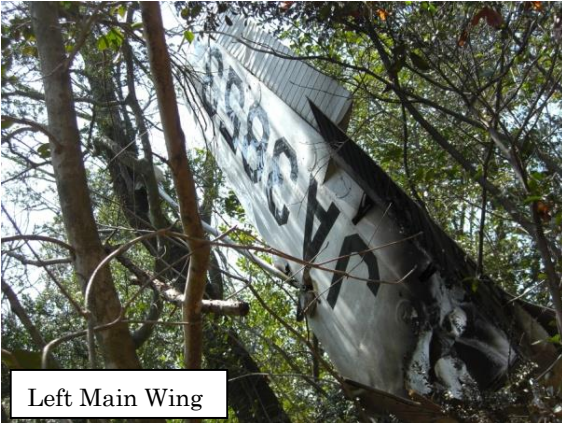
Falling off of the left main wing and burned mark on its fuel tank part
Falling off of the engine and the propeller

Left Main Wing

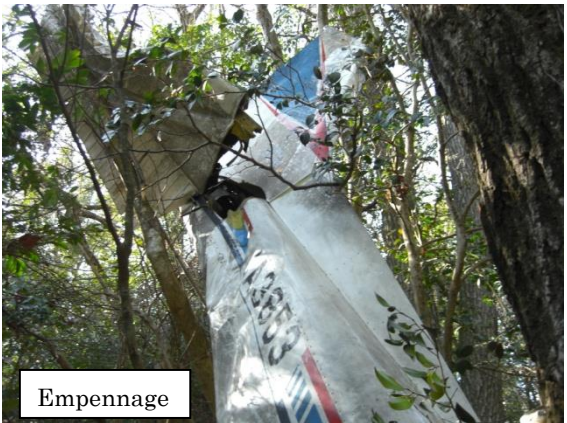
Falling off of the aft fuselage

Empennage

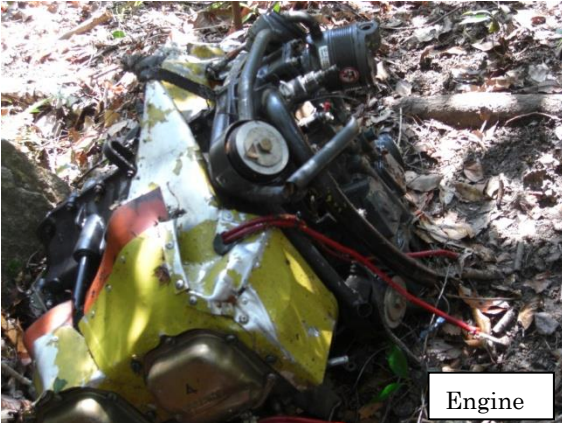
As for the engine fell off from the Aircraft, the condition of the front first and second cylinders could not be confirmed since the lower spark plugs were fractured and missing while evidence indicating normal burning condition of other six spark plugs were confirmed. The damage was severe; therefore, the in-flight condition of the Aircraft could not be confirmed from the wreckage.

Engine

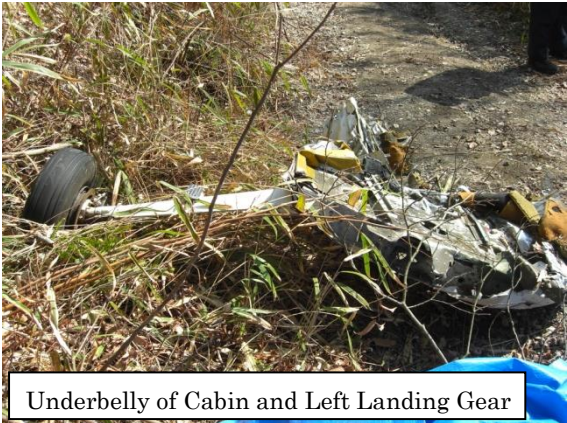
Underbelly of Cabin and Left Landing Gear
