AA2023-5

**AIRCRAFT ACCIDENT
INVESTIGATION REPORT**

**Privately owned
JA 3969**

Company	Privately owned
Type, Registration Mark	Cessna 172P, JA3969
Accident Class	Damage of main wing during taxiing (Contact with apron floodlighting)
Date and Time of the Occurrence	At about 13:57 Japan Standard Time (JST: UTC+9 hours), September 22, 2022
Site of the Accident	Yao Airport, Osaka Prefecture (34°35'51 N, 135°35'39 E)

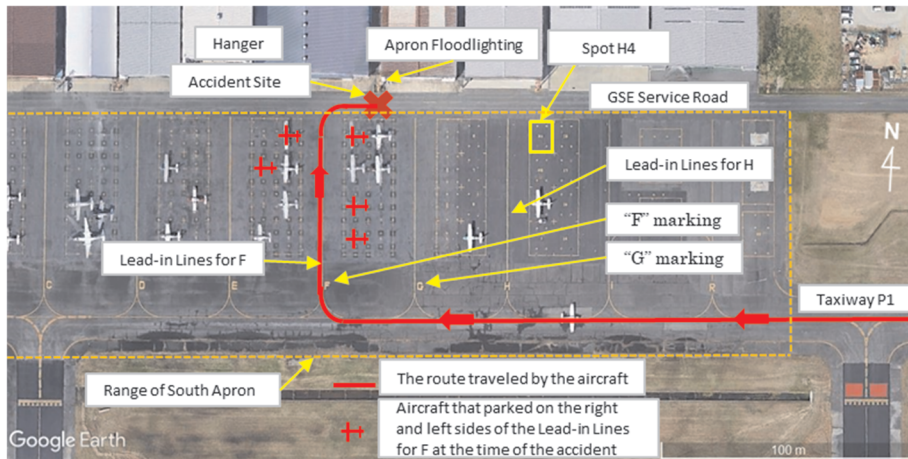
Figure 1: Estimated Travel Route

As seeing a route in front of the hangar after turning to the right, the fellow pilot decided to head for Spot H4 through the route and entered the GSE Service Road*¹.

When taxiing the aircraft on the GSE Service Road, the leading edge of the left wing came in contact with an equipment storage box attached to the pole of the apron floodlighting, the fellow pilot stopped the aircraft.
