**AIRCRAFT SERIOUS INCIDENT  
INVESTIGATION REPORT**

**HONDA AIRWAYS CO., LTD.  
JA4000**

HALT OF ENGINE IN FLIGHT  
HONDA AIRWAYS CO., LTD.  
CESSNA TU206G, JA4000  
OVER AKITA CITY, AKITA PREFECTURE, JAPAN  
AT ABOUT 11:43 JST, NOVEMBER 16, 2013

April 10, 2015

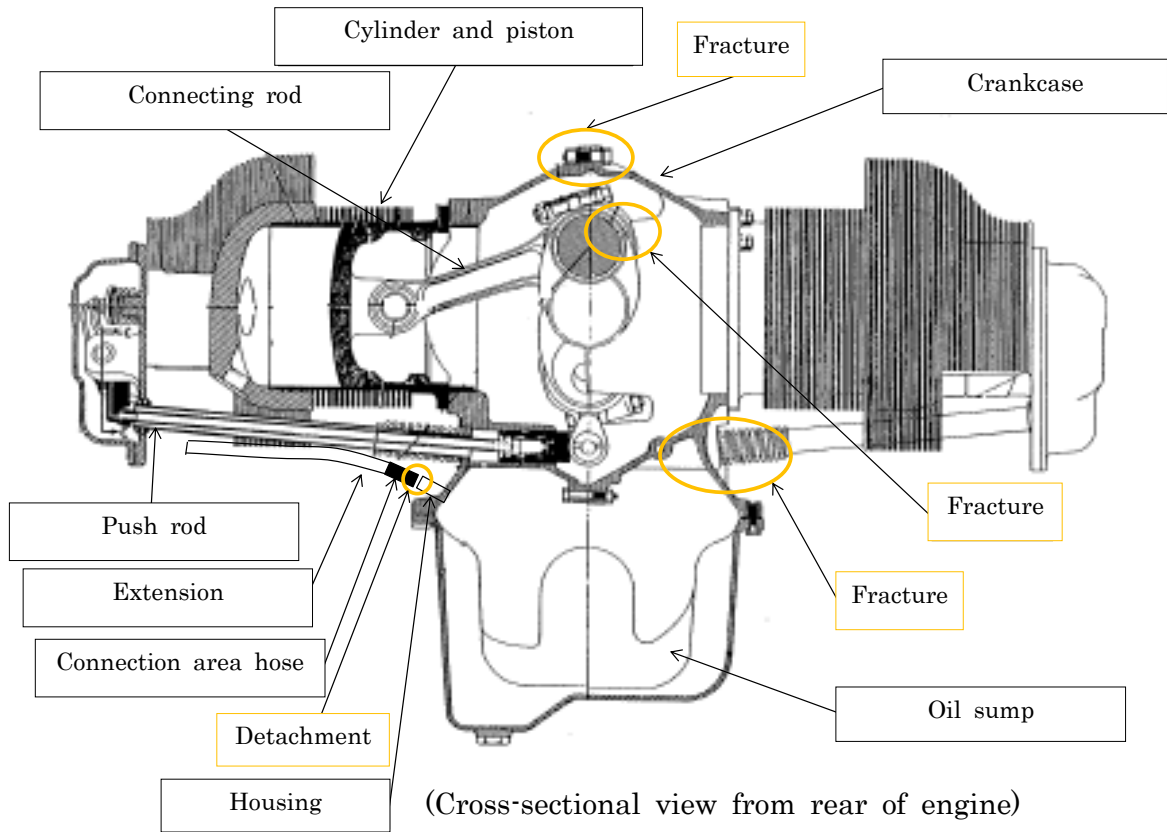
Figure 1: Engine damage

A circular fracture about 10 cm in diameter was found on the top of the crankcase, a rectangular fracture was found near the pushrod at the bottom of the fifth cylinder in the crankcase, and scratches were found on the cylinder liners.

The connecting rods of the fourth and fifth cylinders were also fractured.

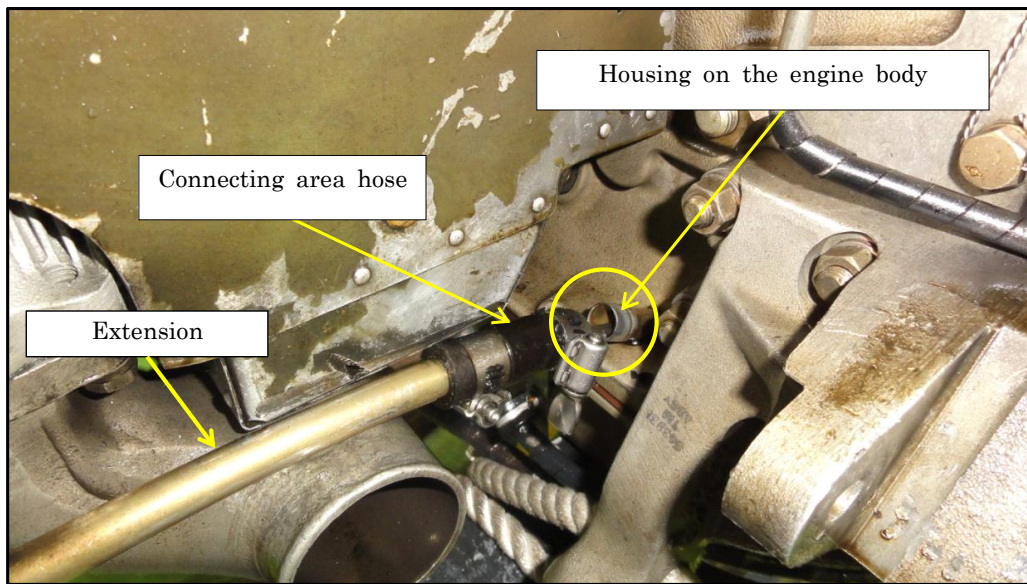
Photo A: Reproduction of detachment of hose from housing on the engine body  
(Different from the condition at time of occurrence of the serious incident)

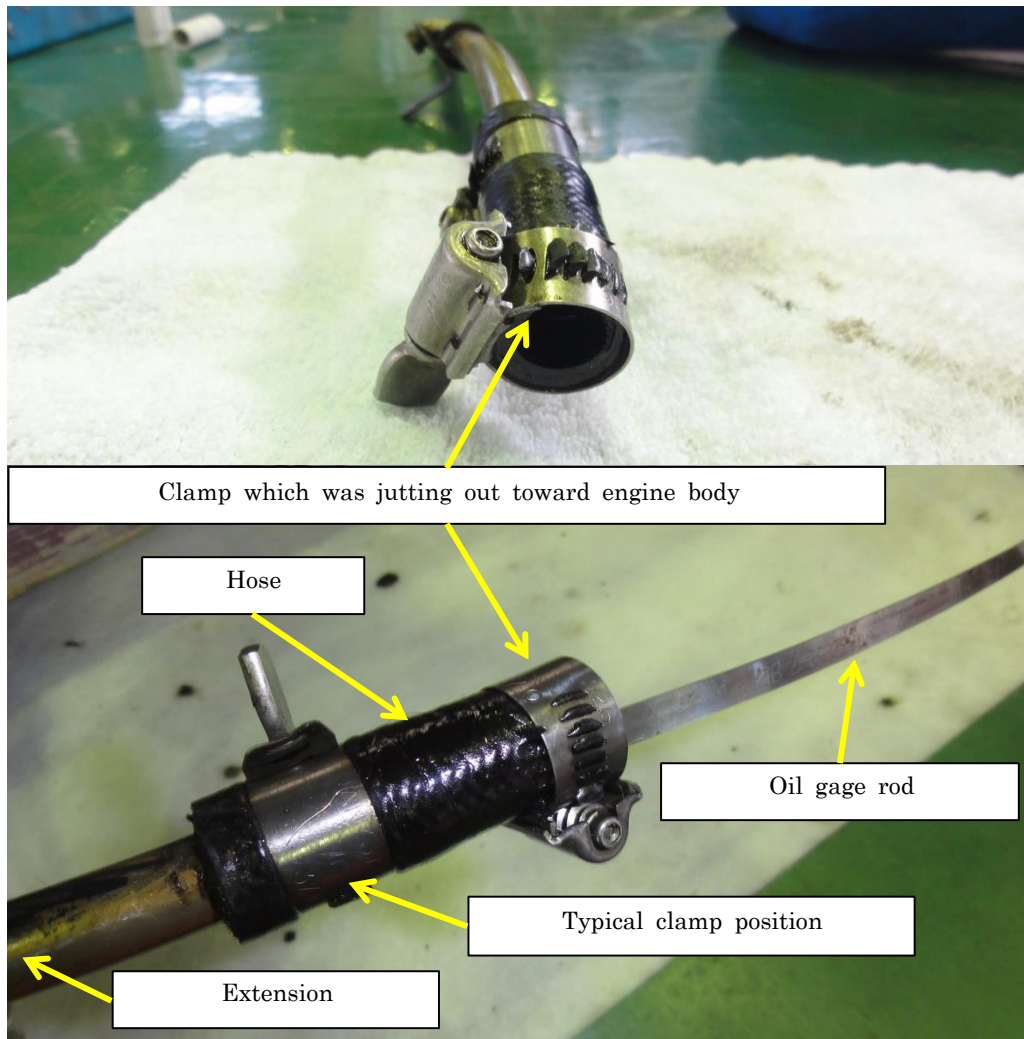
As shown in Photo B, the fitting which clamps the hose that joins the extension to the housing on the engine body was out of the position; therefore, the clamp jutted out toward the engine body, and the hose connection was loose.

Photo B: Condition of hose clamping fittings

As described in 2.3.2(1)②, the fitting which clamps the hose connecting the extension to the housing on the engine body was out of position; therefore, the clamp jutted out toward the engine body, the hose connection came loose, and the hose detached from the housing on the engine body .

It is somewhat likely that the hose had come loose at the connection to the housing because the hose clamp had been installed in a state where it was out of position toward the end of the hose and jutted out toward the engine body; accordingly, uniform and adequate clamping of the hose was not achieved.

To prevent detachment of the connecting hose between the extension and housing, it is necessary to clarify the appropriate installation instructions, to specify the tightening torque of the hose clamp, and avoid attaching the hose in an improper state.

In addition, it is preferable to provide a detachment prevention mechanism, such as by providing a bead on the inside of the clamp in order that the hose will not detach readily even if the clamp becomes loose.

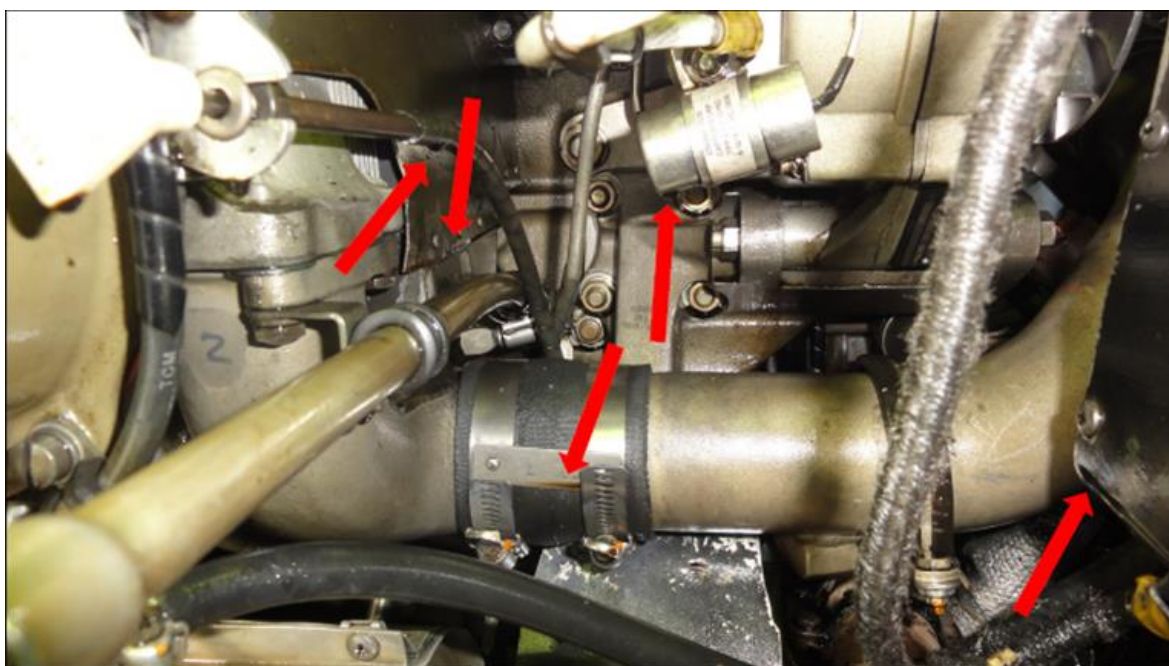
- (4) When JTSCB confirmed in the inspection after occurrence of the serious incident that the extension hose had detached from the housing on the engine body, a photograph of taken of the vicinity thereof, based on which traces of oil splattering around the housing were confirmed (see Photo C); consequently, as a reproduction test, test run was performed for three minutes with the extension hose detached from the housing of an engine of the same model. The results revealed leakage of oil around the housing (see Photo D).

Photo C: Oil splattering around the housing after occurrence of the serious incident  
(The red arrows point to accumulated oil drops and significant oil saturation)

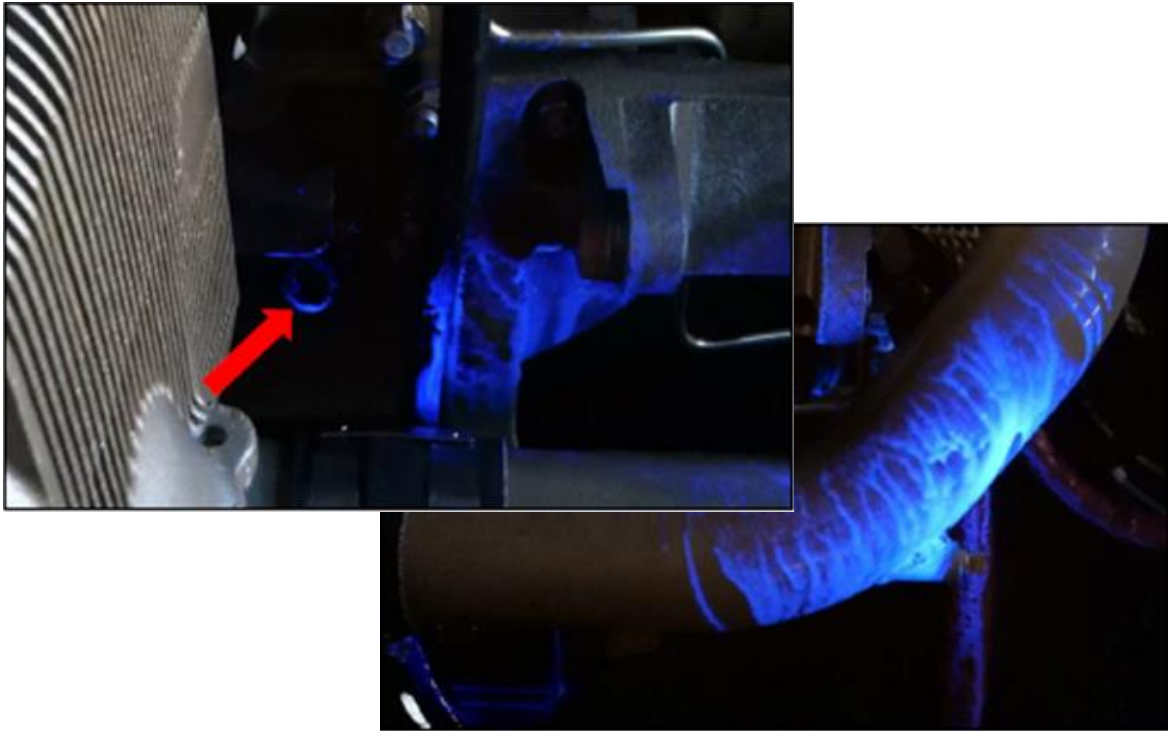
Photo D: Oil splattering during reproduction test  
(Leaked oil has been highlighted with a black light. The red arrow points to normal attach hose.)

As described in 2.10, based on the results of engine teardown examination, the location where the oil leakage occurred could not be found in the engine body, and oil leakage was observed around the housing in an oil leakage reproduction test performed after removing the extension from the housing.

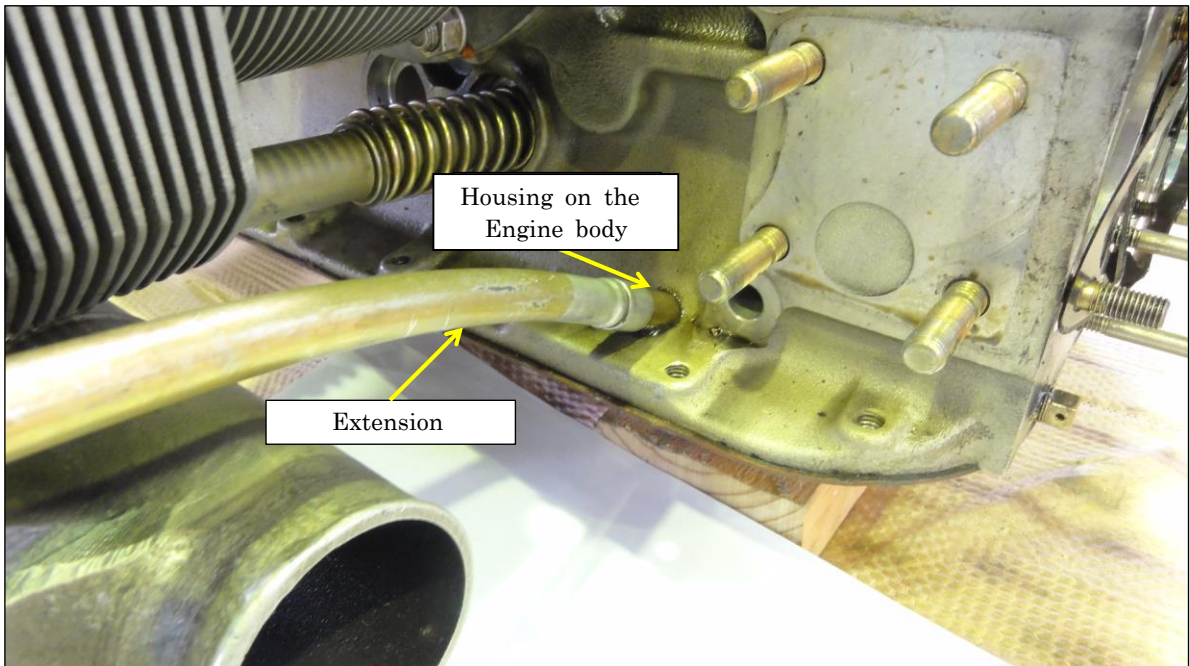
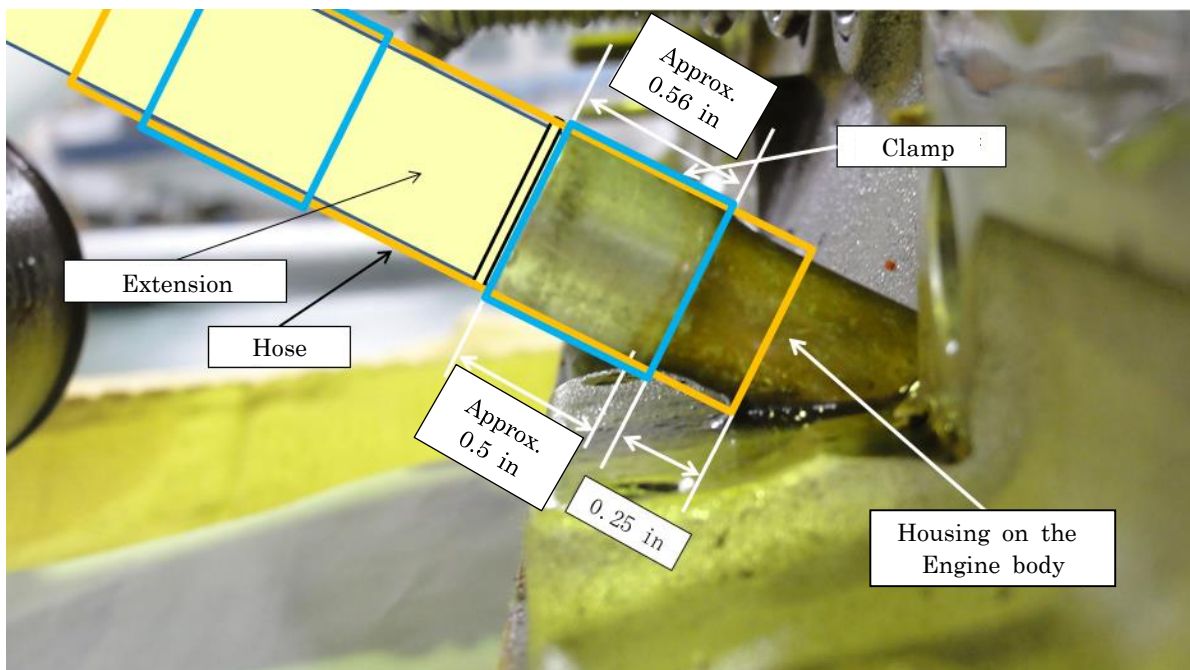
Photo E: Connection area

When connected in accordance with the manufacturer's Installation Instructions described in (3)②, the position of the clamp of the hose (hose is shown by the orange box) is in the area where the diameter of the housing on the engine body becomes thick, as shown by the blue box; therefore, there is no bead to serve as a catch mechanism for preventing detachment of the hose on the inside of the clamp as shown in Figure 7-25 described in (3)①.

In addition, as described in 2.11.1(4), the housing on the engine body side, as shown in Figure 7-25 of 2.11.1(3)①, had no catch mechanism which would prevent detachment of the clamp in the event that it became loose. It is somewhat likely that this contributed to the detachment of the loosened extension hose from the housing on the engine body.

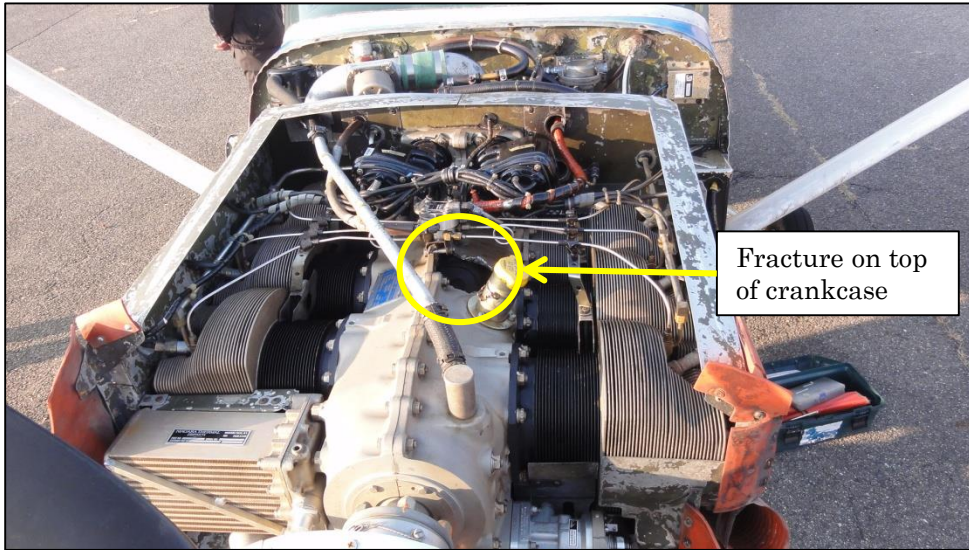
Fracture on top of crankcase

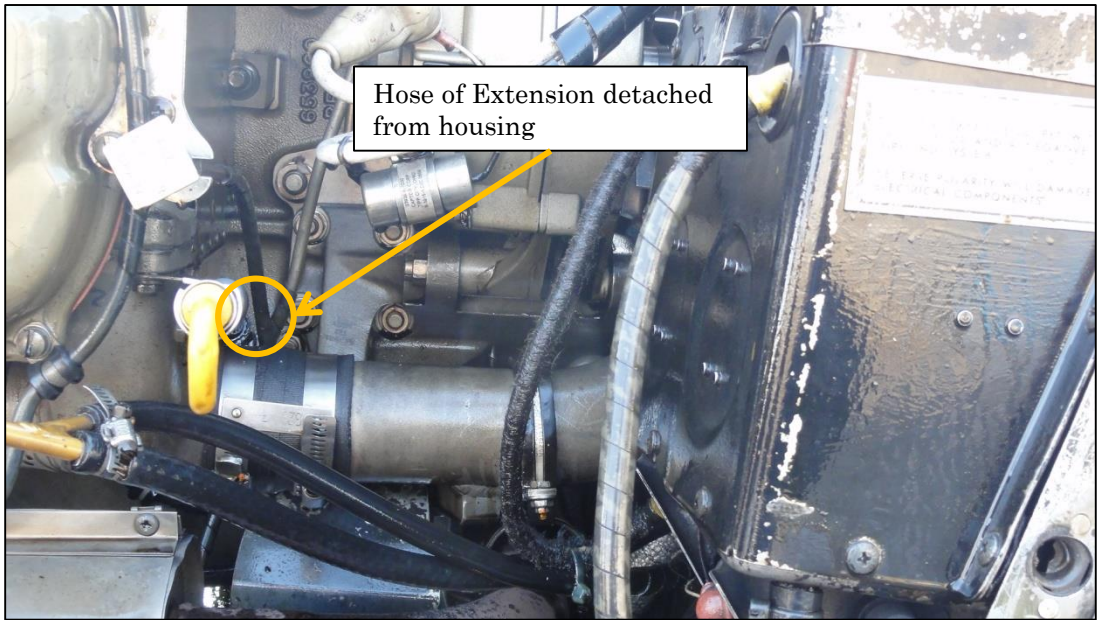
The hose of the housing extension (hereinafter referred to as “extension”) forming part of the oil gage used for checking the oil level was detached from the oil gage rod housing (hereinafter referred to as “housing”) on the engine body.

Hose of Extension detached from housing

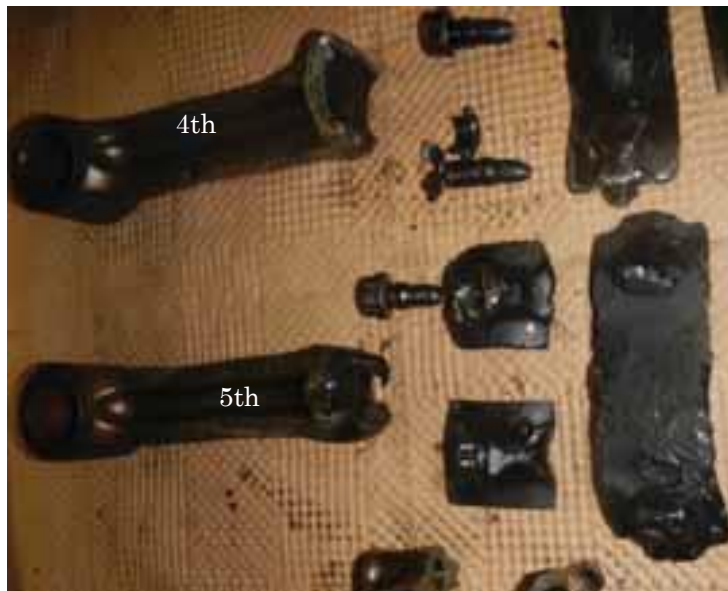
- (1) It is probable that, as a result of exhaustion of the engine oil, the fourth and fifth connecting rods fractured and were liberated; these displayed signs of heat damage and discoloration resulting from heat.

Fractured 4<sup>th</sup> and 5<sup>th</sup> connecting rods
