AIRCRAFT ACCIDENT INVESTIGATION REPORT

DAMAGE TO THE AIRFRAME DURING LANDING

PIPER PA-46-350P, JA4077

SENDAI AIRPORT

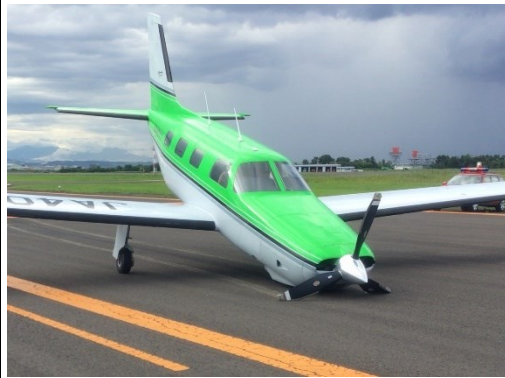
Figure 2: The Aircraft at Time of Accident

| 2.7 Additional Information | <p>(1) Damage to the Aircraft</p> <p>As the retractable NLG collapsed in the retracted direction, the aircraft tilted forward, the lower forward fuselage made contact with the runway surface, which caused the tips of three propellers to be damaged, and the NLG strut and door, and part of the skin of the lower front fuselage to be damaged and deformed.</p> |

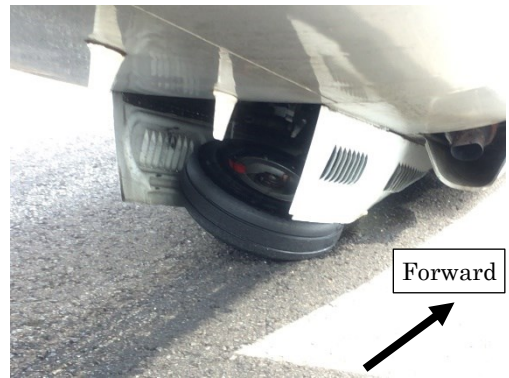
Figure 3: NLG Condition

From the fact that the NLG of the aircraft had collapsed in the retracted direction with the actuator in extended and down-locked position, it is certain that during the landing roll, fractured was the right one of the left and right actuator attachment feet fixing the actuator that had retained the NLG in the down-locked position, thus loads from the NLG concentrated on the left attachment foot, which deformed the engine mount that could no longer support the actuator, leading to the collapse of the NLG in the retracted direction.

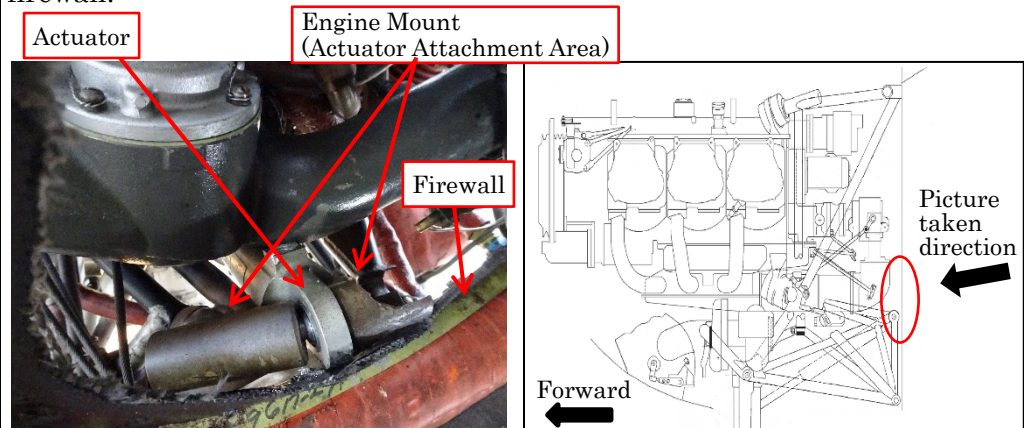
Figure 4: Actuator Attachment Area and Firewall
(See Appended Figure 1 for details)

In addition, in the forward fuselage, part of the engine mount was broken and deformed. (Figure 4 to Figure 6)

The engine mount of the aircraft is a base-like part to fix not only the engine but also the NLG strut and NLG actuator. The NLG actuator is bolted being sandwiched from the left and right sides via the actuator attachment feet, which is part of the engine mount. The engine mount of the aircraft was found deformed where the right actuator attachment foot area was fractured, only the left foot was supporting the actuator, and the tip of actuator had been found hit the firewall, deforming part of the firewall. (Attached Figure 1)

The aircraft is equipped with a retractable landing gear and its NLG is designed to be swung out from the rear to the forward using the NLG trunnion attachment installed on the engine mount as the pivot. The NLG is designed to be swung out when the actuator is extended, and down-locked when the actuator is locked with the actuator in the extended position. It was found that the aircraft's actuator was in the extended and down-locked position and hit the firewall.

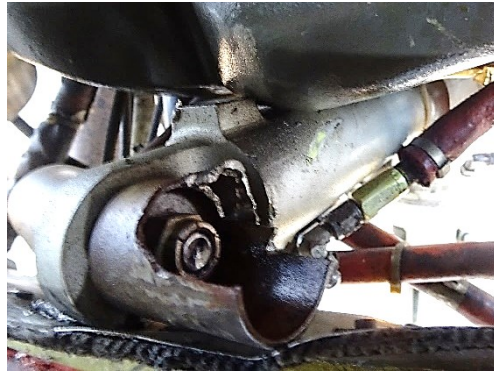
Figure 5: Fractured Portion A
(Actuator Side)

Removal and examination of the Fractured Portion A (Figure 5) revealed partial corrosion on the fracture surface and blisters *1 had occurred on the back side of the welded part.

The JTSA concludes that it is certain that as partial corrosion occurred on the fracture surface of the right actuator attachment foot, the cracking had occurred before this accident occurred and it had progressed over the repeated flights, leading to the fractures.

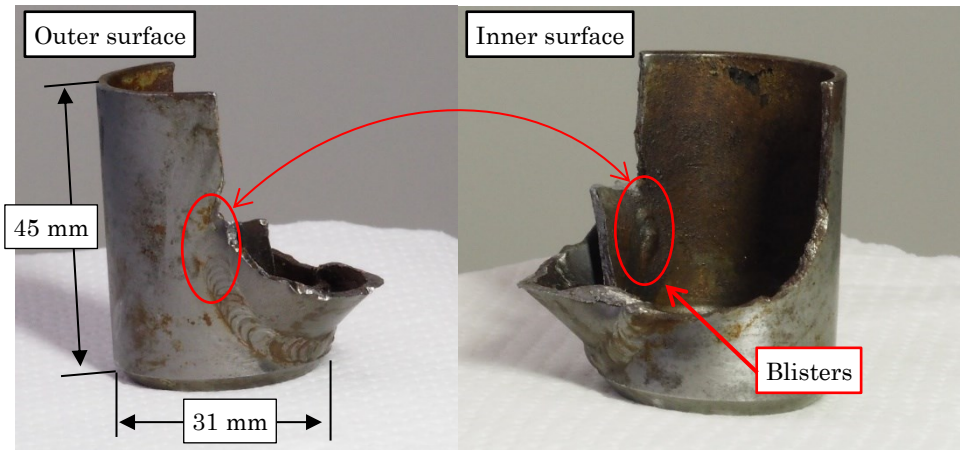
Figure 7: Blisters on Fractured Portion A

The analysis of the fractured surface revealed that the right actuator attachment foot fractured, because blisters around the inner surface of the cylindrical foot along the weld joining occurred due to corrosion, it is probable that in the blister part, non-through cracks originating from the inner surface were formed, developed into through cracks later, and progressed to its end further. (Attached Figure 2)

Regarding the corrosion that occurred on the inner surface of the welded part, it is probably that in addition to the corrosion resistance property in the welded part, several factors contributed to such as the custodial environment and conditions of the aircraft, characteristics of cylindrical shape whose inner surface is considered to be prone to residual moisture due to condensation and others. Therefore, it was unable to determine when and how the corrosion occurred. Japan has a humid climate with a lot of precipitation, making it an environment with a high risk of corrosion. And when using the airport located in coastal areas as its homebase as in the case of the aircraft, it is susceptible to the influence of sea breeze, therefore, careful attention should be paid to corrosion.

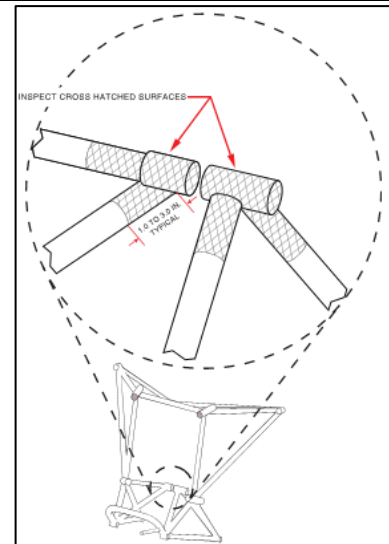
Figure 8: Fluorescent Penetrant Inspection Areas

In response to the failure cases, the design and manufacturing company issued Service Bulletin (SB) 1103 on April 22, 2002 (the latest version at the time of the accident was issued on September 1, 2015 as the SB 1103F), to instruct fluorescent penetrant inspection at each 100 hours time in service for the actuator attachment area. (Figure 8)

For the actuator attachment area, it is possible to confirm the presence of cracking by appropriately conducting the fluorescent penetrant inspection that the company instructs at each 100 hours time in service, therefore, when cracks are confirmed during maintenance work, appropriate actions can be taken before leading to fractures. Besides, as anticorrosive measures are included in the inspection procedure, with periodical inspections, continuous anticorrosive effect can be expected.

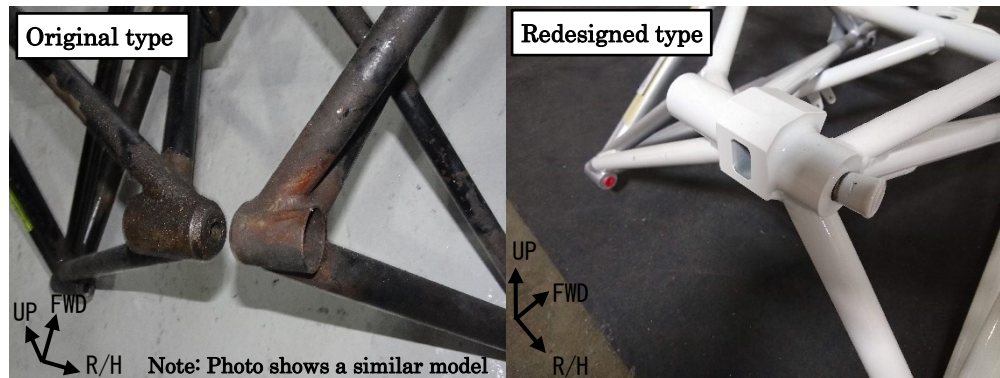
Figure 9: Configuration Comparison between Two Actuator Attachment Areas

The company has redesigned the actuator attachment foot and currently provides the redesigned engine mount that each attachment foot is a one-piece machined part (Figure 9). The airplanes whose engine mounts were replaced with the redesigned ones can eliminate the fluorescent penetrant inspection at each 100 hours time in service.

Furthermore, replacing the original engine mount with the redesigned one is probably effective to prevent cracks in the actuator attachment area from occurring.

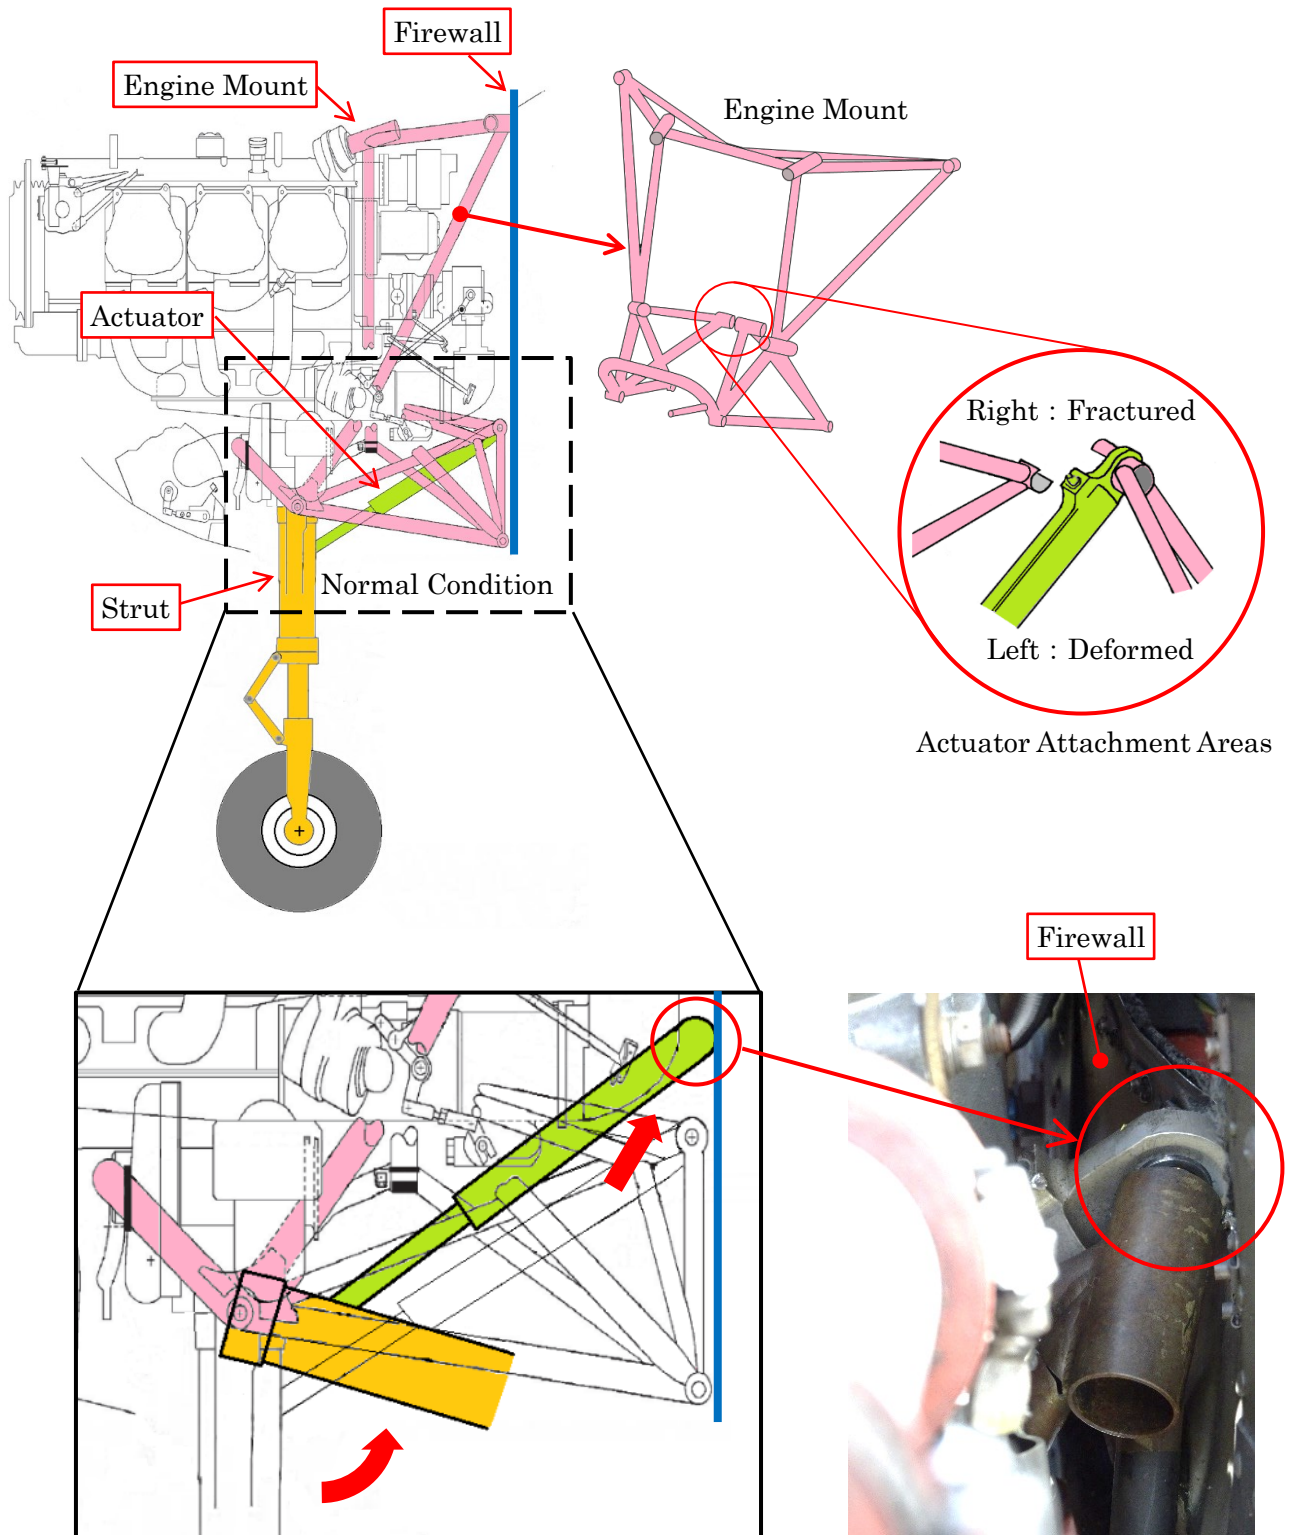
Image Diagram of Damage to Firewall and Engine Mount

The engine mount was deformed, and the actuator hit to deform the firewall.

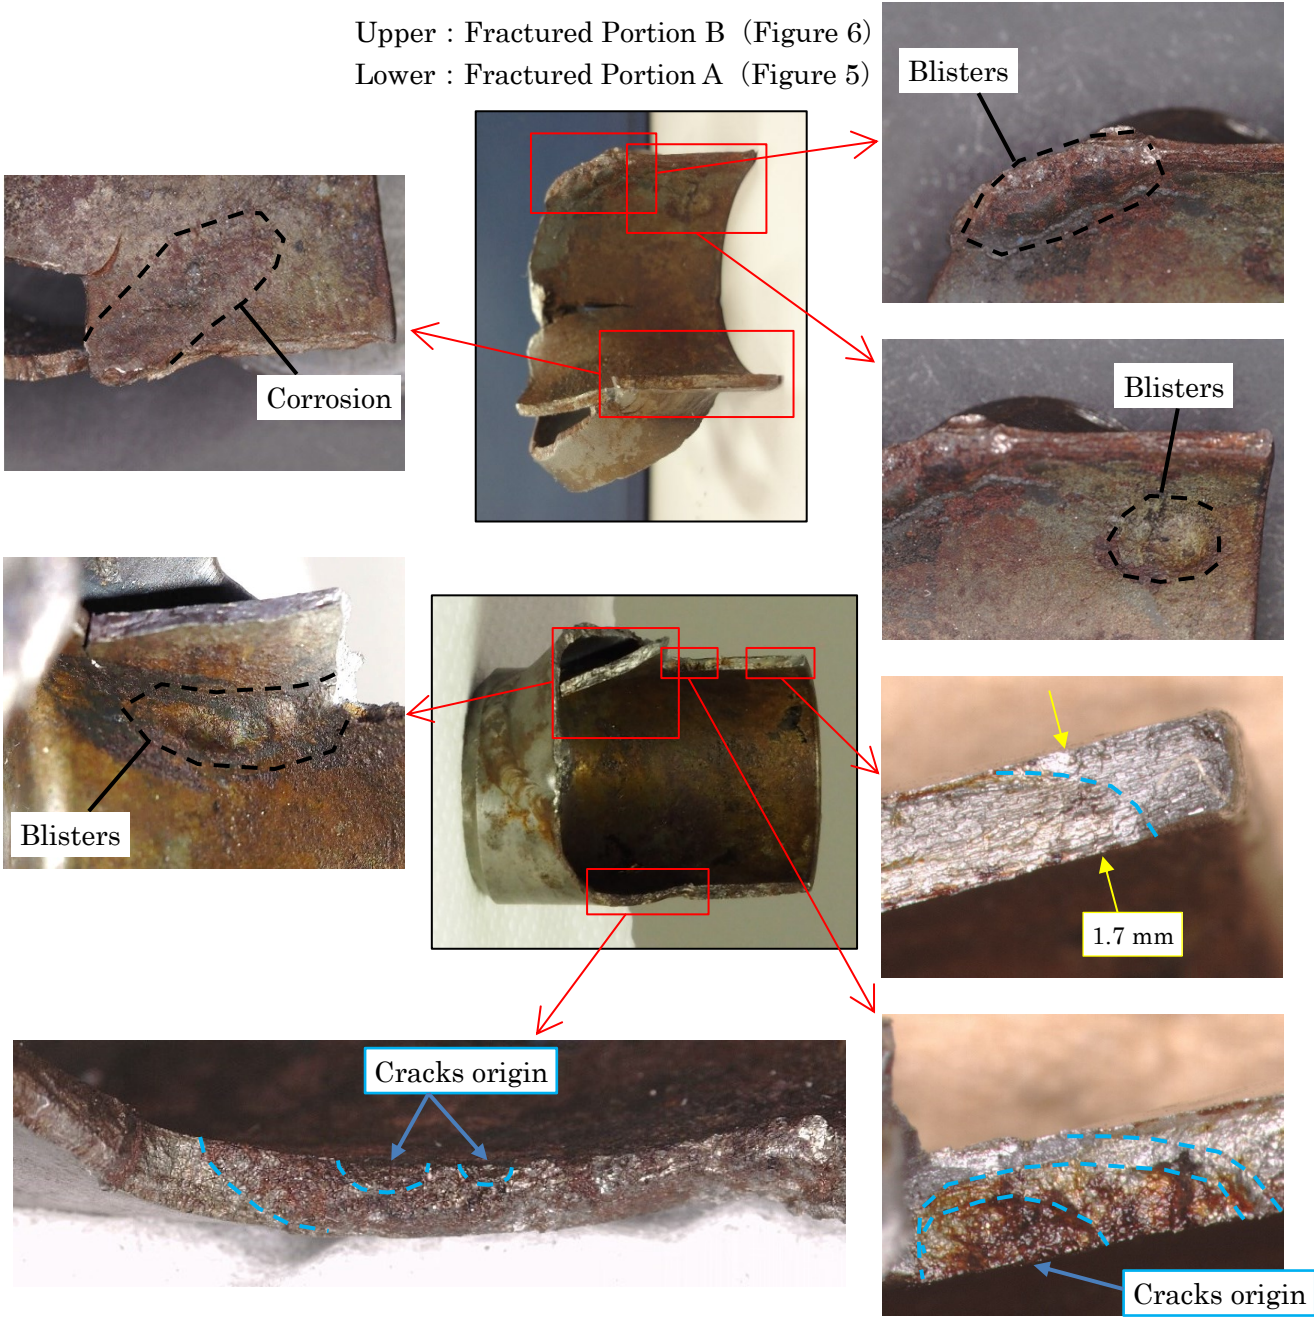
Visual Examination of Right Actuator Attachment Foot

Upper : Fractured Portion B (Figure 6)
Lower : Fractured Portion A (Figure 5)

Note: The light blue dashed line indicates the crack tip in the stepwise progression of the crack.
