**AIRCRAFT ACCIDENT  
INVESTIGATION REPORT**

**J A 4 0 7 9**

**Japan Transport Safety Board**

**PRIVATELY OWNED  
PIPER PA-28R-201T, JA4079  
ON THE RUNWAY OF MATSUYAMA AIRPORT  
AT AROUND 15:35 JST, OCTOBER 10, 2009**

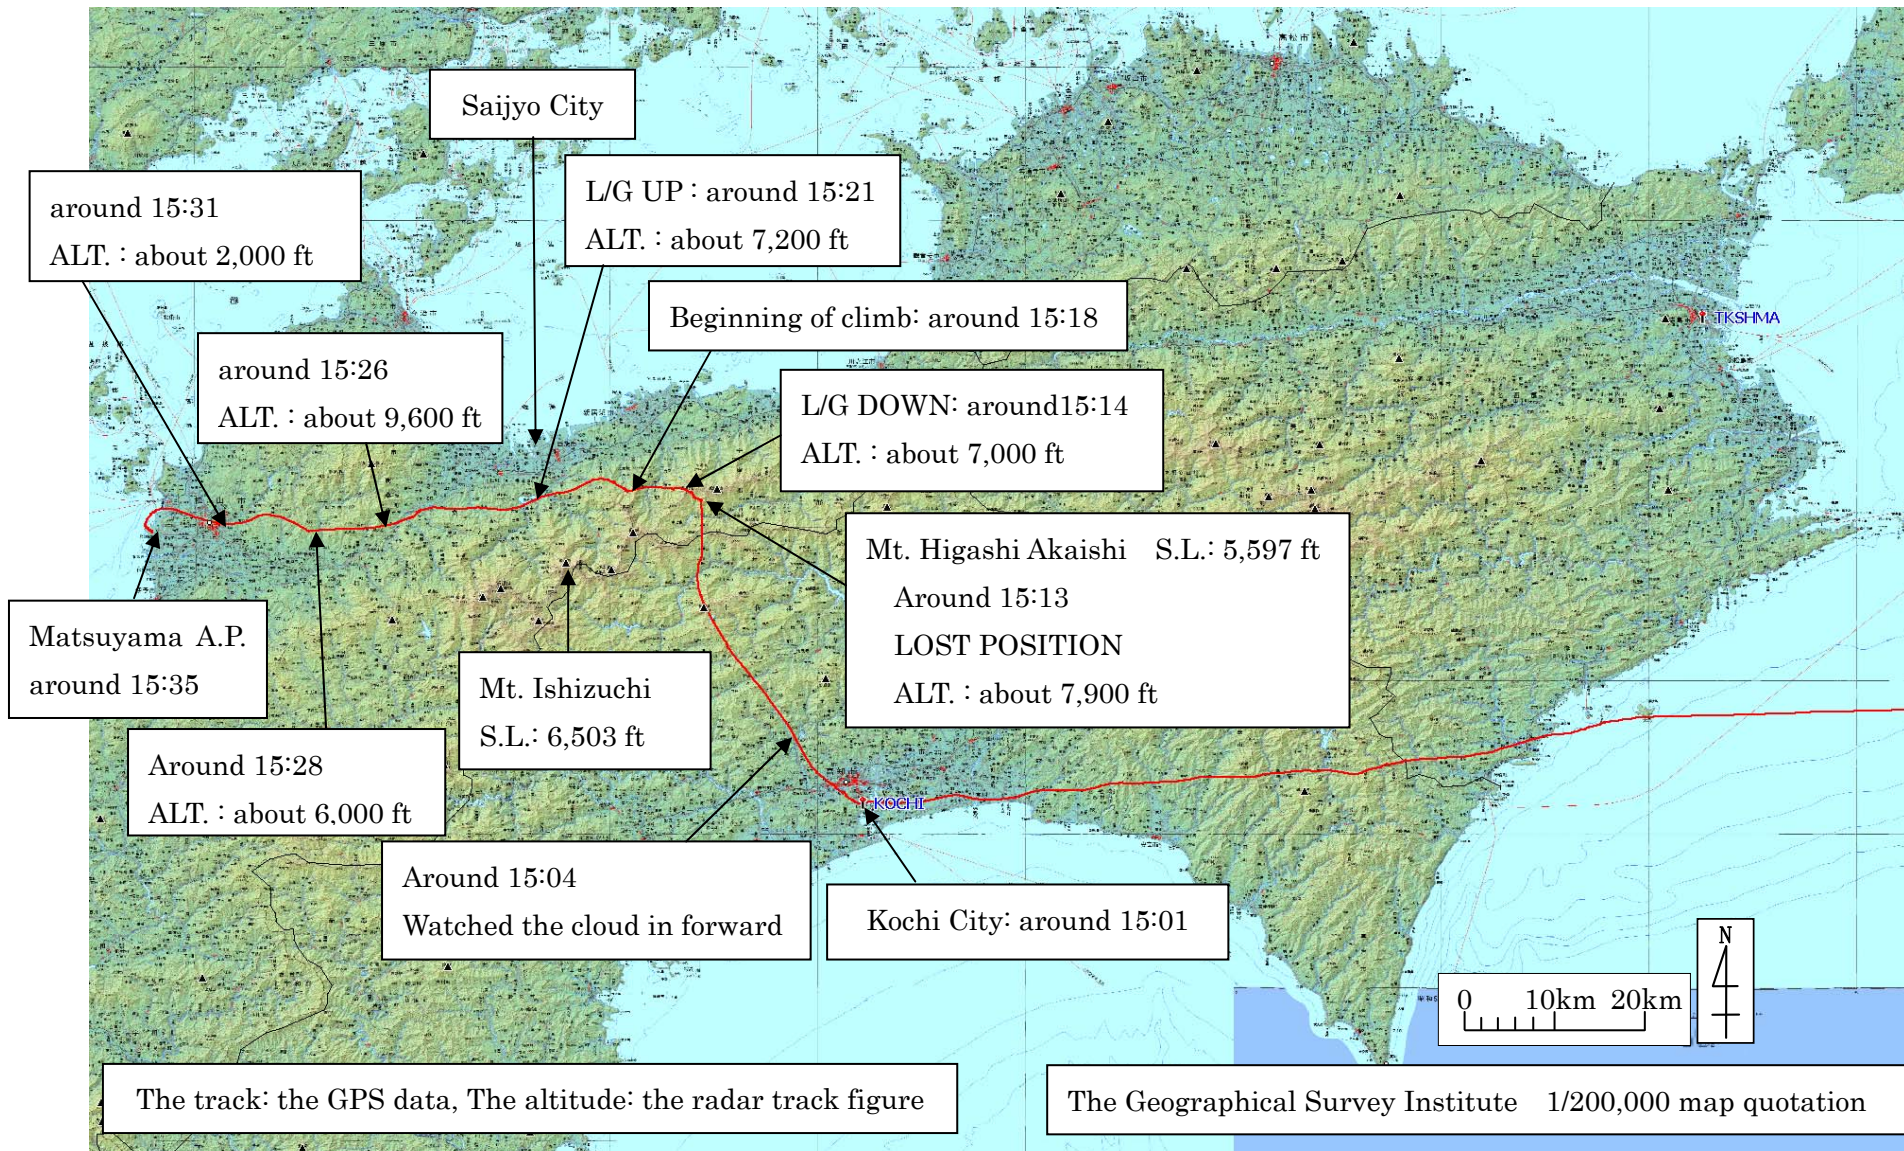
Figure1 Estimated Flight Route (In Shikoku-Island)

In the actual flight, it is considered highly probable that, since the captain checked the Aircraft's position using VOR or GPS, he could not grasp the geological formation when the signal of Matsuyama VOR/DME was not able to be received in the situation that the ground was temporarily invisible from the Aircraft during on-top flight, so he was flying to Matsuyama Airport relying solely on GPS.

As described in 2.1.1, the Aircraft descended to 5,000ft from 7,900ft when it had not passed the mountainous terrain. This is considered probable that the Aircraft attempted to avoid the clouds to confirm the ground. But it was descending at an altitude of 6,000ft when it was passing the east side of Mt. Kuromori. It is considered probable that it was dangerous to lower its altitude over the mountainous terrain without knowing its position. It is considered highly probable that it had a very instable flight, in which it started climbing, after reaching 5,000ft, to 9,600ft, and steeply dived to 1,800ft.

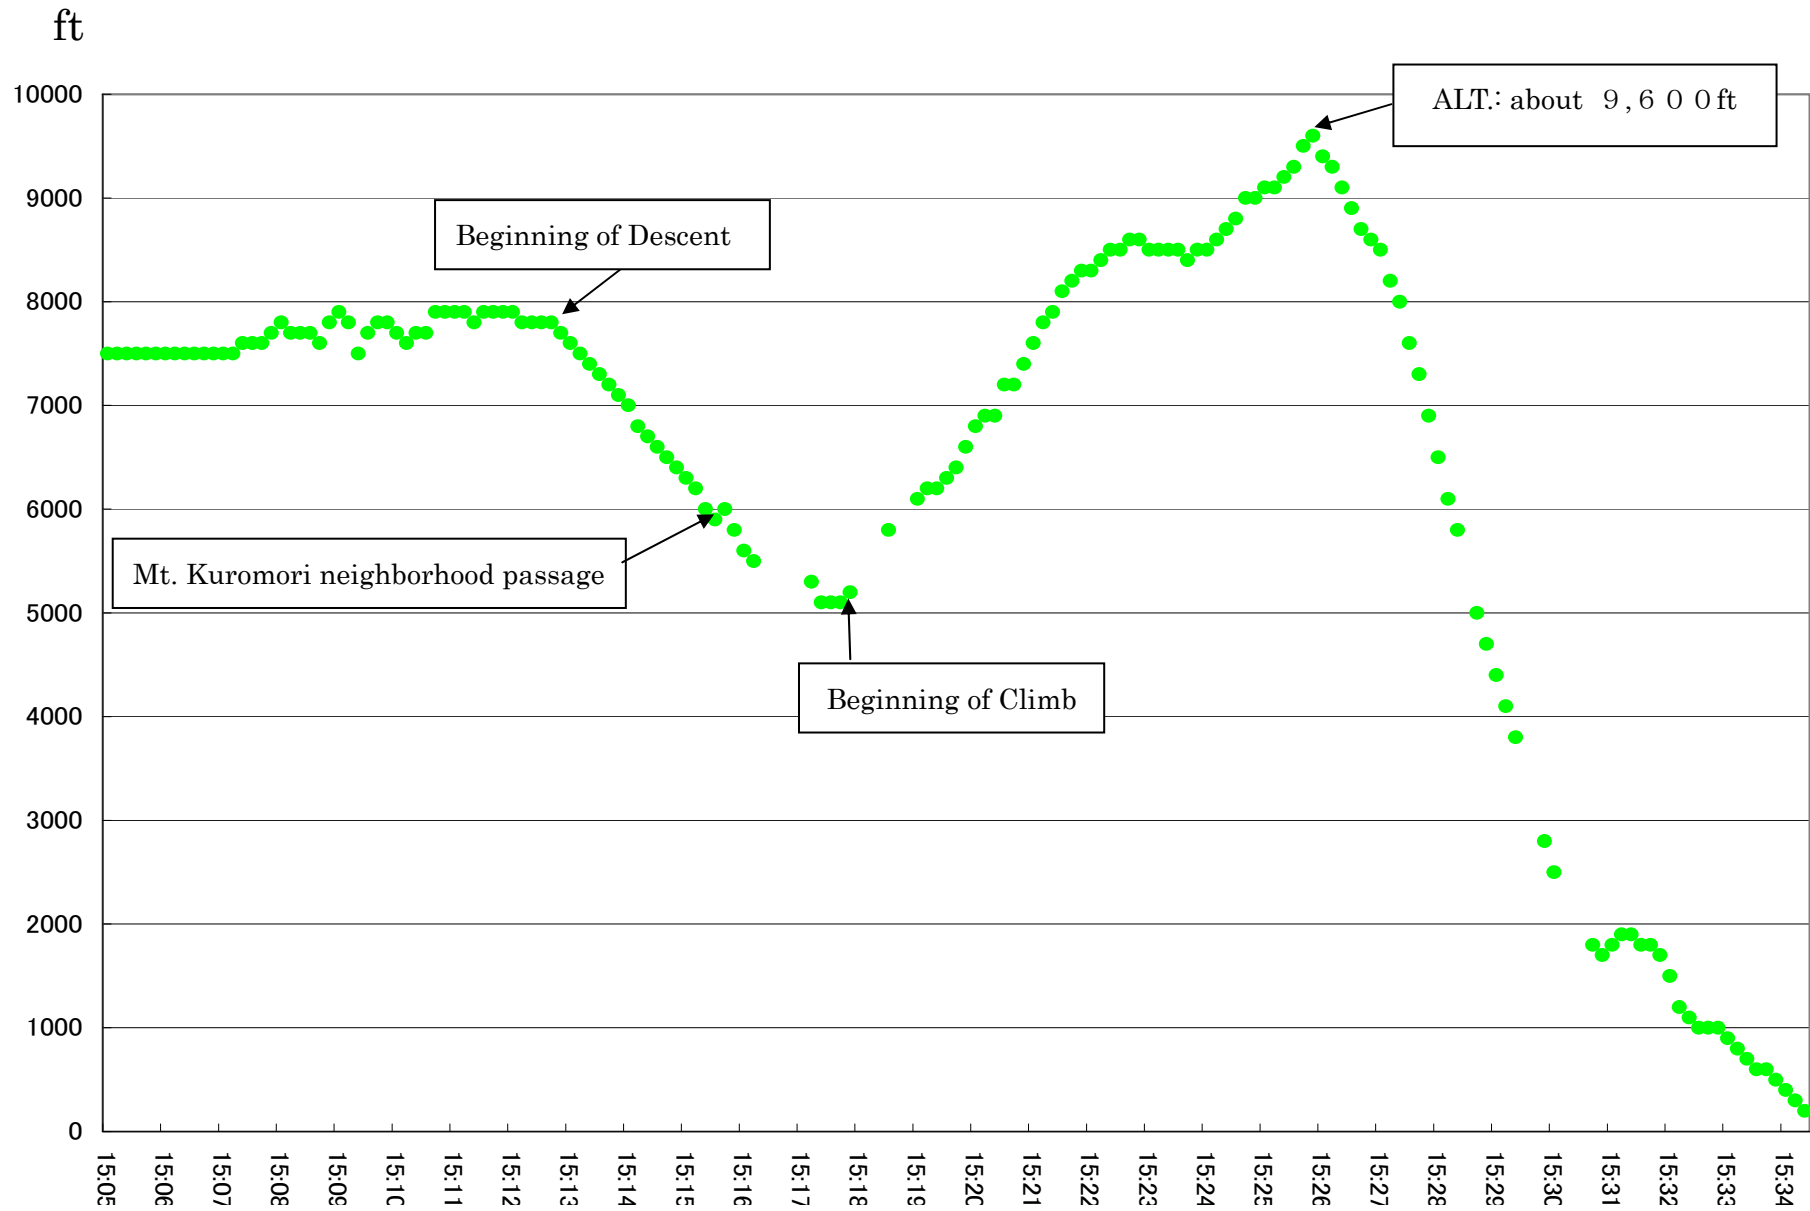
Figure 2 Altitude Change of the Aircraft in the Track Record

500ft/min, which is normal for a small aircraft. However, since the altitude of the Aircraft was 7,200ft then and was even rising to about 9,600ft despite approaching the Airport, it is considered highly probable that he did excessive descent of the Aircraft in a forced manner.

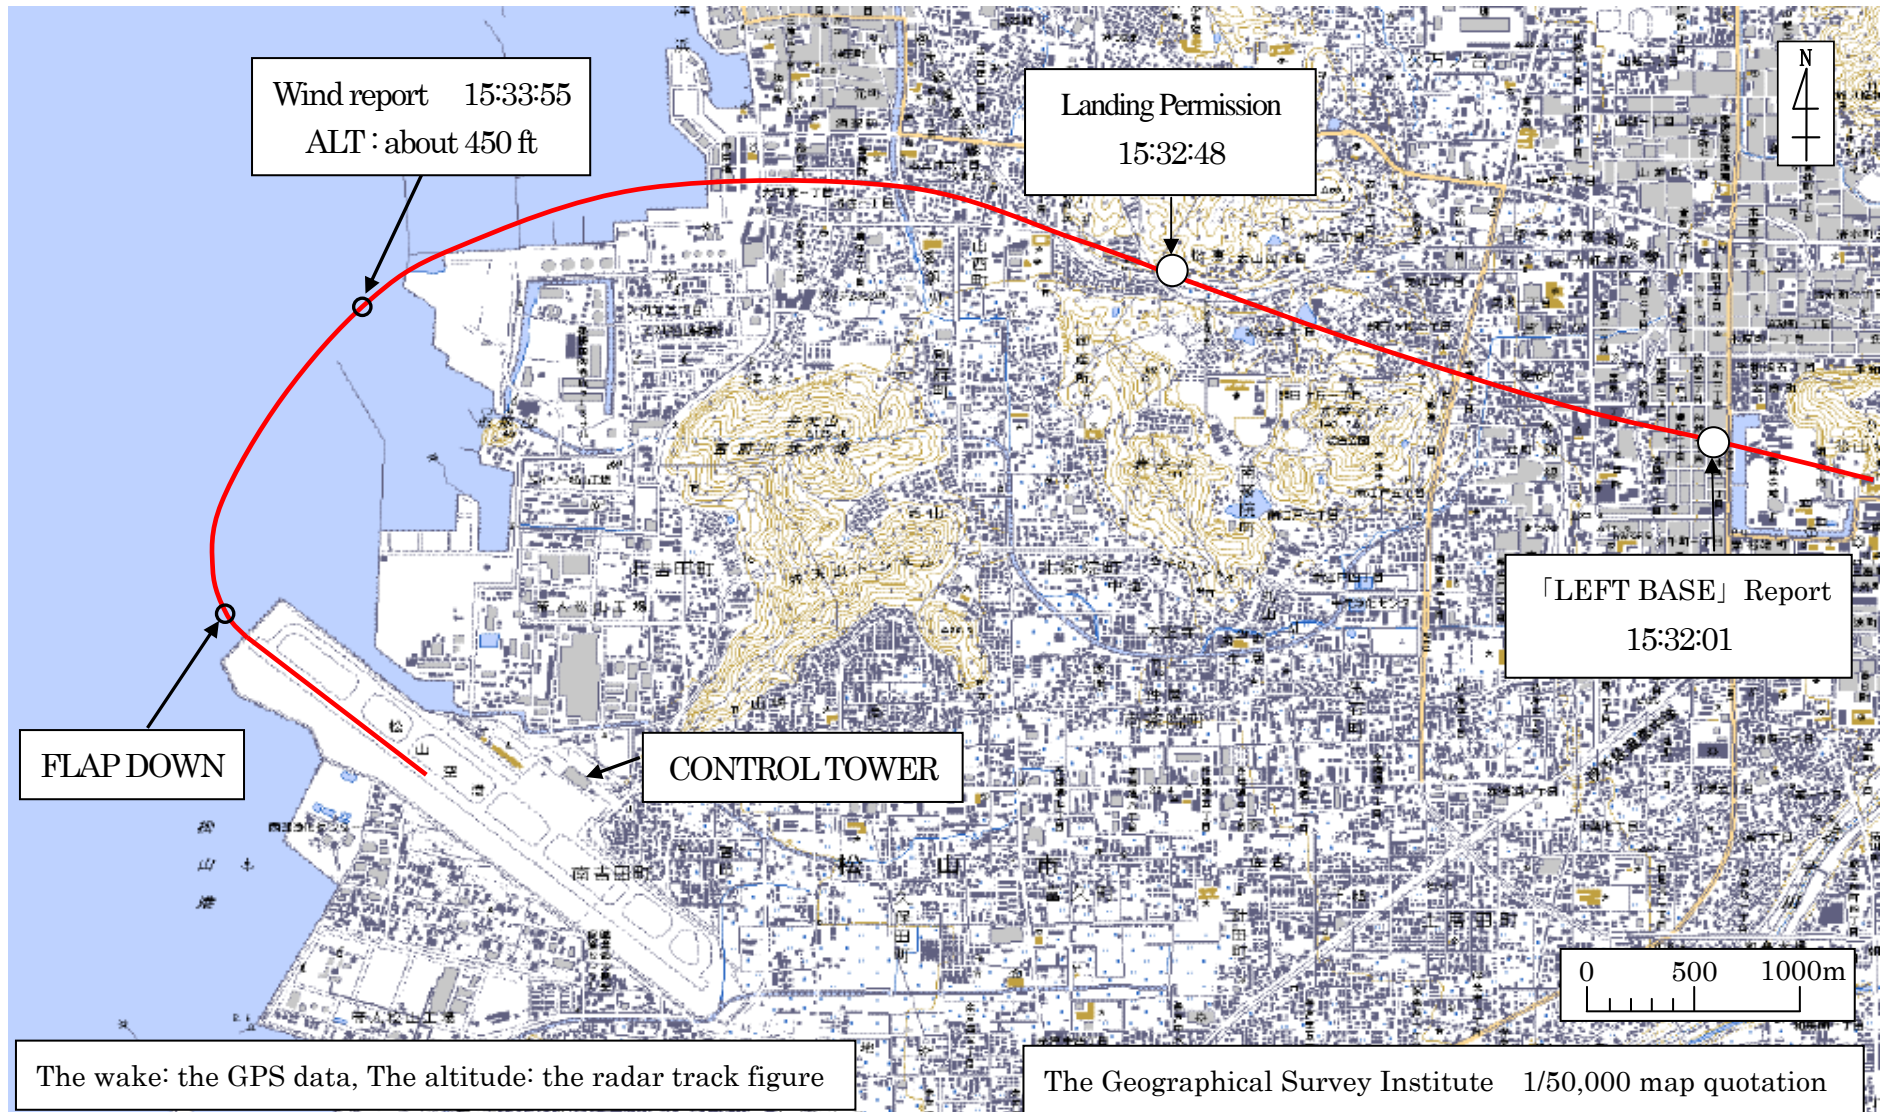
Figure 3 Estimated Flight Route (Approach)

Judging from the statements of the captain described in 2.1.2 (1), it is considered highly probable that the captain visually confirmed Matsuyama Airport when it was about five nm from the Airport and at about an altitude of 2,000ft, and it is considered highly probable that, based on the radar track, the Aircraft did not follow the normal traffic pattern, and ended its final turn at the runway threshold.

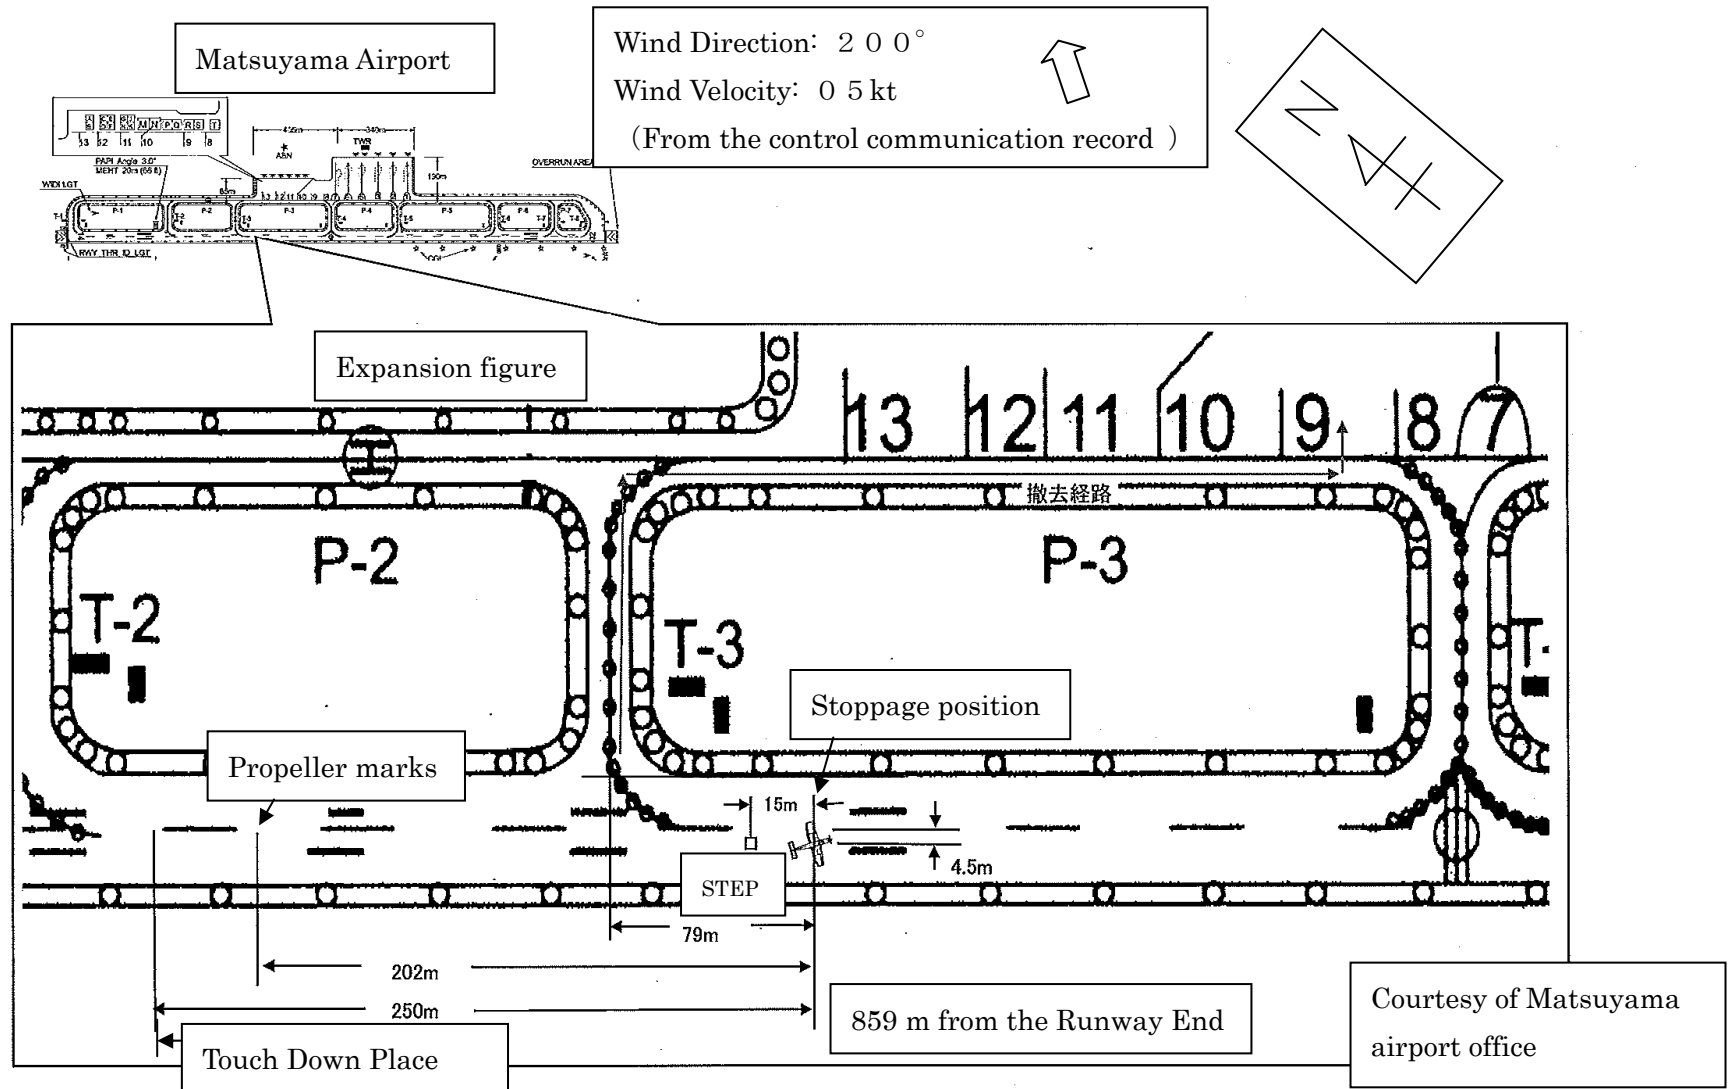
Figure 4 Accident Site Sketch

The accident site was on the runway 14 at Matsuyama Airport (859m from the runway end.), and the tread of the step was found 15m away from the airplane.

On the runway, the traces made by the Aircraft were left 609m away from the runway 14 end to the place where it stopped. Hit marks which would be made by propeller were also found on the way of the trace.

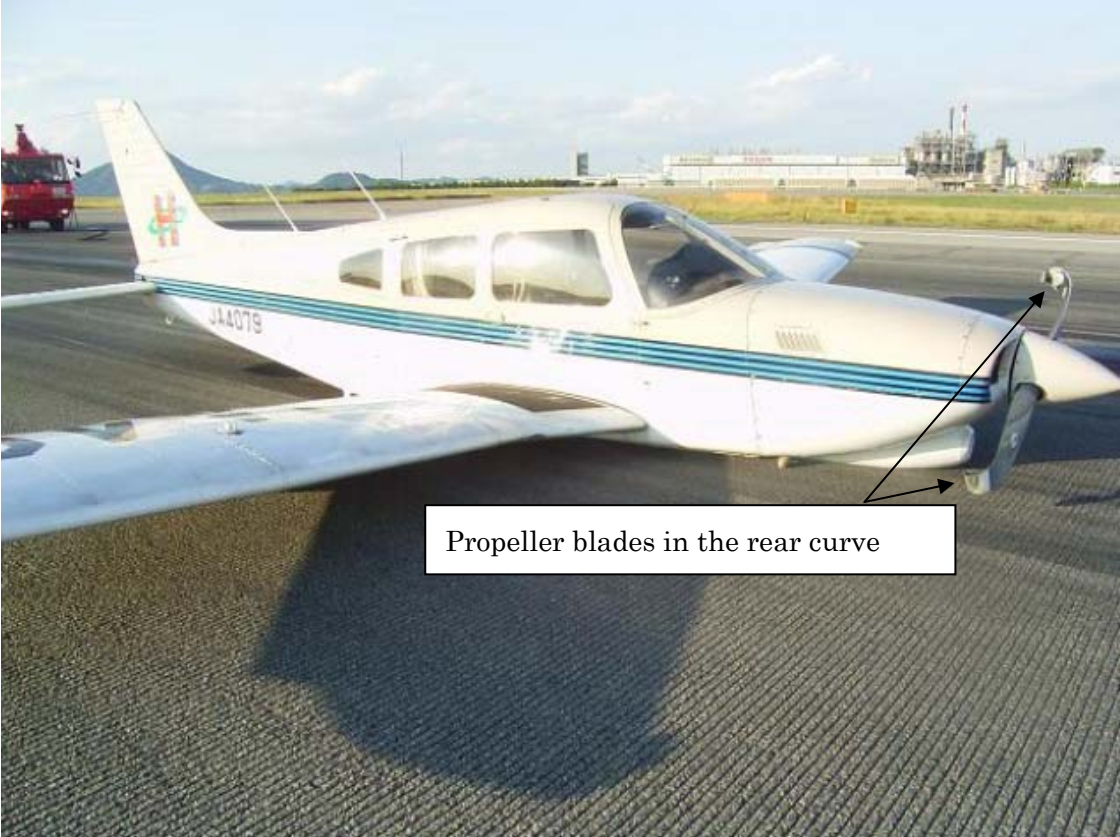
Photo 1 The Accident Aircraft

| (1) Propeller | Tips of the both blades were bent. |
| (2) Fuselage | Lower surface of the fuselage was damaged (Keel was damaged). |

- (3) Flap                      The trailing edge of both right and left side were damaged and destroyed due to the abrasion.
- (4) Step                      The tread were missing.
- (5) Antenna                  The ATC transponder antenna and DME antenna were worn due to the abrasion.

Flaps of the Aircraft were full down.

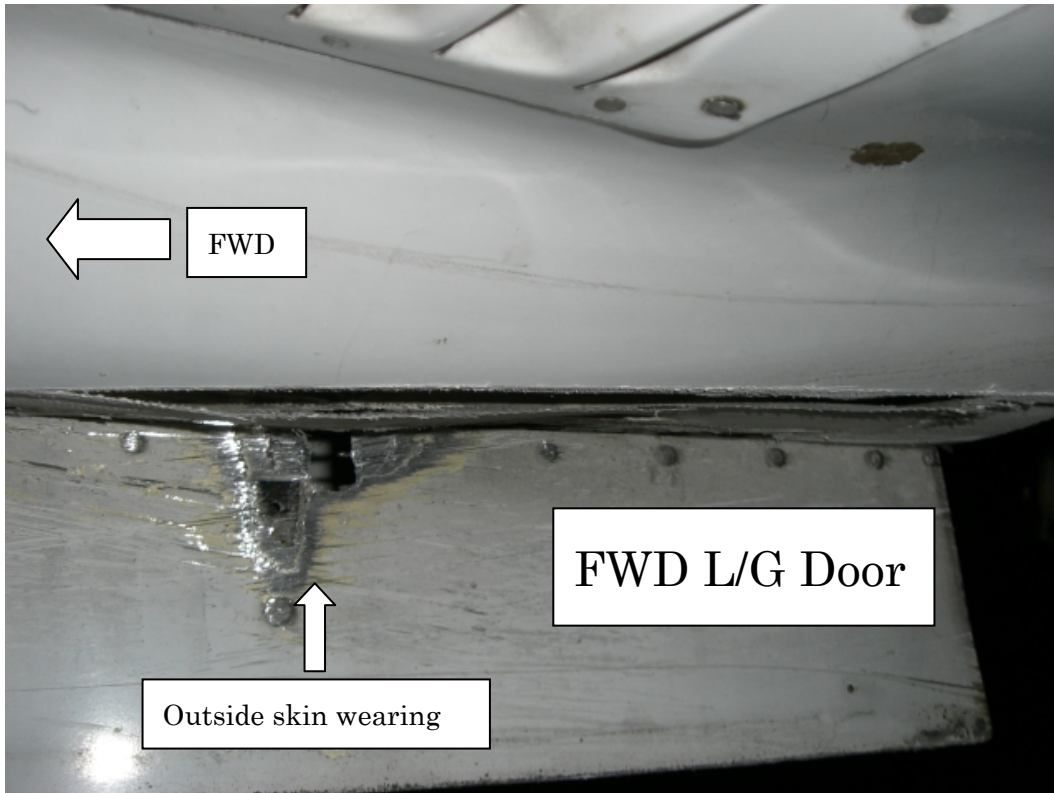
Photo 3 Damaged FWD L/G Door

It was after we heard an abnormal sound that I realized the landing gears had not been extended at the time of landing at Matsuyama Airport. I had believed that it had been a normal landing. The propeller stopped after one or one and a half revolutions. I felt as if the Aircraft had slid over the snow after touch down, but I found its step torn after it stopped. Its flap edges and its FWD

landing gear doors were damaged, although its main frame seemed to be intact.

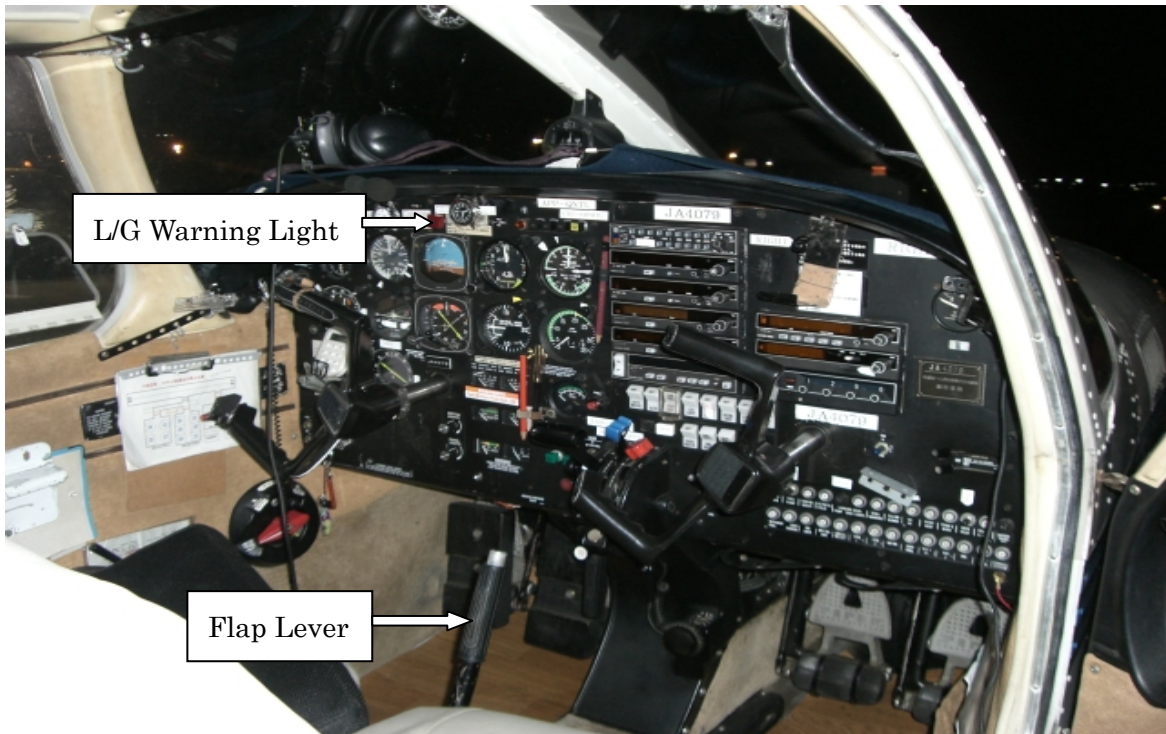
Photo 5 Full View of the Instrument Panel

*Three green lights on the instrument panel light up individually when the landing gears corresponding to each light are locked in the Down position.*

In addition, with regard to the fact that the captain was not aware of the lighting-up of the landing gear warning light, it is considered possible that he was intensively looking at solely on the runway, paying no attention to the landing gear warning light.

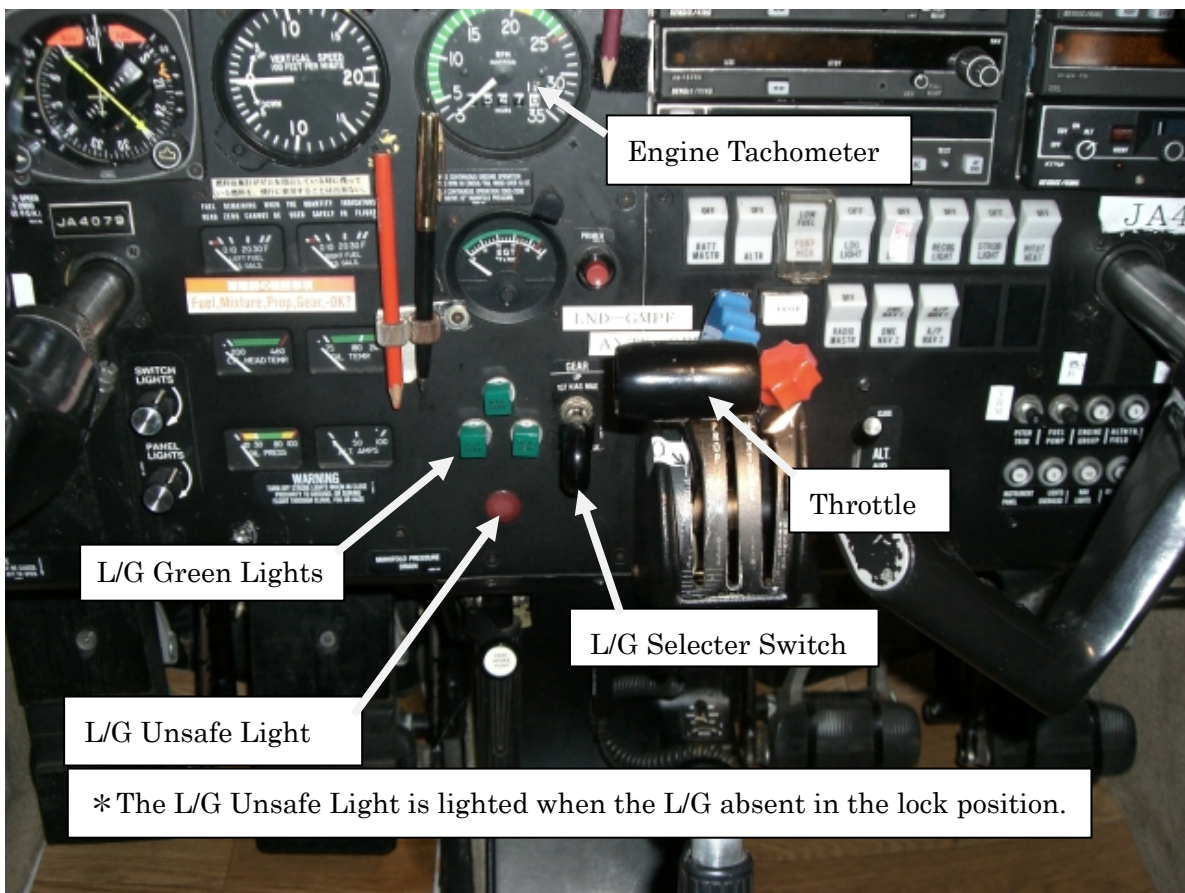
Photo 6 Instrument Panel and others of the Accident Aircraft

The captain said he was unaware of the landing gear warning, but the Aircraft had its flaps fully down at the time of landing, and the flap warning was normal in the operation test described in 2.10. Therefore, it is considered highly probable that all the conditions for activating the flap warning were met, and the landing gear warning horn was sounding. With regard to the fact that the captain did not notice the landing gear warning horn sounding, it is considered possible that he was focused on maneuvering the aircraft toward the runway.
