**AIRCRAFT ACCIDENT
INVESTIGATION REPORT**

**PRIVATELY OWNED
J A 4 1 7 5**

DAMAGE TO AIRCRAFT DUE TO OVERRUN

PRIVATELY OWNED GULFSTREAM AEROSPACE AG-5B, JA4175

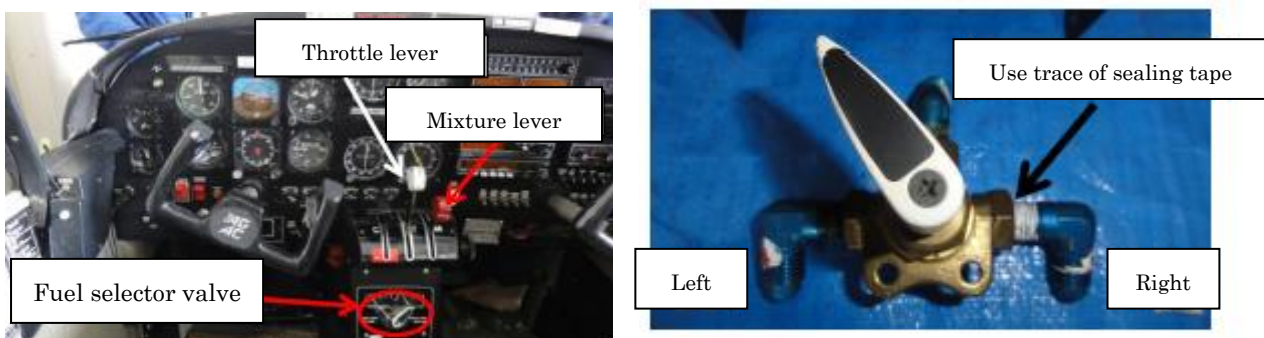
Photo 1: Fuel selector valve of the Aircraft

When the left-right switching function of the fuel selector valve was being checked, the valve handle shaft became stuck; accordingly the valve could not be switched. In addition, it was verified that sealing tape had been used at a screwed portion of connection joint.

This sealing tape was made of teflon, but the aircraft maintenance manual of the aircraft contained no instruction about using the sealing tape for repair or maintenance work.

With regard to repair and maintenance work, the maintenance records of the Aircraft after it was manufactured were checked, but there were no records concerning the fuel selector valve. The relevant parties involved in the maintenance of the Aircraft did not make any statements about the related repair/maintenance work.

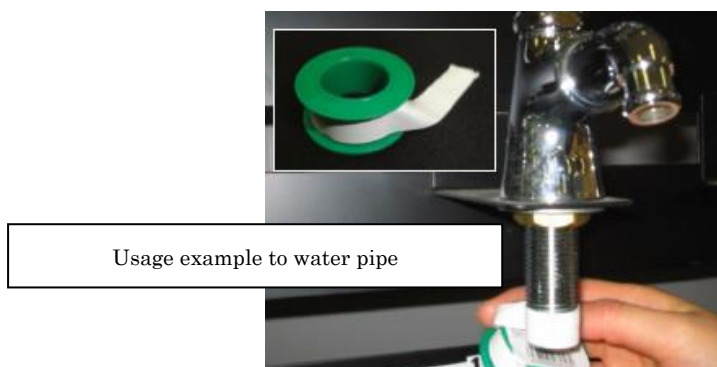
Photo 2: Usage example of Sealing tape on water pipe

Typically, sealing tape is used to stop water leakage in water piping works and others. (Photo 2), and is not used on pipe fittings to stop fuel or hydraulic fluid leakage in aircraft maintenance works. According to the manual providing instructions for use from the manufacturer of the sealing tape, when it is not used properly on pipe fittings (winding the tape in the opposite direction from the direction of the screw, or leaving the tape sticking out from the edge of the screw), fragments of the sealing tape may enter the pipe and cause equipment malfunction or failure.

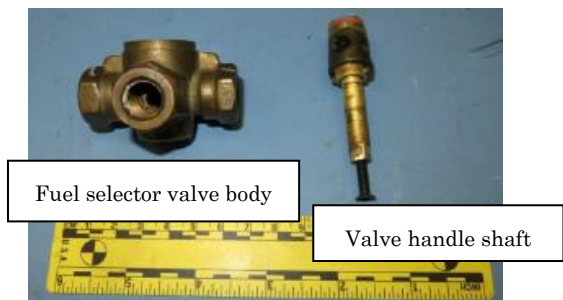
The fuel selector valve on which the handle shaft was stuck showed no abnormalities when its internal parts were examined by X-ray. However, the result of the examination conducted by breaking it down showed that the internal parts of the valve handle shaft and the selector valve were crimped. When it was resolved from this crimp state of compression, and then function tests were conducted on the fuel selector valve, no abnormalities were found.

In the examination conducted by breaking down the parts, it was found that the sealing tape had been used on all the three screw portions of joint on the valve.

Photo 3: Examination of Fuel Selector Valve Photo 4: Substances adhered to the Valve outlet port

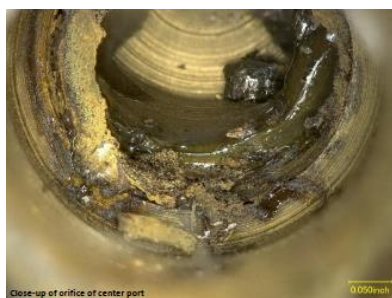
Moreover, teflon fragments that are thought to have originated from the sealing tape, as well as deteriorated lubricant that is thought to have originated from grease (lubricant) used on the handle shaft were found on the outlet port of the fuel selector valve. (Photo 4)

Of the substances found at the outlet port of the fuel selector valve, it is probable that the fragments of teflon were torn pieces of from the sealing tape used that had entered the inside of the valve.

It is probable that the teflon fragments had affected the operation of the valve, obstructed fuel supply to the engine, and resulted in engine malfunction. However, the cause for the loss of engine power could not be determined.
