**AIRCRAFT ACCIDENT
INVESTIGATION REPORT**

**PRIVATELY OWNED
JA 4193**

DAMAGE FROM THE BELLY LANDING A PRIVATELY OWNED PIPER PA-28R-201, JA4193 SAPPORO AIRFIELD AT AROUND 15:38 JST, AUGUST 19, 2015

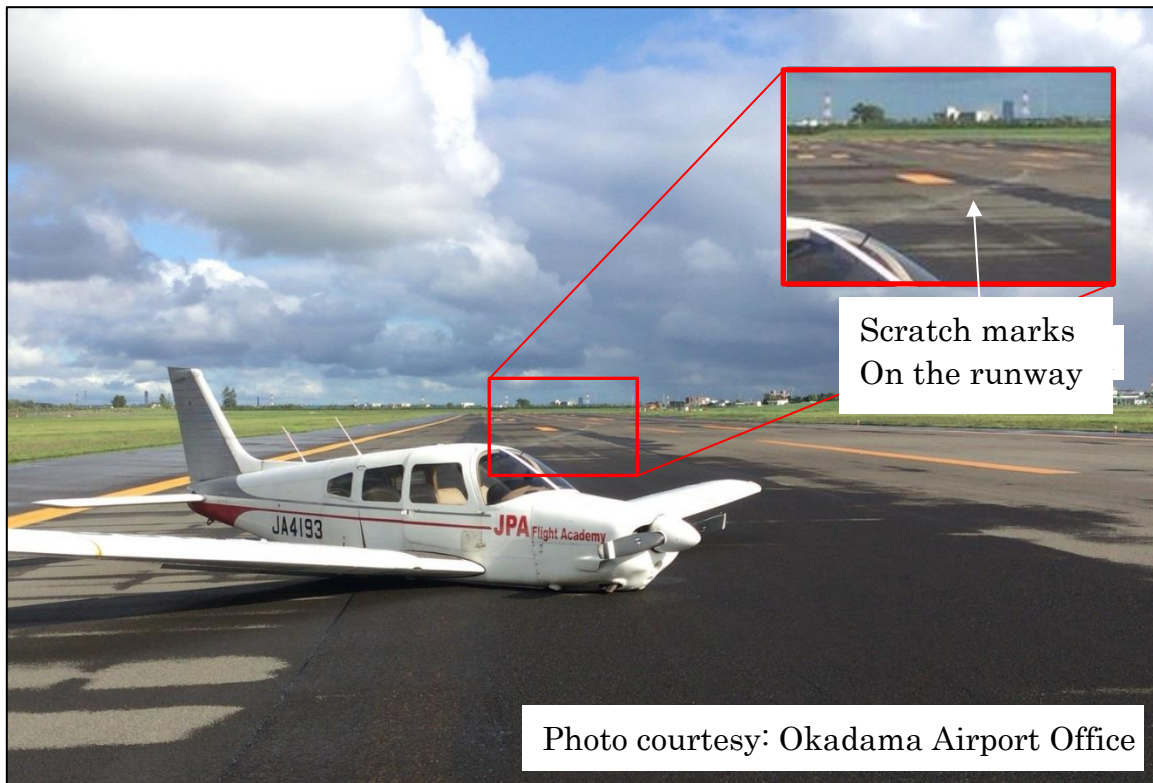
Photo1: Accident Aircraft

In this accident, it is certain that the aircraft made a belly landing without extend the landing gears during the power-off accuracy approach in the Practical Examination.

Structural members of the fuselage	Abrasion
Bottom of engine cowling	Damage
Propeller Blade	Bent
The inner rear edges of the right and left flaps	Deformed
The footstep	Damage

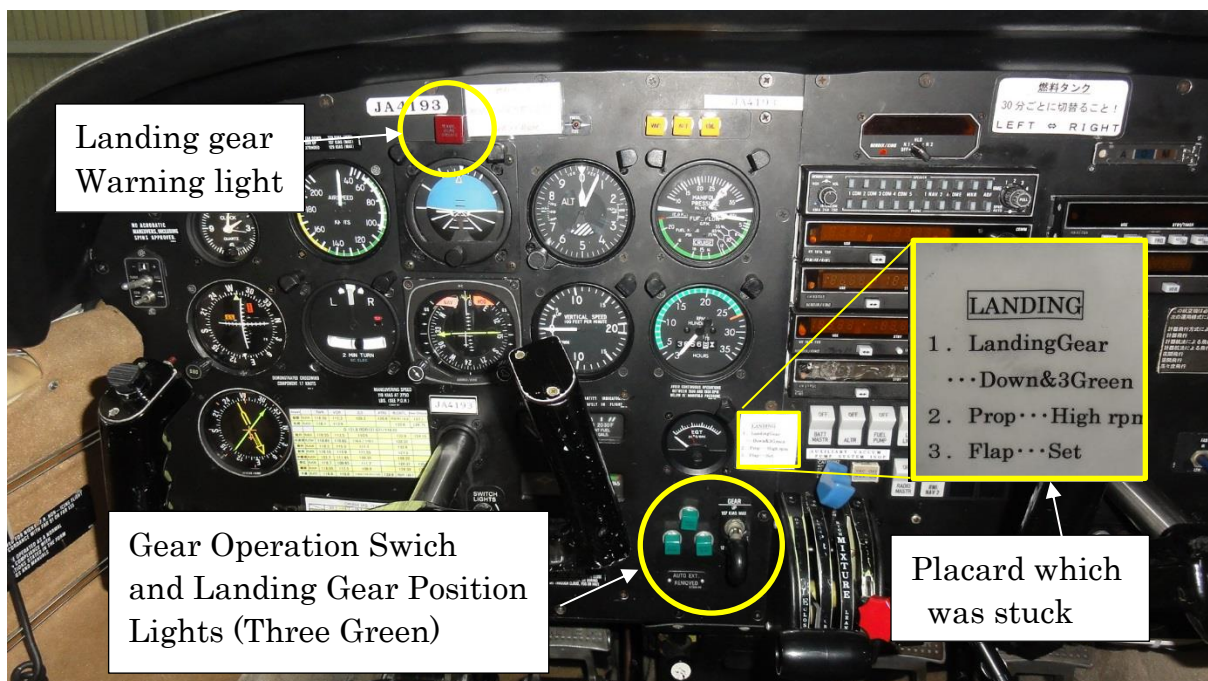
Photo2: Instrument Panel

After the belly landing, the examinee recognized that the landing gears were not extend when he noticed that the landing gear warning lamps were lit and the landing gear warning horn was kept sounding. The examinee reported to the Tower, following the instruction of the Examiner, that the aircraft landed without landing gear down and that there was no person injured. The examinee, being almost in a daze, after finishing the subsequent measures by the instruction of the Examiner, including to turn off the switches, got-off the aircraft.
