# AIRCRAFT ACCIDENT INVESTIGATION REPORT

BEEHCRAFT A36, JA4577

IEJIMA AIRPORT, OKINAWA PREFECTURE, JAPAN

AT ABOUT 12:46 JST, MARCH 12, 2022

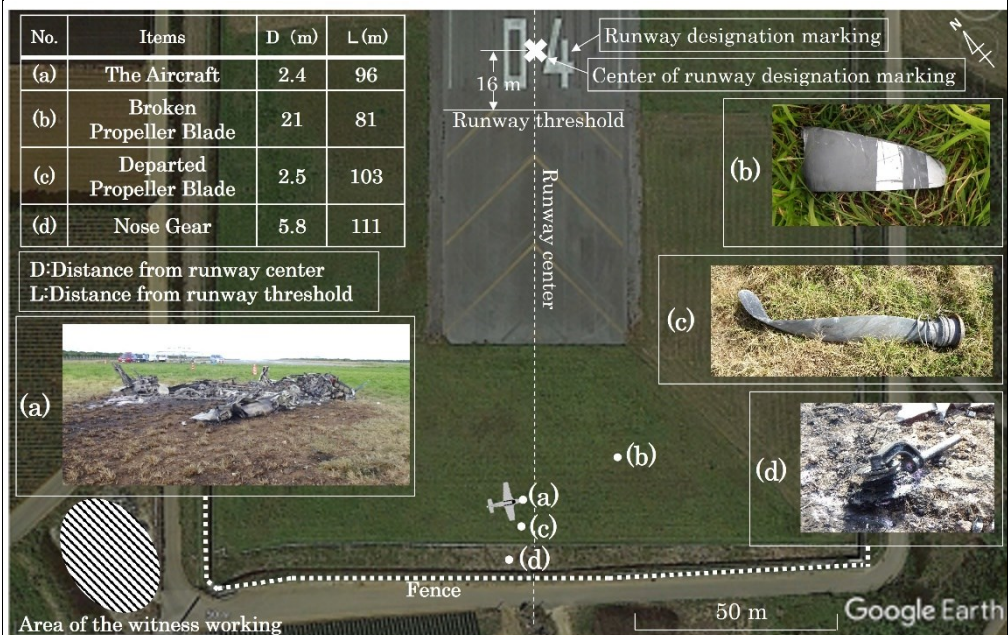
Figure 4: The Accident Site (1)

The aircraft had been burned out with its nose pointed in the direction of about 120° near 100 m southwest of the threshold of Runway 04 (see Figure 4 (a)). The grassy area and slopes on the southwest side of the aircraft scorched black.

Besides, on the slope starting from about 110 m southwest of the threshold of Runway 04, the impact marks of the aircraft, part of the nose landing gear detached from the aircraft, and others were found (see Figure 4 (d)).

The No.1 propeller blade of the three propeller blades of the aircraft had been detached from the propeller hub and found approximately 7 m southwest of the aircraft with its tip bent backward (see Figure 4 (c)). The No.2 and No.3 propeller blades were fixed to the propeller hub, and the tips were broken off. The No.2 propeller blade tip was not found, but the No.3 propeller blade tip was found about 23 m east of the aircraft (see Figure 4 (b)). In addition, there were scratches in the same direction as the propeller rotation on all propeller blades.

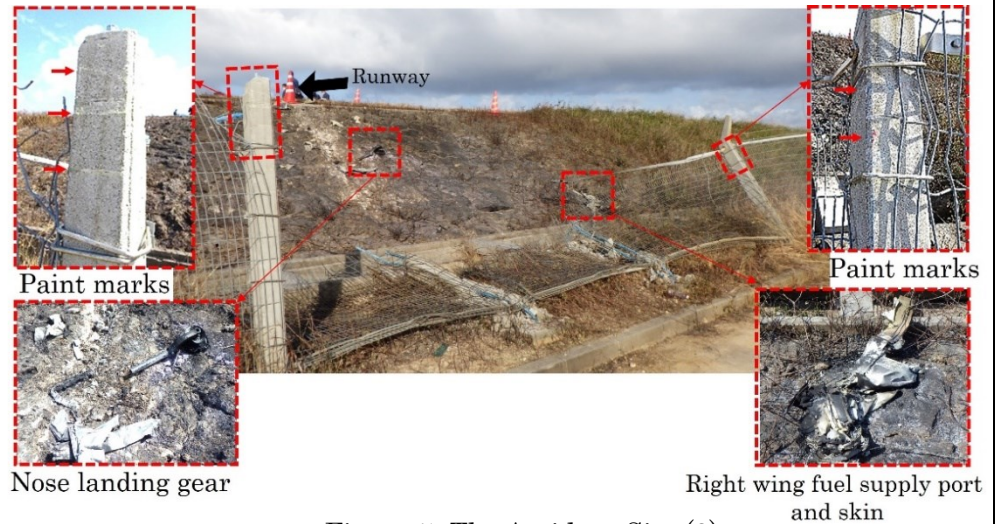
Figure 5: The Accident Site (2)

Furthermore, the fence, which had been located about 118 m southwest of the threshold of Runway 04 to indicate the airport boundary, collapsed about 8 m wide including four posts. On the outer two of the four broken posts, the same paint color marks as the paint color of the aircraft's wings were found at about 1.8 m from the base of the 2.2 m high posts.

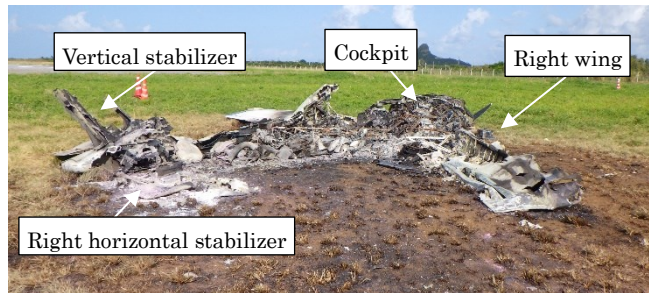
Figure 6: The Aircraft (from the right rear)

The cockpit, right wing, right horizontal stabilizer and vertical stabilizer of the aircraft were too significantly burned out to recognize their original forms. Each instrument also burned out, and except that the altimeter was reading approximately 200 ft, it was unable to read the indicated values of other instruments.

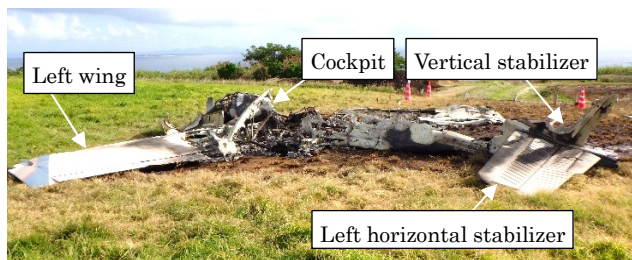
Figure 7: The Aircraft (from the left rear)

The left wing of the aircraft was burned out except for the wing tip from its center, and it was unable to check the aileron movement because the wing tip section was deformed due to the impact. Besides, impact marks with the same width as the fence posts were found on the leading edges of both wings. Furthermore, the impact marks on both wings indicated that the aircraft had collided with the fence posts from the lower wings. The flap actuator was in the state where the flap was deployed.

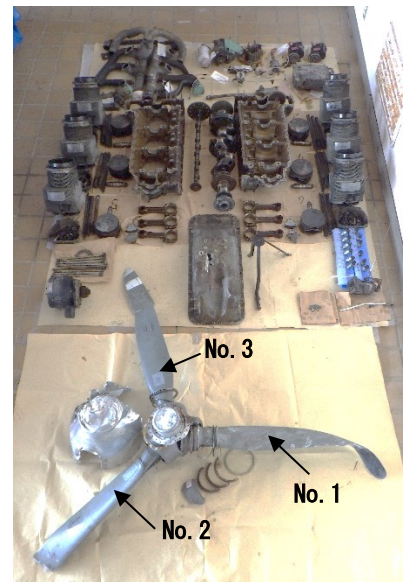
Figure 10: Engine and Propeller

Regarding the engines, there was no significant damage by crash and fire except that the engine mount was broken, and the engine oil pan at the bottom and the propeller driving system were damaged.

As a result of the exterior inspection of the engine and fuel system, the function check of the ignition system, and the inspection of the propeller driving system, any failures that would lead to the engine shutdown were not found. Besides, any failures that would lead to the engine shutdown were not also found in the disassembly inspection of the engine.

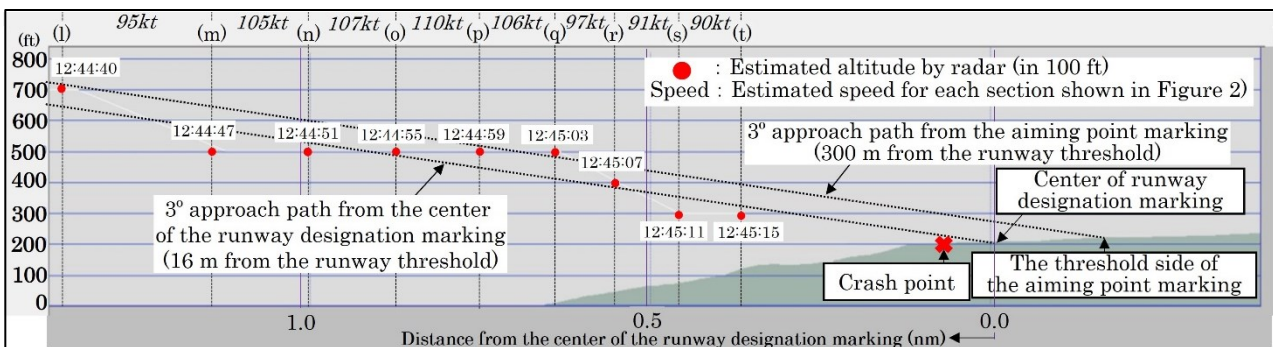
Figure 11: Altitude Change on Final Leg

On the other hand, the aircraft's altitude estimates on the final leg based on the radar records are information in 100 ft increments as shown in 2.7 (9), and although there is a defect of information between (l) and (m), they are as shown in Figure 11. It is possible that the aircraft did not fly maintaining a stable descent rate on the final leg, but it probably continued its approach.

Although the aircraft's estimated speed based on the radar records was higher than the approach speed of 79 kt described in the flight manual, from (m) to (q) in Figure 11, they generally remained between 105 and 110 kt. And the aircraft likely reduced the speed due to approaching the runway even after (q), therefore, the speed control and vertical control for the aircraft were likely possible up to about (t).

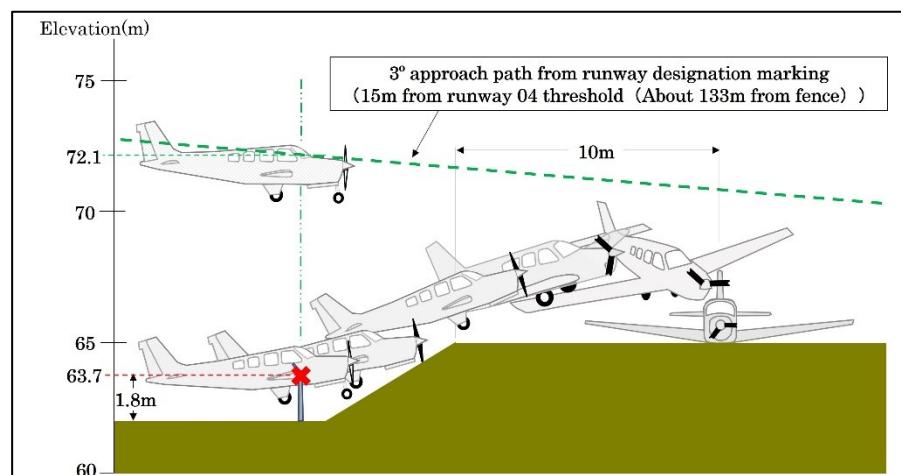
Figure 12: Diagram of the Aircraft Crash

From the statement of the witness, it is probable that after that, the aircraft made an approach on the path lower than usual, and collided with the fence at the point equivalent to an elevation of about 63.7 m (about 209 ft), where the aircraft could have passed above the fence at the altitude of about 72.1 m ( about 237 ft) if it had made an approach on the path with a descent angle of 3°. In addition, based on the statement of the witness and the impact marks between the aircraft's both wings and the fence posts, the aircraft probably collided with the fence with its nose raised. And despite of trying to correct the approach path or execute a go-around, it collided with the fence. Then, the aircraft hit the slopes in the airport, bounced, and crashed into the grassy area short of the runway, and it was destroyed and bursting into flames. During this time, the two persons on board were probably fatally injured as a result of trauma due to the strong impact.
