AA2013-3

**AIRCRAFT ACCIDENT  
INVESTIGATION REPORT**

**J A 5 3 2 4**

## BIRD STRIKE IMMEDIATELY AFTER TAKEOFF FIRST FLYING CO., LTD. BRITTEN NORMAN BN-2B-20, JA5324 ABOVE THE RUNWAY AT AGUNI AIRPORT, JAPAN AT 16:22 LOCAL TIME, OCTOBER 16, 2012

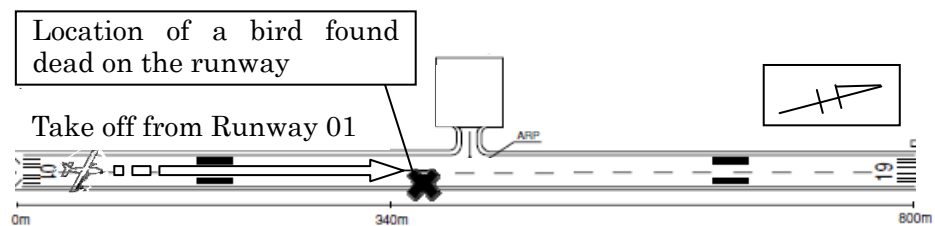
Figure 1 Circumstances of Bird Strike Event at Takeoff from Aguni Airport

ft) above the runway, he found something like a bird approaching from his right ahead. Then the bird seemed to have passed below the right wing. As he didn't recognize any noticeable impact or abnormal vibration at that time, he continued the flight and contacted the flight dispatcher with radio to report the event of a bird approaching to the airplane.

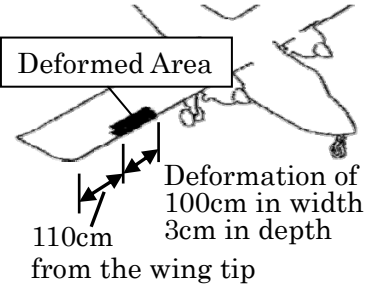
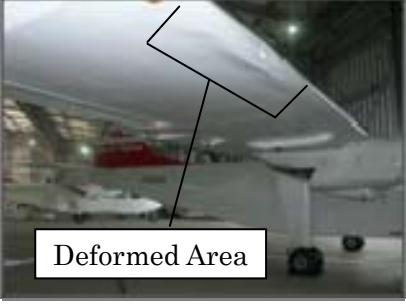
<p>Figure 2 Location of Deformed Area    Photo 2 Overview of Deformed Area</p>

When the airplane landed at Naha airport at 16:46 and parked on the apron, the mechanic found the deformation (dent) on the right wing leading edge. Such damage was not found at the preflight external check by the PIC.

<p><b>2.2 Injuries to Persons</b></p>	<p>None</p>
<p><b>2.3 Damage</b></p>	<p>Extent of Damage: Substantially damaged</p> <ul style="list-style-type: none"> <li>● Deformation on leading edge of the right wing</li> <li>● Slight bloodstains on the skin adjacent to the above deformed area</li> </ul>

staff in the airport administration office upon receipt of the PIC report. After landing, large deformation was found on the right wing leading edge, with the slight bloodstains on the skin adjacent to the deformed area. Therefore, it is certain that the airplane sustained damage to the right wing leading edge due to the bird strike immediately after takeoff.

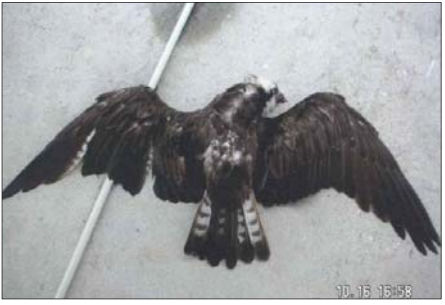
The bird colliding with the airplane was identified as the osprey, which is a fish-eating bird and belongs to the osprey family
