AIRCRAFT ACCIDENT INVESTIGATION REPORT

AIRCRAFT DAMAGE DUE TO COLLISION WITH A VEHICLE

BOEING 767-300, JA603A

NARITA INTERNATIONAL AIRPORT, JAPAN

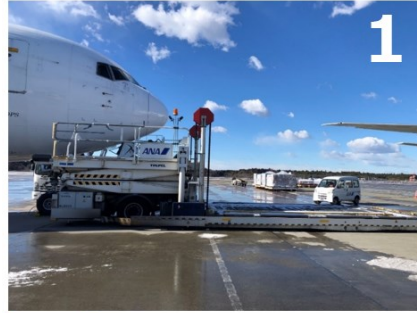
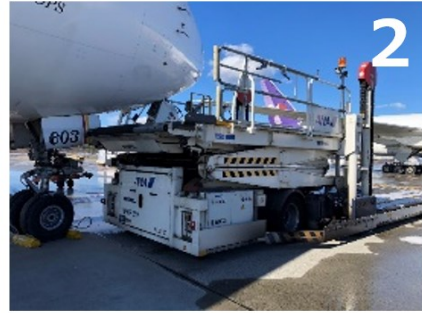
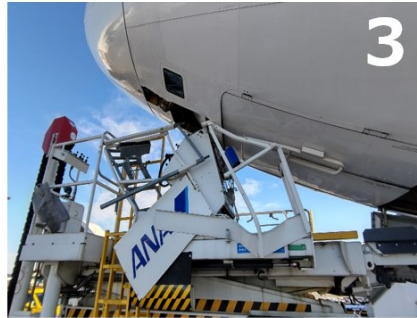
Figure 3: The Aircraft After Stopping and the Ground service equipment.

The aircraft continued to slide on the Spot while rotating counterclockwise, the lower surface of the nose had hit a ground service equipment that parked in the vicinity of the Spot when the heading direction deflected to 322°, came to a stop. (Figure 1, 4, Figure 2, 4, Figure 3)

(2) Damage to the Ground Service Equipment (Figure 3)

The driver seat and control console were damaged and deformed, and the console handrail was deformed and broken.

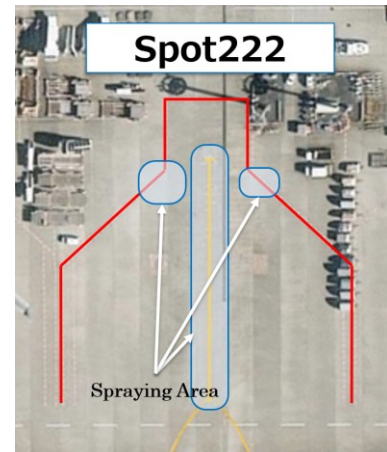
Figure 6: Spraying Area of Anti-icing Agents

At about 06:50, being instructed by the Airside Supervisor, the ground operator sprayed a total of approximately 10 kg of anti-icing agents into the area of the right and left of about 1 meter along with the approximately 61-m-long Aircraft Stand Lead-in Line in the Spot, and within the area where the ground service equipment was working. (Figure 6)

The surface conditions on the Spot had not been fully improved, because within the Spot, the anti-icing agents were sprayed only part of the spot surface over which the aircraft's tires passed, in addition, the amount of the sprayed anti-icing agents was less than the one applied after snowfall as specified in the anti-icing agents' specifications, thus, the inappropriate spray range and amount of the anti-icing agents probably contributed to it.

The company did not stipulate the specific spray procedures such as the spray range, amount and timing of the anti-icing agents. It is important for the company to stipulate the specific spray procedures for the anti-icing agents to ensure the spot surface conditions are suitable for aircraft to taxi safely.

At each airport, in case of judging that it is dangerous for aircraft to taxi, it was decided that entering the spot should be prohibited. In addition, the spray range of the anti-icing agents was specified, and education and training were provided to all concerned.

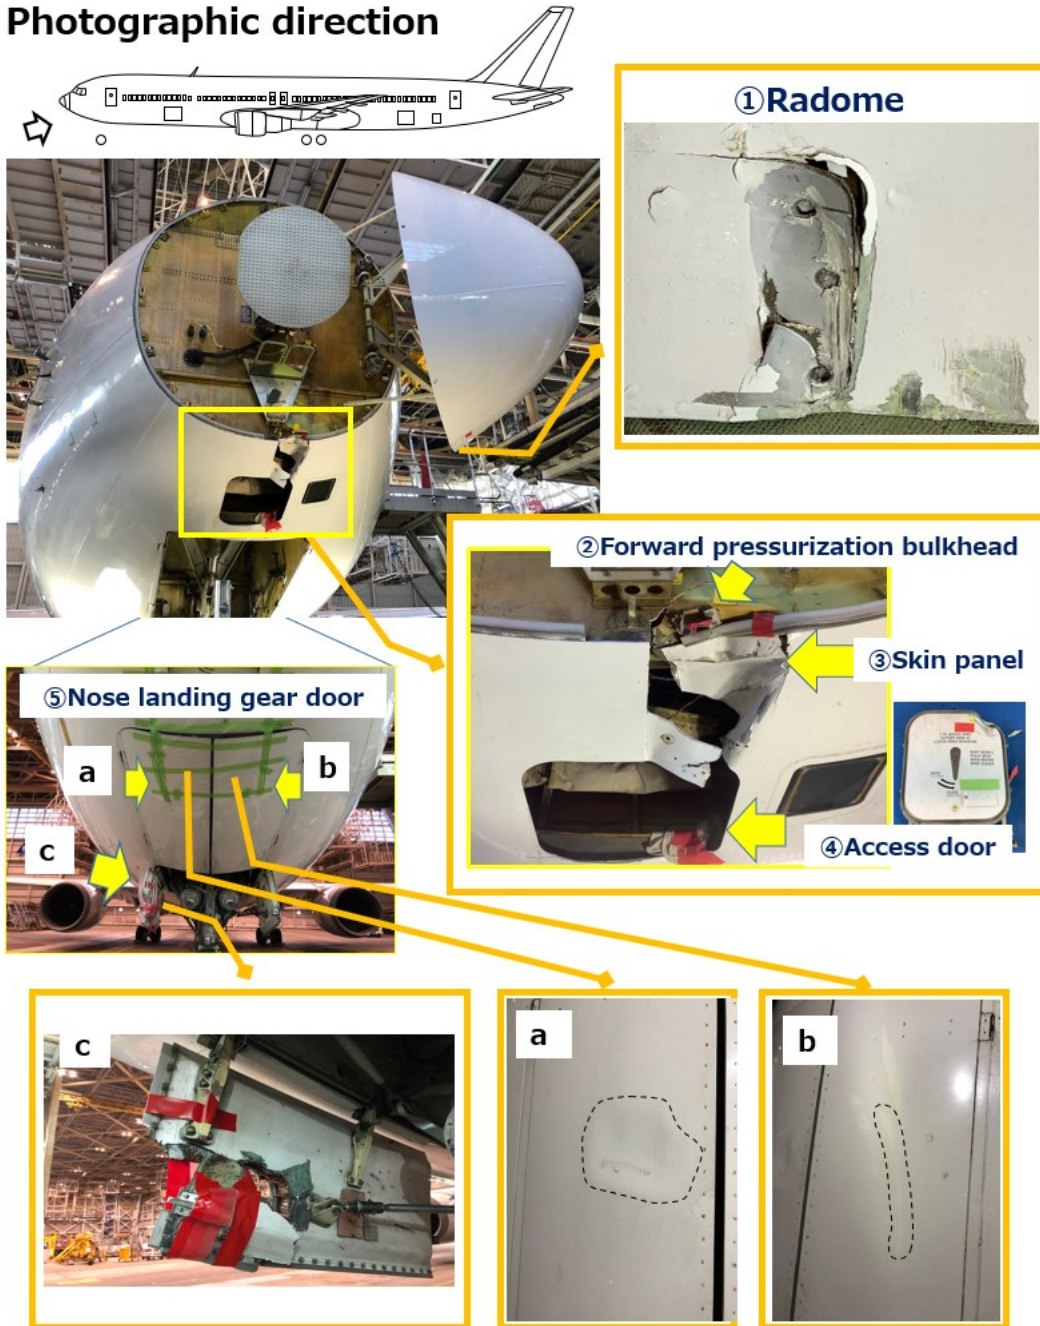
Attached Figure: Damage to the Aircraft

(1) Extent of Damage: Substantial damage

Radome, forward pressurization bulkhead, lower skin panel of fuselage, forward access door, nose landing gear door and others were damaged. (Attached Figure)

The JTSB concludes that it is certain that while turning toward the Spot, the aircraft slip on the icy surface on the Spot and the PIC became unable to control the taxiing of the aircraft, thus the aircraft collided with a ground service equipment parking around the Spot, resulting in damage to the airframe.
