AA2023-7

**AIRCRAFT ACCIDENT
INVESTIGATION REPORT**

**Japan Airlines Co., Ltd.
J A 6 0 3 J**

AIRCRAFT ACCIDENT INVESTIGATION REPORT
FLIGHT ATTENDANT INJURY BY THE SHAKING OF THE AIRCRAFT
JAPAN AIRLINES CO., LTD.
BOEING 767-300, JA603J
AT AN ALTITUDE OF APPROX. 8,500 M (FL280)
OVER NAKATSUGAWA CITY, GIFU PREFECTURE
AT 17:35 JST, MARCH 26, 2022

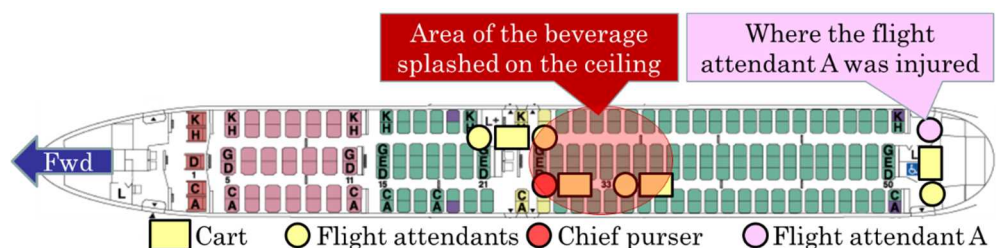
Figure 2: Situation at the Time of Occurrence of the Accident

The chief purser had just finished delivering beverages to passengers near the center of the cabin when he encountered a sudden "thump" downward. At the time, three of the four carts were near the center of the cabin, and the cart aft of the right aisle was being returned to the aft galley by two flight attendants, including the flight attendant A (see Figure 2).

The JTTSB concludes that the two flight attendants responsible for the cart aft of the right aisle were in the process of stowing the cart and beverages in the aft galley when the aircraft encountered shaking (sudden descent); in addition, because the aft galley of the aircraft is a large space and the beverages and carts are stored in different directions and at different heights, it was probably difficult for the flight attendants to grab the galley bar at a moment's notice because the relative positions of the galley bar and themselves changed depending on their task.

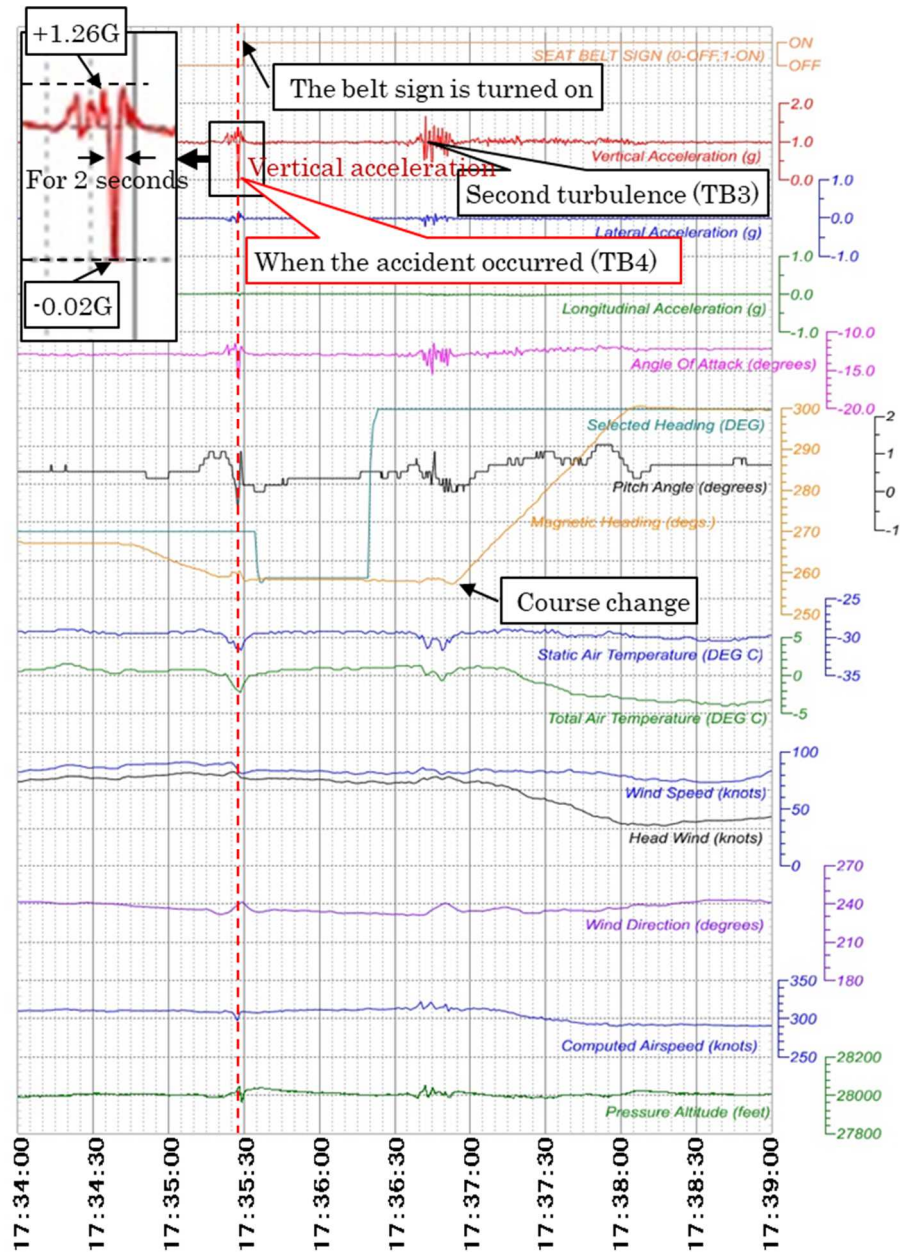
Figure 3: DFDR Records

According to the DFDR recordings of the aircraft, at 17:35:27, just before the accident, the vertical acceleration increased slightly from about 1.0G to 1.26G, then changed to -0.02G in the next 1 second, and then returned to 1.28G in the next 1 second (Figure 3).

The decrease in calibrated airspeed and angle of attack acts as an aerodynamic force to reduce the lift of the wings (main wings and horizontal stabilizer), whose effects are mainly seen in vertical acceleration and pitch angle. The vertical acceleration recorded on the DFDR at the time of this accident was 1.28 G of negative G from 1.26 G to -0.02 G in about one second, which highly probable caused the aircraft to "thud " and sink, and the flight attendant A to float. In addition, there was a positive G of 1.30 G from -0.02 G to 1.28 G in the next second. It is most likely that the flight attendant A was injured when her body was lifted by the negative G and she fell when she lost her body balance and was hit hard by the aircraft floor which was lifted by the positive G.

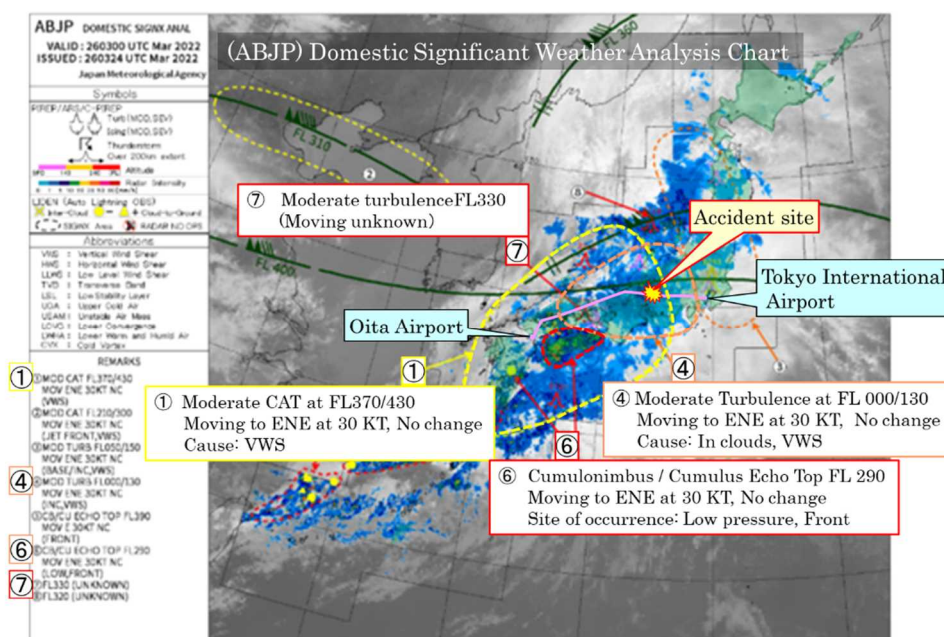
Figure 5: Domestic Significant Weather Analysis Chart (ABJP) (partly edited)

near the low pressure area, and turbulence was expected to occur near the accident site at altitudes between FL130 and FL170.

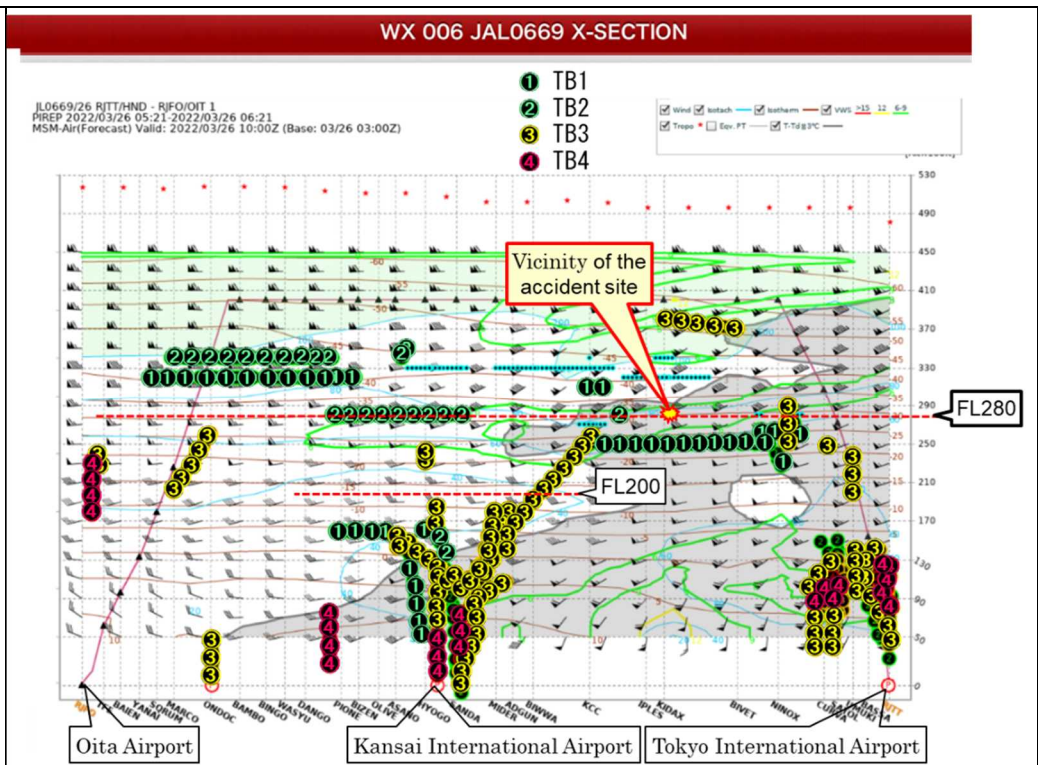
Figure 6: PIREP on Cross-Section Chart (partly edited)

The flight crew checked the cross-section chart on the tablet terminal provided by the company, which allows them to check the weather forecast and PIREP for the target time, it was expected that the area of vertical wind shear*6 area above 12kt, which is considered the threshold of CAT, would expand at altitudes higher than FL330 in the vicinity of the aircraft's flight path. In addition, according to the PIREP (Figure 6), from 14:21 to 15:21, turbulence TB1 to TB2 was reported by aircraft of the same size as the aircraft flying at cruising altitude around FL280, and many turbulence TB3 to TB4 was reported by aircraft arriving at or departing from the Kansai area airport below FL200.

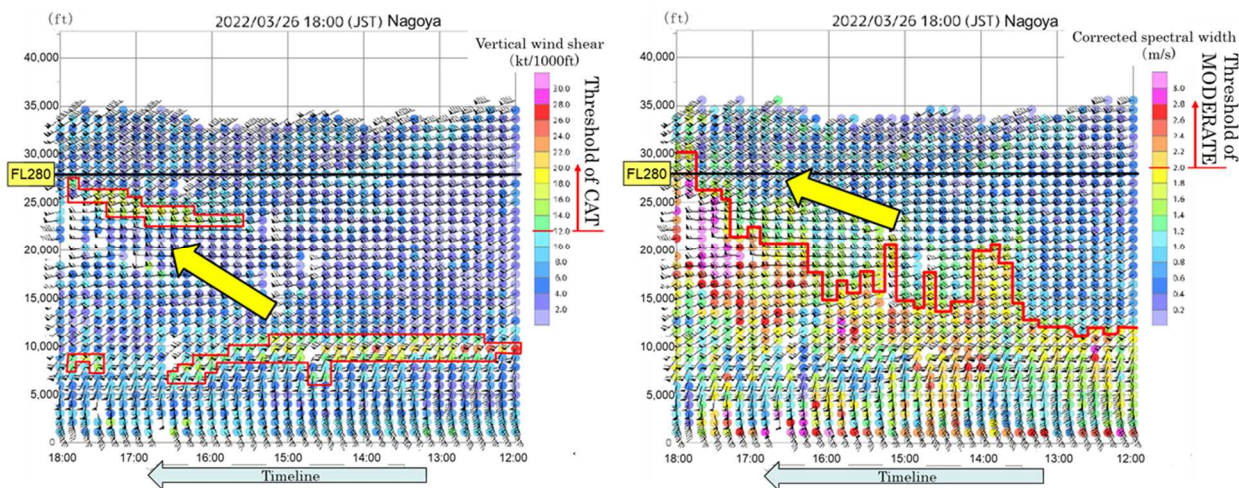
Figure 7: Observation Data from the Wind Profiler, Nagoya Observatory Station (partly edited)
(Left: Vertical Wind Shear, Right: Corrected Spectral Width)

profiler*7 (Nagoya Observation Station) located about 60 km west of the accident location. The left figure shows a cross section of wind direction and speed with vertical shear added, and the area framed in red indicates the altitude at which vertical shear of 12 kt/1,000 ft or greater was observed, which is the threshold for the occurrence of CAT. The right figure shows wind direction and speed with corrected spectral width*8 added, and the area below the red line indicates the altitude at which a corrected spectral width of 2.0 m/s or greater was observed, which is the threshold for MODERATE (TB4 equivalent) turbulence based on PIREP's statistical analysis.

Using the wind profiler at the Nagoya Observatory Station, it can be confirmed that in Nagoya, along with the values of vertical wind shear and corrected spectral width, the altitude that is supposed to be the threshold of CAT and MODERATE turbulence increased with time, reaching about FL 280 at about 18:00. From this, it is likely that these turbulences also occurred in the vicinity of the accident site, about 60 km east of Nagoya Observatory Station, at the time of the accident.
