AIRCRAFT ACCIDENT INVESTIGATION REPORT

PASSENGER INJURY AND AIRCRAFT DAMAGE

PRIVATELY OWNED AÉROSPATIAL AS350B (ROTORCRAFT), JA6050

June 7, 2024

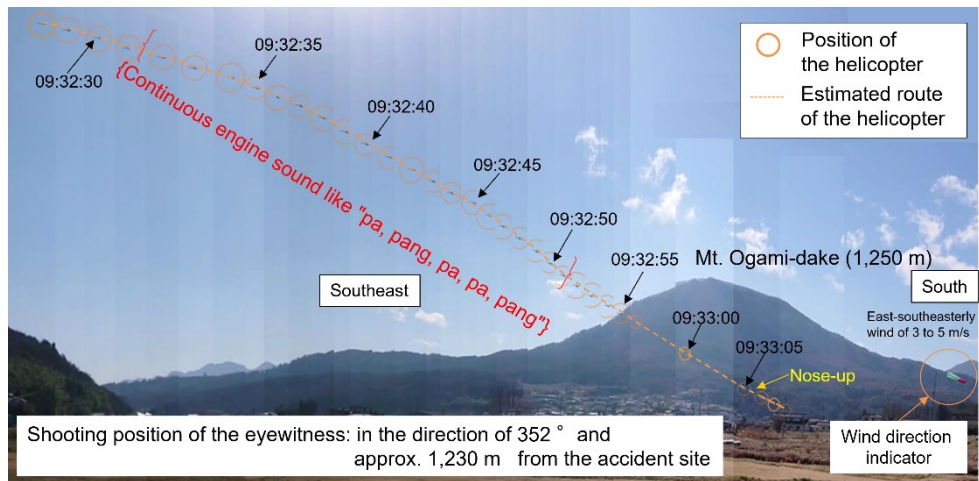
**Figure 2: The Helicopter When Making a Forced Landing
(created from the video taken by the eyewitness)**

The video taken by the eyewitness recorded a "pang" sound followed by a continuous engine sound like "pa, pang, pa, pa, pang", and the helicopter descending toward Mt. Ogami-dake. The wind direction indicator at the paraglider school showed an east-southeasterly wind of 3 to 5 m/s.

gradually and increased temporarily, but as shown in Figure 2, at about 09:33:06, a flare maneuver was assumed to be performed with nose-up. On the bank of the farm road, there were touchdown marks of landing gears (skids) and on the ground surface short of the touchdown point, contact marks with the tail skids, and the landing gears were broken to the backward side, therefore, the helicopter probably touched down as keeping moving slightly forward after the flare maneuver. Besides, based on the Passenger's statement that making the forced landing was something like falling freely from the height of the third floor of a building and the captain's statement that the collective pitch lever had reached to the highest position at a height of about 2 to 3 m immediately before the touchdown, the helicopter highly probable touched down on the bank of the farm road at a nearly vertical descent angle while increasing the rate of descent. Furthermore, there were contact marks with the main rotor blade on the surface of the farm road on the left side of the helicopter, and the rear seats were buckled forward left, therefore, it is probable that a load was temporarily applied that caused the aircraft to tilt to the left after the touchdown.

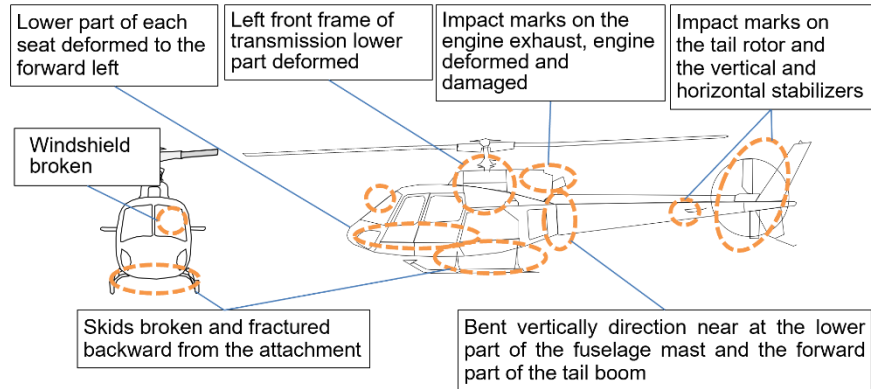
Figure 4: Overview of Damaged Parts of the Helicopter

- a. The fuselage was seriously bent backward and forward, and the cockpit windshield was partially broken.
- b. The landing gears (skids) were all broken with the cross tubes rotating backward.
- c. The left pilot seat was compressively buckled forward right, and the rear seats forward left.
- d. There were impact marks on the tail rotor and the vertical and horizontal stabilizers.
- e. Fire did not occur, but the fuel was leaked from the lower part of the fuselage.

f. Due to the touchdown impact, the Emergency Locator Transmitter (ELT) was activated. (Threshold value: 6 to 8 G)

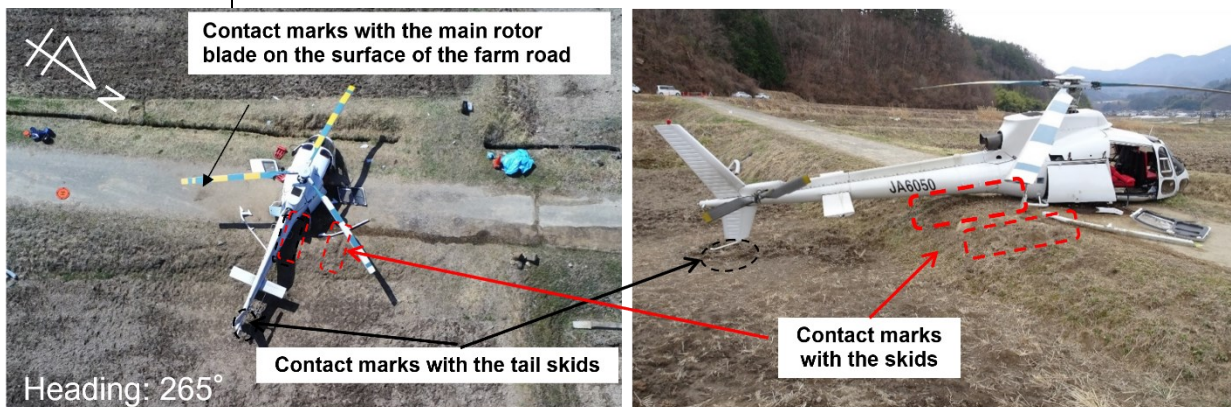
Figure 5: Contact Marks around the Helicopter

The site where the helicopter made a forced landing was on the asphalt farm road about 3.5 m wide that was located in the paddy field area. The helicopter made a forced landing facing in a 265° direction. There were touchdown marks of its landing gears on the bank of the farm road, and contact marks with the tail skids behind the position where the helicopter remained stationary. And there were contact marks with the main rotor blade on the surface of the farm road about 4 m left side of the helicopter.

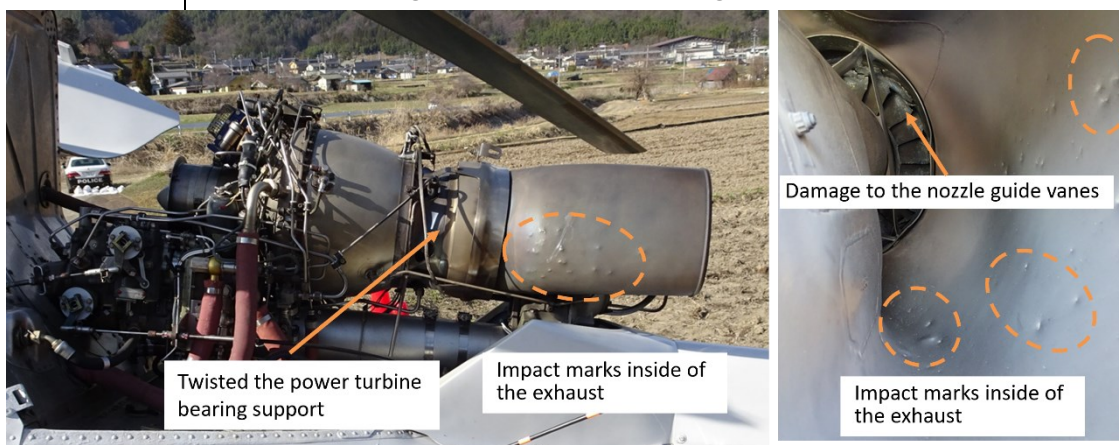
Figure 7: Engine Exterior Damage

- a. The power turbine bearing support in the center of the engine was deformed due to twist.
- b. There were multiple impact marks inside of the exhaust.
- c. The nozzle guide vanes were damaged.

c. The power turbine bearing support had impact marks, was twisted damaged, which was most likely caused by an impact with the rotating power turbine blades that were still bonded to the disk.

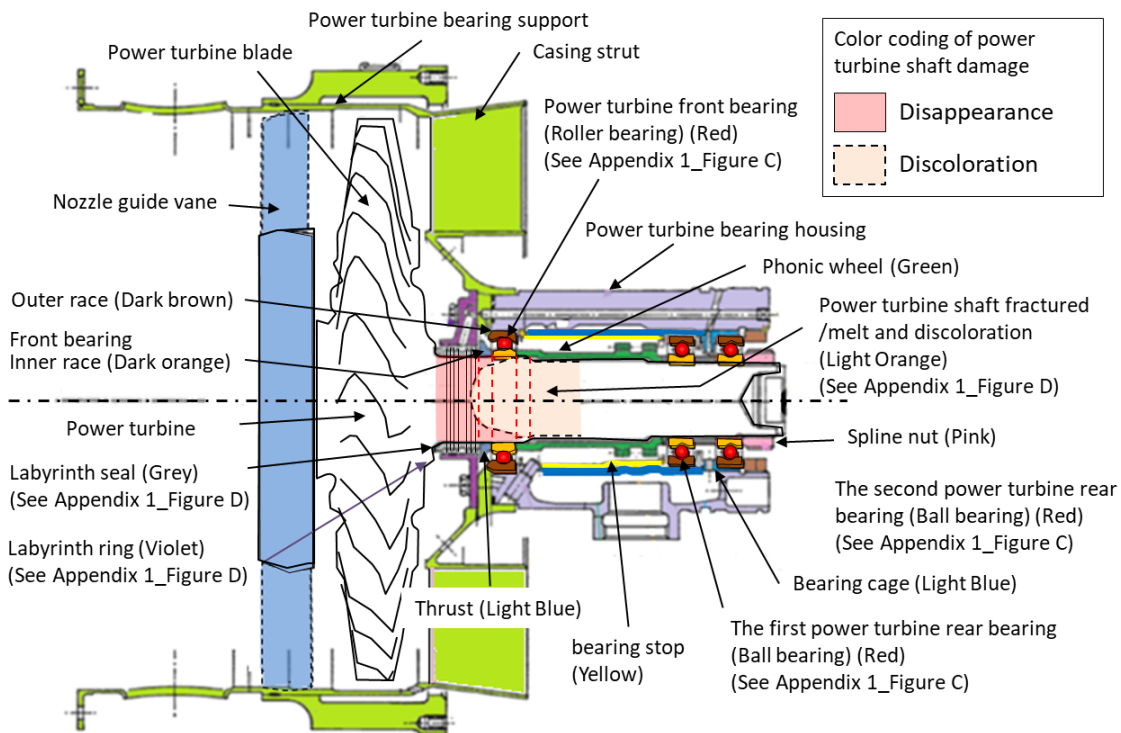
Figure 9: Names and Damaged Parts of Module M04 (Power Turbine Section)

- (c) The forward part of the power turbine shaft was melted and fractured. In addition, the surface of the ruptured rearward part discoloration, and the hardness inspection and metallurgical analysis confirmed it had reached to a high temperature of 1,300 °C or more. (See Figure 9 and Appendix 1_Figure D)

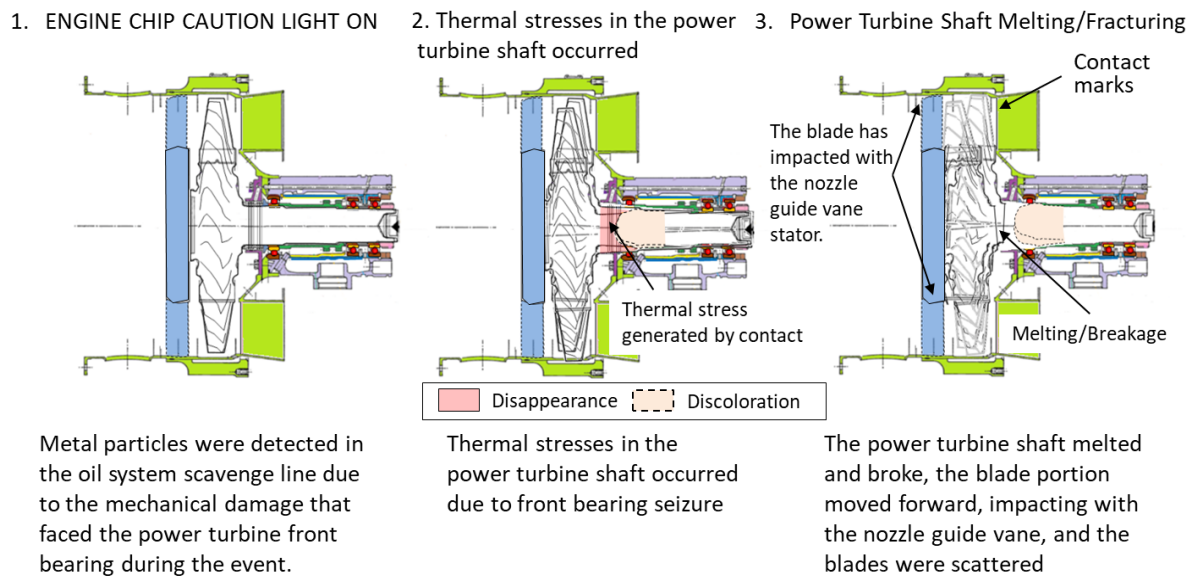
Figure 11: Melting and Rupture of Power Turbine Shaft

The JTSTB concludes that from the result of the detailed disassembly inspection of the engine conducted by the design and manufacture company, the process from the illumination of the engine chip caution light leading to the engine damage is probably as follows: (See Figure 11)

b. Regarding the power turbine shaft, from its conditions of the damage of the melted parts and the aggregation of the metal materials on the front bearing outer race (See Appendix 1_Figure C), it is probable that the front bearing seizure. It was more likely that because of the front bearing becoming stuck, the inner race that was fixed to the power turbine shaft began to rotate and causing the power turbine shaft to heat up to the near melting point of 1,300°, in addition, due to thermal stresses ^{*16} the inner race disappeared, and the power turbine shaft fractured. Additionally, the power turbine spline nut had moved forward by more than 2 mm, and it is more likely that it moved forward when the power turbine shaft fractured. From there was evidence that the spline nut was fixed with adhesive, this fact that it had moved 2mm forward could be, it is unknown whether it comes from abnormal thermal exposition during the power turbine front bearing damage which would significantly lower the glue properties or from another factor like inappropriate gluing process.

- f. It is highly probable that a power turbine front bearing deterioration led to the front bearing seizure and to the melting and fracturing of the power turbine shaft, resulting in the engine's sudden loss of power.
- g. The disassembled engine examination revealed severe damage to the power turbine front bearing that was lubricated. The level of damage did not permit to determine the cause of its deterioration during the examination.

Although no other similar accident have occurred, in order to whether the problem is unique to the parts, it is desirable for the design and manufacturer company to collect the replaced parts of same type engine, and examine the deterioration status, and consider additional countermeasures.

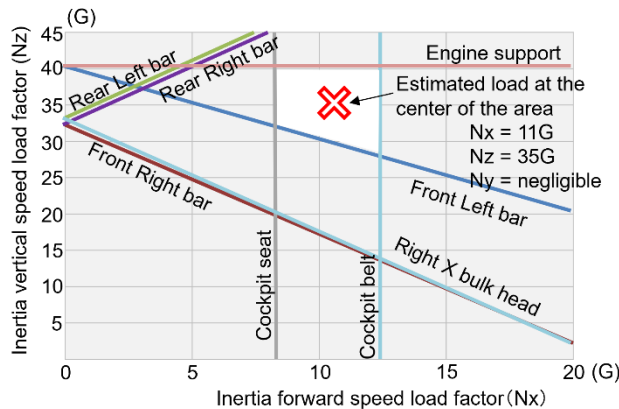
Figure 12: Estimated Load Factor at Forced Landing

Based on the damage to the helicopter at the time of the forced landing, the designer and manufacturer company estimated the load factor at the forced landing by means of the load factor limit line. It is highly probable that considering the damage to such as the airframe and equipment as shown in Figure 12, the inertia forward speed load factor (N_x) is estimated to be 11 G, and the inertia vertical speed load factor (N_z) is estimated to be 35 G. Besides, the vector-based calculation of the load factor results, as shown in Figure 13, revealed that the direction of the helicopter movement was about 73°. And from the ANALYSIS 3 (1), a combined radial and axial load of about 37 G was most likely applied in the approach direction of the helicopter at touchdown as the helicopter had made an approach at low speed in a steep angle of about 73° with its nose-up. Therefore, the inertia vertical speed load factor (N_z) of 35 G probably means that the helicopter touched down at a rate of descent of 1,656 ft/min or more.

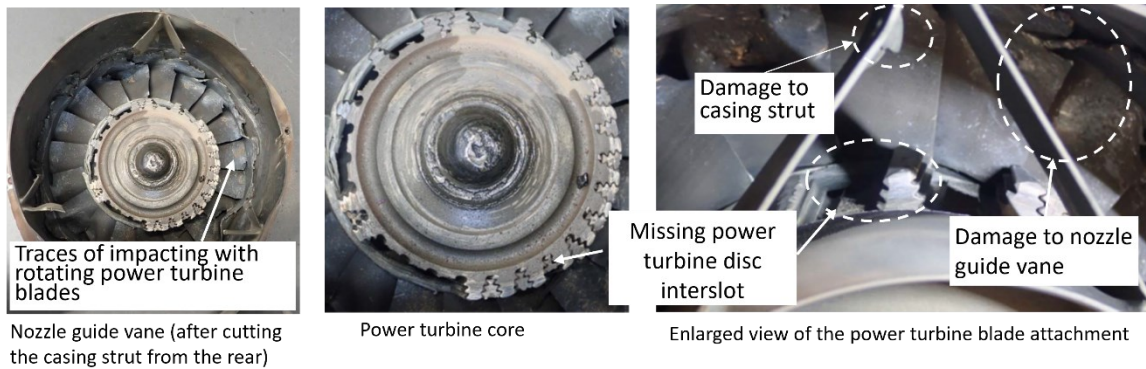
Figure B: Damage to MODULE M04 Power Turbine

<p>2.7 Teardown Investigation of the Engine and Maintenance Information</p>	<p>(1) Overview of Engine Damage</p> <p>In order to make a detailed examination for causes of the engine's power loss, the disassembly investigation of the engine was performed. Under the witness of an accredited representative of the French Republic, the investigations were performed in the facility of the design and manufacture company. The result was as follow:</p> <p>a. Gas Generator Section</p> <p>(a) There were the local thermal damages on the hollow shaft and the combustion chamber shroud.</p> <p>(b) Some of the HP2 turbine blades were damaged, and some were ruptured in the middle or near four-fifths of the trailing edges of the blades. In the rupture, no fatigue rupture nor sign of overtemperature were observed. (See Appendix 1 Figure A)</p> <p>b. Power Turbine Section</p> <p>(a) There were signs that the power turbine disk went in contact with the power turbine nozzle guide vane while it was rotating, and the power turbine bearing support twisted and damaged. All power turbine blades were missing and part of power turbine disk interslots were</p>

missing. (See Appendix 1_Figure B)

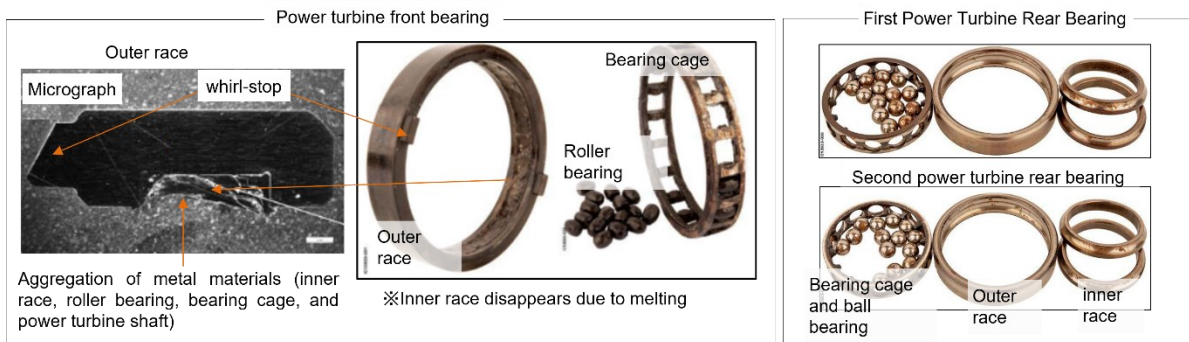
Figure C: Damage to MODULE M04 Power Turbine Bearing

- (b) The power turbine front bearing rollers (5 mm diameter x 5 mm length) were found deformed: their diameter decreased by 1mm, and their length increased by 0,1 to 0.2 mm. And the front bearing inner race was melted and disappeared, a micrographic and EDS*⁶ analysis showed trace of the aggregation of metal materials (inner race, roller bearing, bearing cage, and power turbine shaft) within the outer race. (See Appendix 1_Figure C)

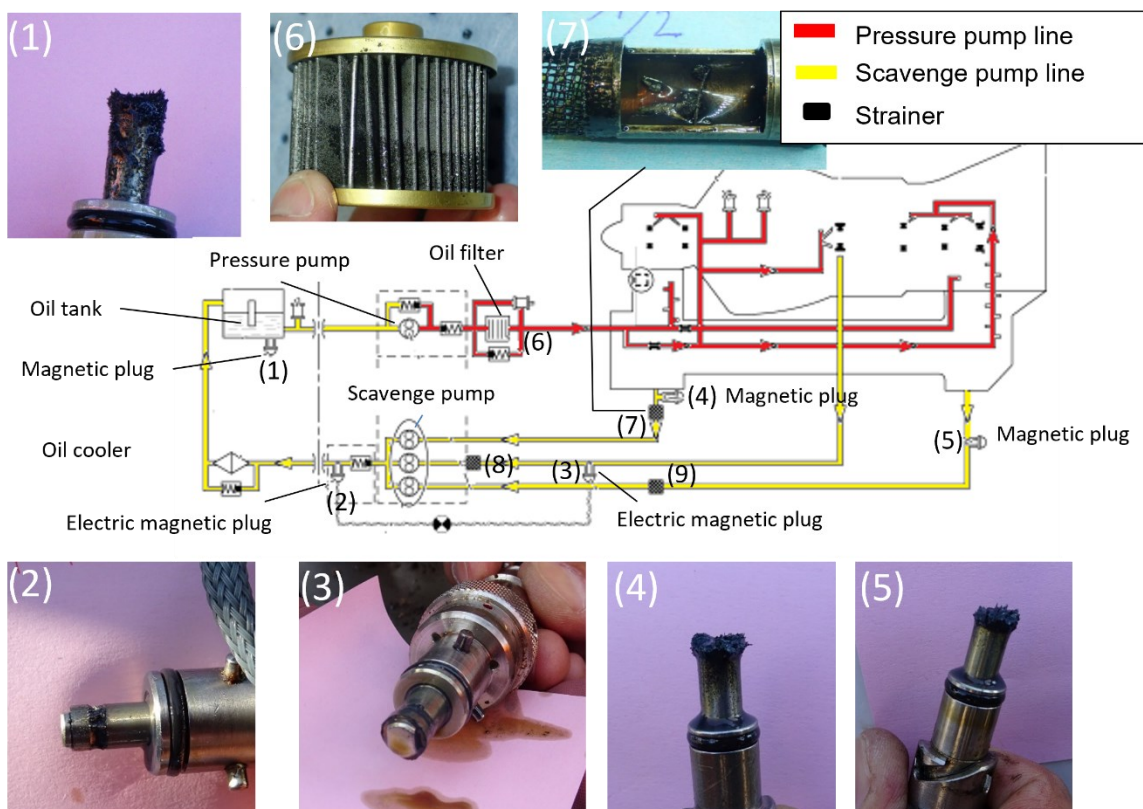
Figure A: Engine Oil Flow and Situation Contaminated by Metallic Particles

- (a) The analysis of metallic particles contained in the oil did not detect any materials other than those related to the engine.
- (b) Significant quantity of metallic particles was present in the scavenge pump*7 and the polluted engine oil contained metals including materials of the bearing and power turbine shaft.
- (c) The disassembly inspection revealed that no sign of any engine oil overtemperature was found and the three power turbine bearings appeared to be lubricated. The collected engine oil did not contain any impurities other than the engine material.
- (d) The significant amount of metallic particles were collected from the oil tank and oil filter*8.

a. The reason why the engine chip caution light came on was probably because from the conditions of the pollution of the magnetic plug engine oil and the deterioration of the power turbine front bearing in Appendix 2_Figure A and Table 1, the metallic particles of power turbine front bearing (Bearing steel 80DCV40) and of the power turbine shaft (Heat-resistant alloy NCK19DAT) in the Module M04 were mixed into the oil system, which the electrical magnetic plugs (Appendix 2_Figure A (2)) first detected.

The significant amount of metallic particles collected from the oil tank and oil filter contained power turbine material, most of which probably came from the damaged power turbine.
