AI2007-3

AIRCRAFT SERIOUS INCIDENT INVESTIGATION REPORT

BELL 206L-3, JA6114

TWO EMERGENCY LANDINGS DUE TO ENGINE STOPPAGE,
IN FLIGHT

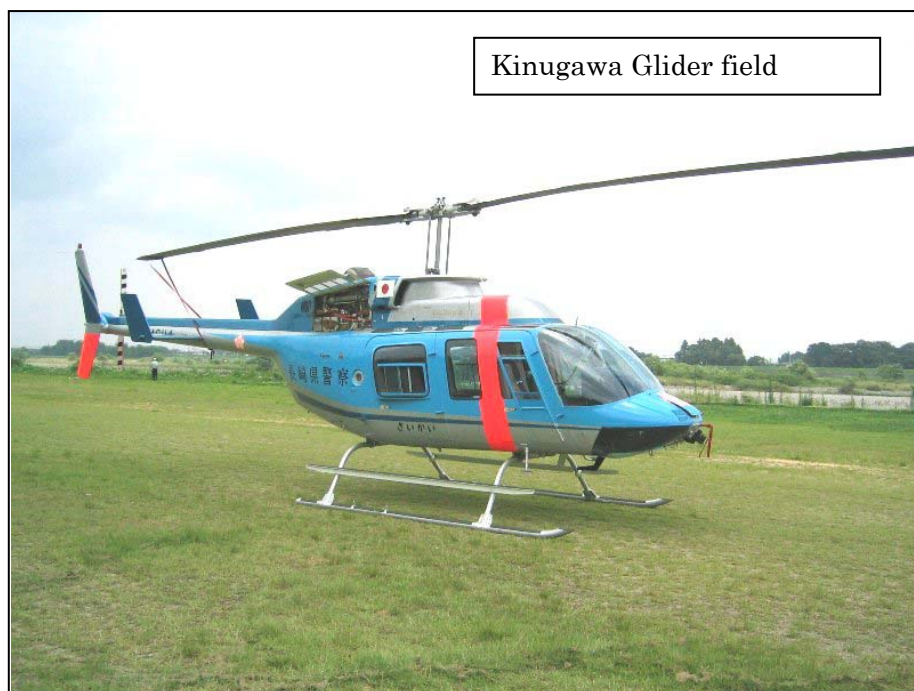
Photograph 1 The aircraft (1)

2.5.1 Incident A occurred about 1km northwest of Kinugawa field at an altitude of around 2,800ft. The site of the emergency landing was on the runway of Kinugawa field (length: 600m, width: 25m, surface: unpaved and rolled), which is located on the dry riverbed of the Kinu River in Kamikawachi-Cho, Kawachi-Gun, Tochigi-Prefecture, about 50m from the south end of the runway (about 1.1km south of Ujiie Bridge).

The aircraft came to rest with its nose pointing south approximately parallel to the runway.

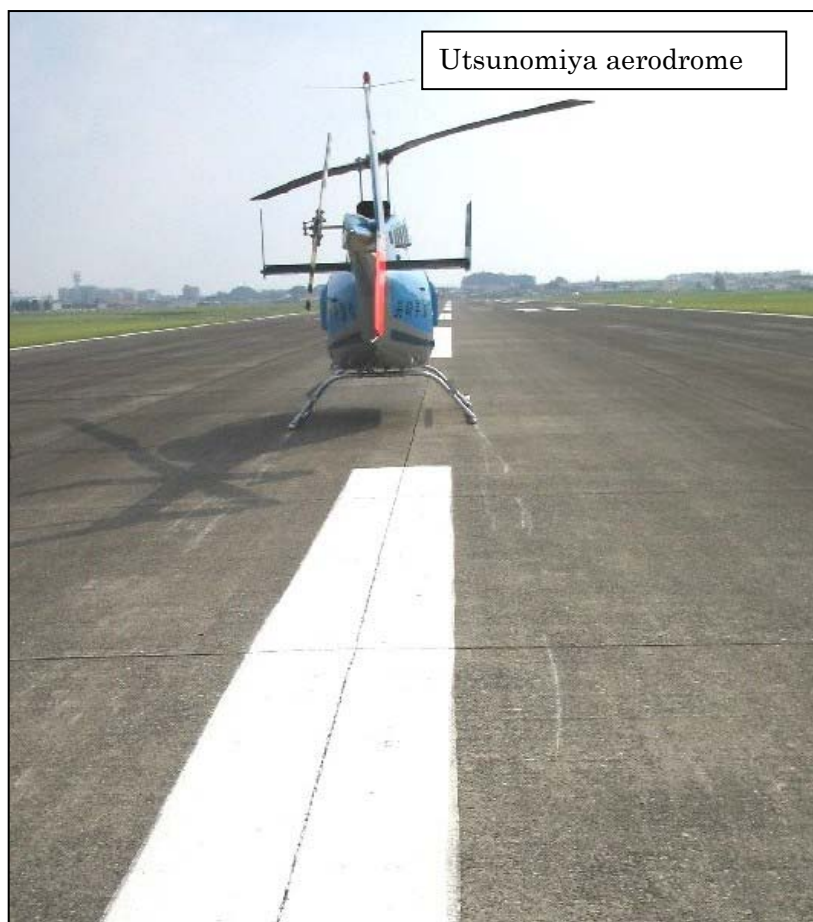
Photograph 2 The aircraft (2)

2.5.2 Incident B occurred over the runway of Utsunomiya aerodrome at an altitude of around 1,000ft. The site of the emergency landing was on the runway of Utsunomiya aerodrome (length: 1,700m, width: 45m) on the centerline around 350m north from the south end of the runway.

The aircraft came to rest with its nose pointing south parallel to the runway.
