AIRCRAFT ACCIDENT INVESTIGATION REPORT

AKAGI HELICOPTER COMPANY LIMITED.
AEROSPATIALE SA315B ALOUETTE III (ROTORCRAFT), JA6119
MISUGI VILLAGE, ICHISHI DISTRICT
(TSU CITY FROM JANUARY 2, 2006),
MIE PREFECTURE, JAPAN
AT ABOUT 15:50 JST, OCTOBER 18, 2005

Aircraft and Railway Accidents Investigation Commission
Ministry of Land, Infrastructure and Transport

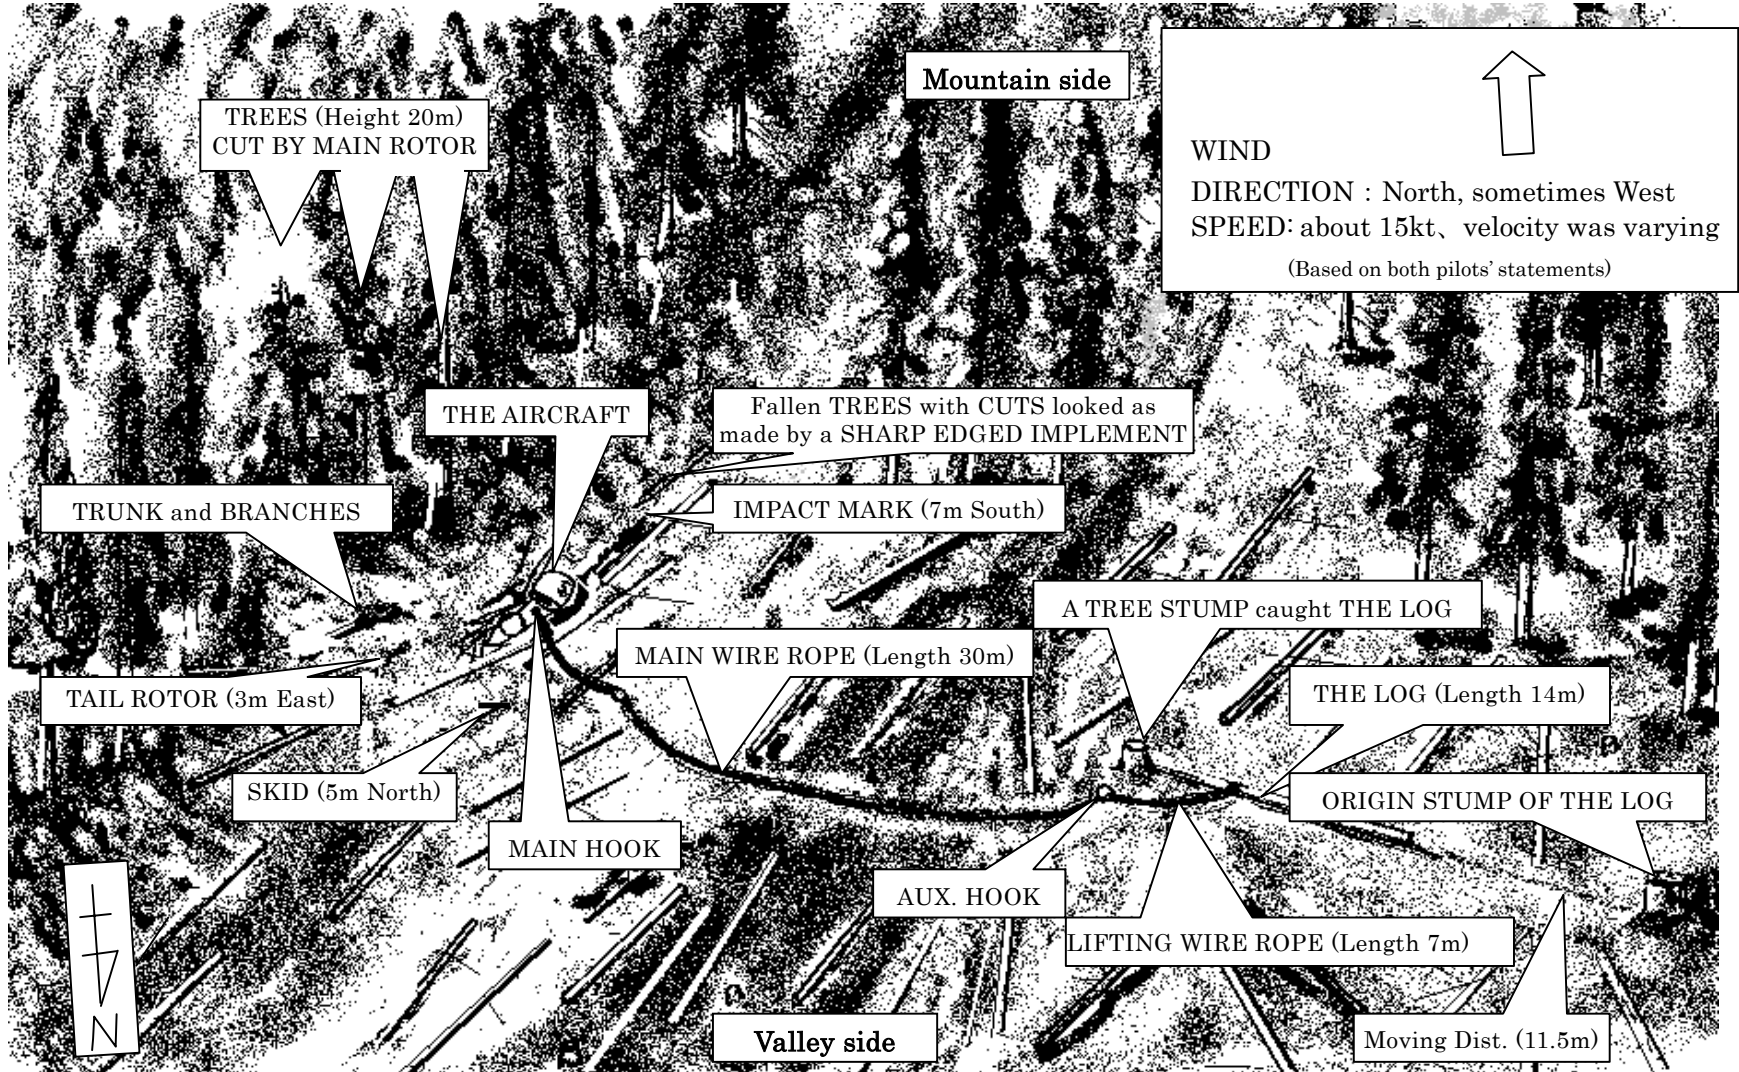
Figure 3 ACCIDENT SITE SCKETCH

The accident site was approximately 640 meters above sea level, about half-way up Mount Yagashira in Misugi Village, Ichishi District, Mie Prefecture, on a northern slope that has a gradient of approximately 40°. Stones and gravel were scattered around the site.

The aircraft stopped with its nose pointing westward and its left side downward. Approximately 7 meters up-mountain (southward) from the aircraft, there were impact marks on the ground. On two fallen trees further up-mountain (southward), there were cuts that looked as though they had been made by a sharp-edged implement. The aircraft's tail rotor was on the ground approximately 3 meters east of the aircraft. There were trees with a height of approximately 20 meters standing to the east of the tail rotor. Parts of the trunk and branches of the tree had been severed and had fallen to the ground. The aircraft's right-hand skid had fallen approximately 5 meters down-mountain from the aircraft. On the end of the main hook attached to the bottom of the aircraft, there was a main wire rope of 30 meters in length. On the auxiliary hook at the other end of the main wire rope, there was a lifting wire rope of 7 meters in length. A log with a length of approximately 14 meters and a weight of approximately 700 kilograms was attached to the other end of the lifting wire rope. The end of the log had caught on a tree stump. Fibers near the root end of the log had been torn away. The stump of the wire-attached log was located approximately 11.5 meters northeast of the log, in alignment with the extension of the line on which the log was lying. Part of the trunk had been torn away. From the stump of the wire-attached log to the stump on which the log had caught, there was an uphill gradient.

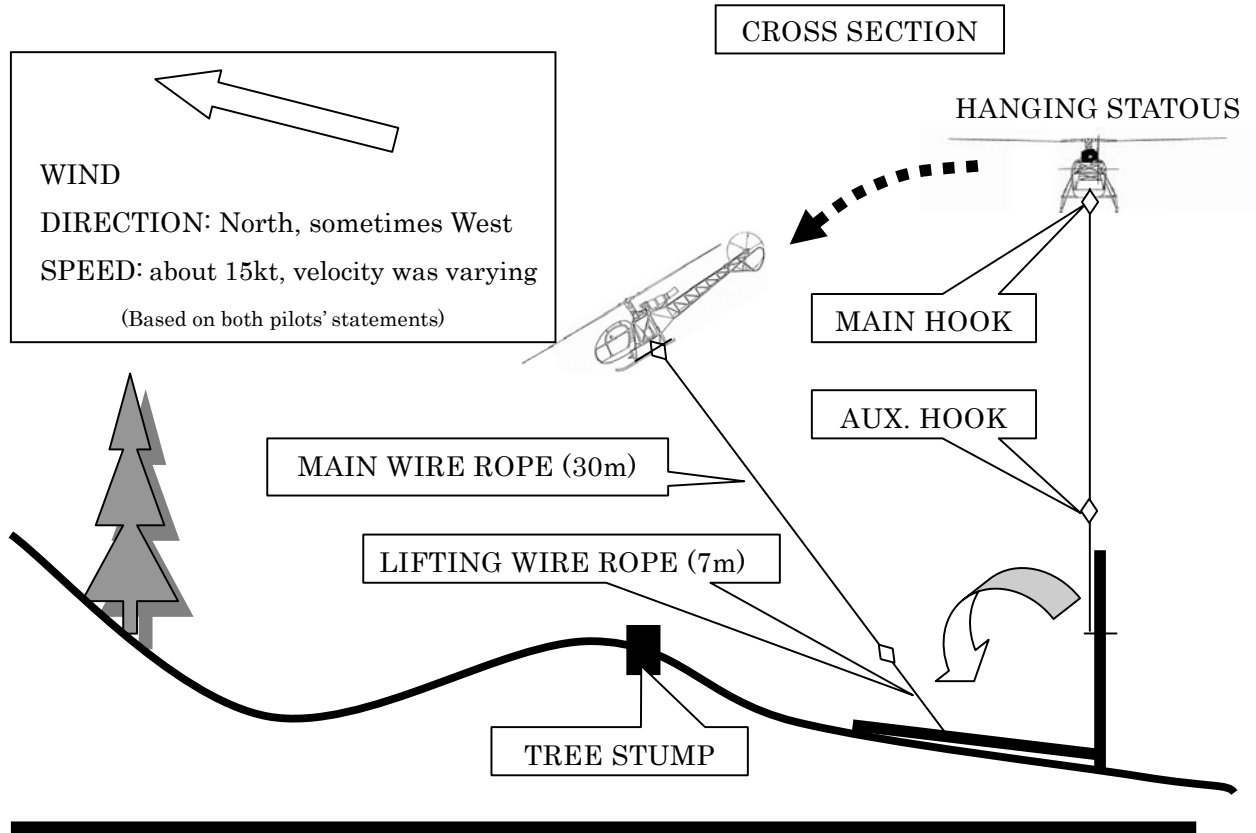
Figure 4-1 PRESUMED ACCIDENT

With regard to the increase in the aircraft's forward-tipped angle, the following sequence of events appears likely to have took place: When the collective pitch lever was pulled upward in an attempt to increase the lift of the main rotor, the wire rope became taut. As theoretically assumable, in the accident aircraft with the main hook located below its center of gravity, the tension of the wire would have caused a moment that acted to tip the aircraft in the direction in which the line of action of the main rotor and the straight line between the main hook and the wire rope's ground restricting point aligned with each other. Next, as theoretically assumable again, when this moment overcame the aircraft attitude

With regard to this accident, it is estimated that the aircraft, during repeated attempts by the fellow pilot to lift a log that had not been completely severed from its root, tipped forward, was restrained by the wire rope attached to the log and, owing to the fellow pilot's subsequent upward movement of the collective pitch lever, struck the slope in that condition, resulting in the aircraft being destroyed and the pilots being seriously injured.

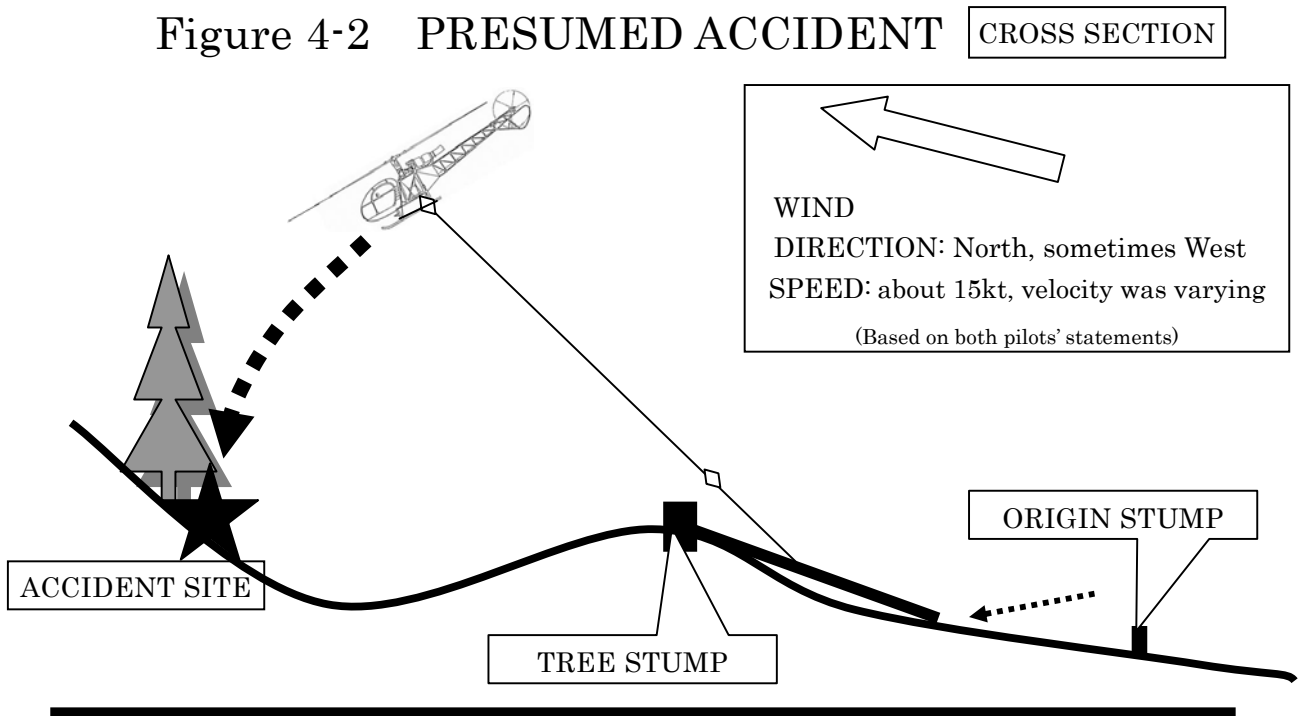
Figure 4-2 PRESUMED ACCIDENT

According to the pilot-in-command and fellow pilot, after the aircraft first tipped forward, the aircraft nose transiently rose but the aircraft subsequently tipped forward again. It is estimated that the cause of the above series of events was as follows: Because the log was torn from its root, the restraint imposed by the wire rope upon the aircraft momentarily eased during the log's approximately 11.5 meters of movement, allowing the aircraft nose to rise. The log then caught on a stump, and the aircraft returned to a forward-tipped attitude.

It is estimated that the rustling sound heard by the fellow pilot roughly when the aircraft assumed a forward-tipped attitude for the second time was the sound made by the main rotor blades cutting the trees. It is also estimated that the main rotor blades were damaged by the contact with the trees, that their lift further decreased as a result, and that the aircraft then struck the slope.

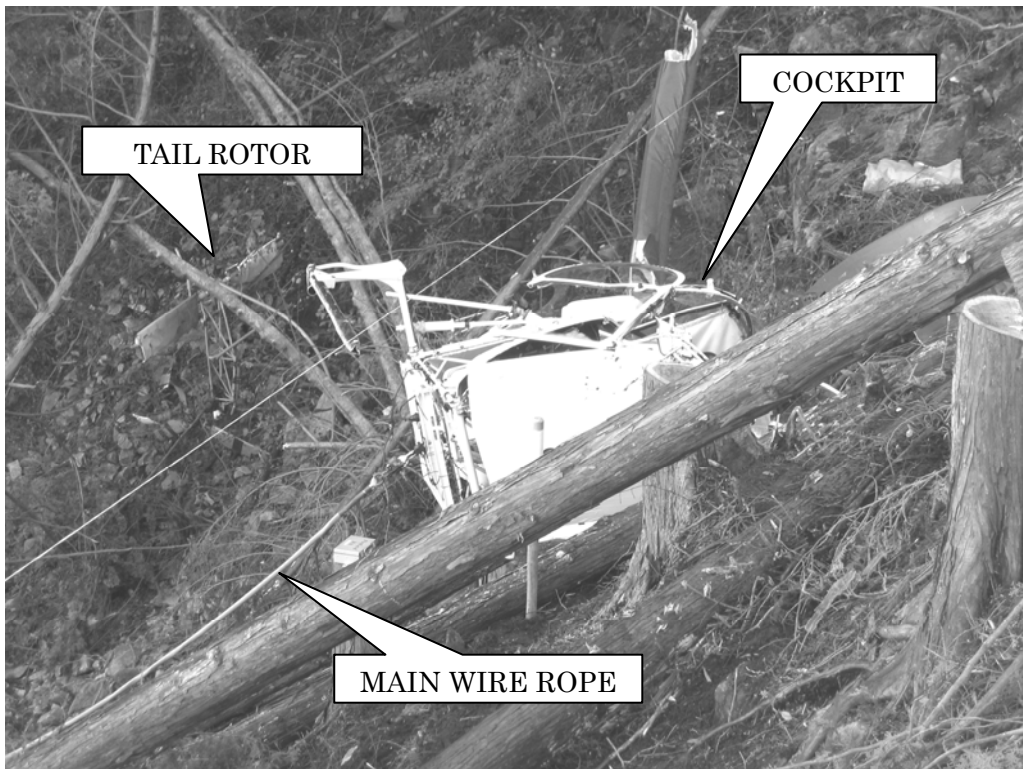
Photograph 2 THE AIRCRAFT

Cockpit:	Destroyed
Main rotor blades:	Blade tips torn off
Engine:	Damaged
Skids and crosstubes:	Torn off
Tail boom:	Torn off near the rear end
Horizontal stabilizer and tail rotor:	Torn off

(1) With regard to the cockpit, the beams running lengthways in the floor were bent and

structural members of the outer framework of the cockpit were destroyed.

- (2) The main rotor blades were severely bent upward and had knocks and abrasions from contact with the trees and ground.
- (3) The engine's rotor case had a hole with a diameter of approximately 30 millimeters in its 12 o'clock position. The edge of the hole was bent inward or toward the engine.
- (4) The right skid was separated from the crosstube at the front of the airframe.
- (5) The tail boom was severed near its aft end.
- (6) The skin of the horizontal stabilizer was torn, and the tail rotor blades were bent.
- (7) The collective pitch lever was in a position near the fully up position. The cyclic stick system was broken.

With regard to the hole in the engine's turbine case as mentioned in paragraph 2.8.2 of this document, given the nature of the hole, i.e. it was made from the outside toward the inside, and the condition of the area around the sideways-tipped aircraft, it is estimated that the hole was made by contact with a stone when the aircraft hit the ground.

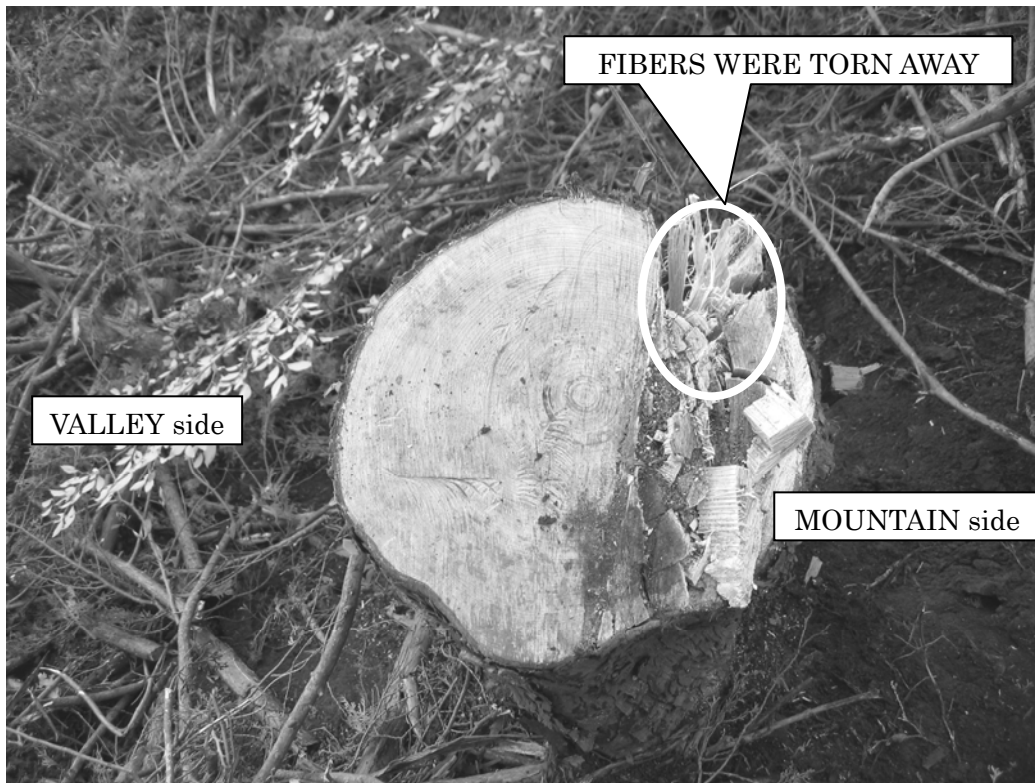
Photograph 3 ORIGIN STUMP OF THE LOG

With regard to the particular log that the aircraft was attempting to lift at the time of the accident, it is estimated that a woodcutter of the forestry company neglected to completely sever the connecting wood from the root by oversight or some other reasons before attaching a wire rope to it a few days prior to logging. Also, it is estimated that the ground worker of the Company neglected to check whether the connecting wood had been severed prior to lifting or performed the check but failed to notice that the connecting wood had not been severed.
