**AIRCRAFT ACCIDENT
INVESTIGATION REPORT**

JAPAN AIRLINES INTERNATIONAL Co., Ltd.

J A 6 1 1 J

BOEING 767-300

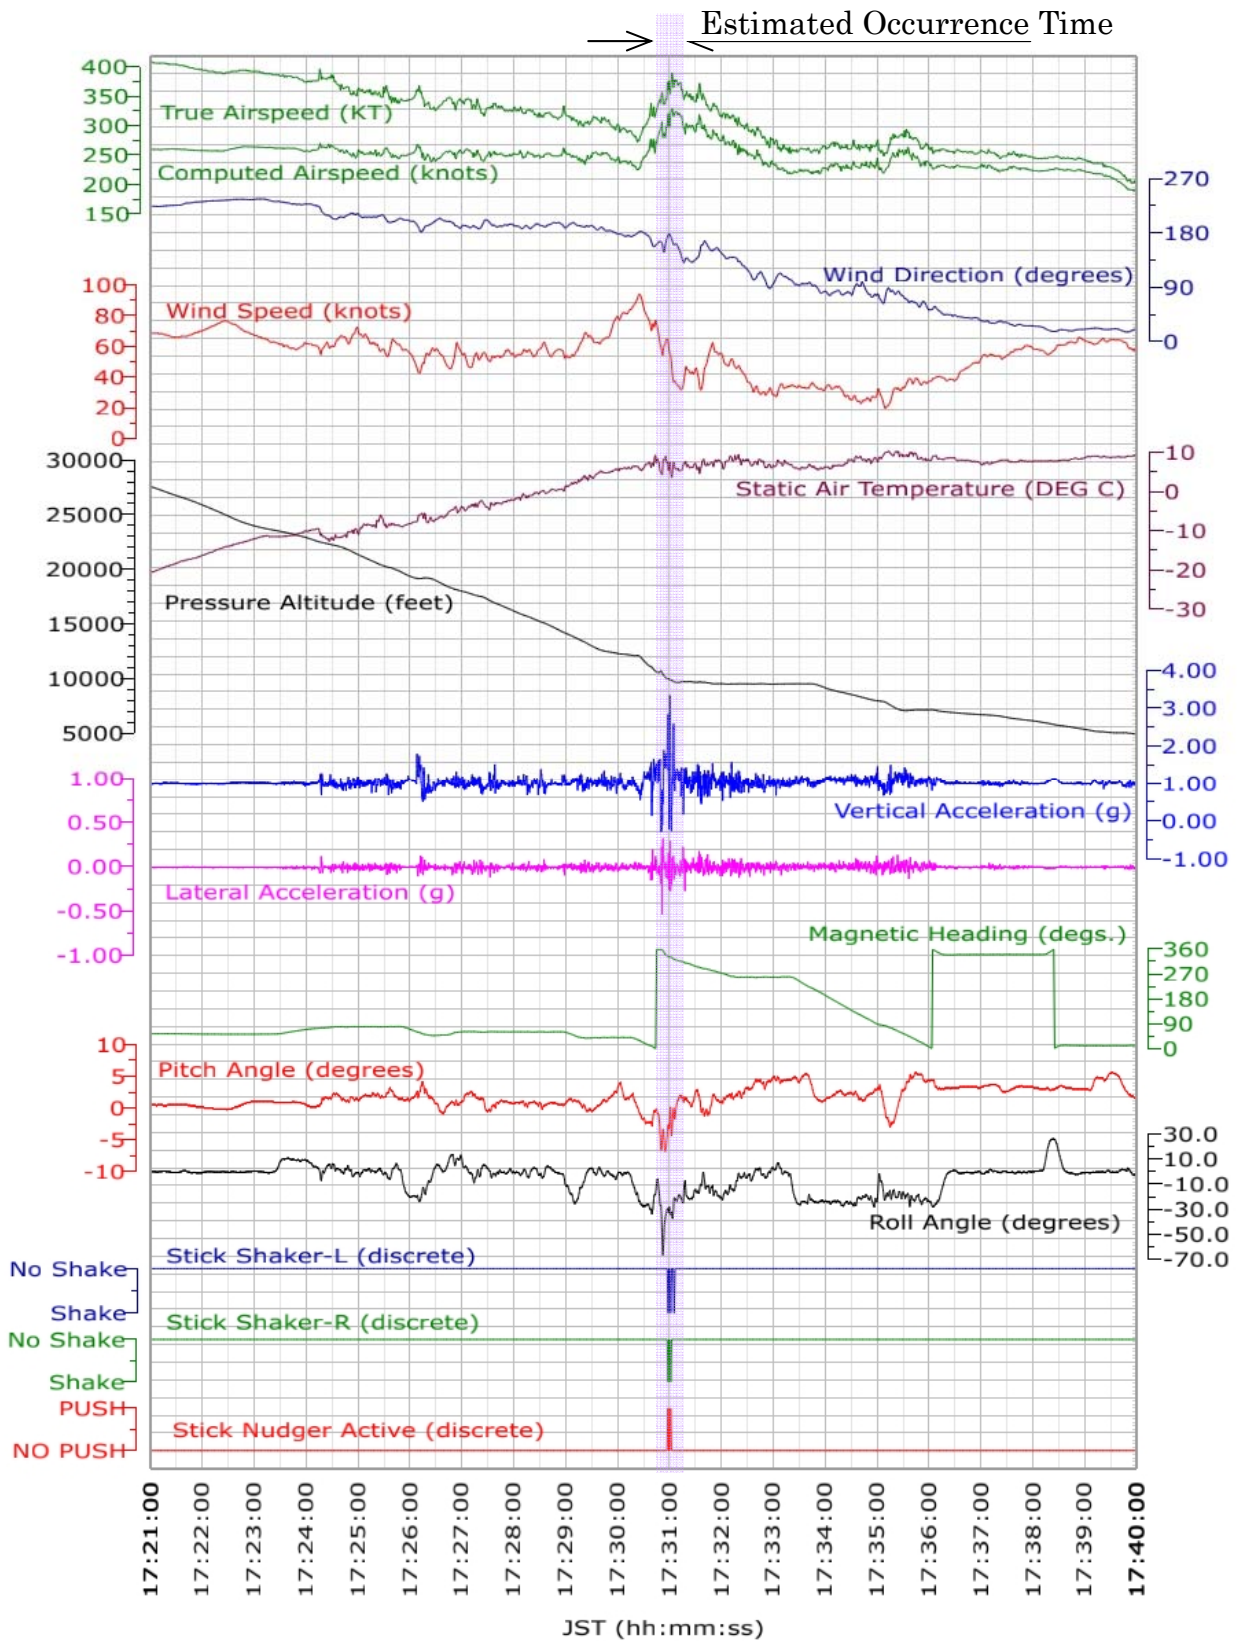
Figure 2-1 DFDR and QAR Records

After 17h:30m:48s, at an altitude of approximately 10,500 feet, the aircraft started to experience intense turbulence, with the vertical acceleration intermittently exceeding +1.5G (minimum value -0.29G) and the roll angle marking a largest value of 66.8° leftward at 17h:30m:53s. After that, the roll angle of the aircraft later recovered. At 17h:30m:58s, the vertical acceleration exceeded +2G (minimum value +1.46G) from an altitude of approximately 10,000 feet, and recorded a maximum value of +3.34G at 17h:31m:01s (minimum value -0.27G two seconds later). The intense turbulence ceased at 17h:31m:07s, at an altitude of approximately 9,700 feet. However, the aircraft continued to fly in turbulence afterwards, and landed at Narita International Airport at 17:51.

For 19 seconds from 17h:30m:48s to 17h:31m:07s, during which the aircraft experienced intense turbulence, the instantaneous activation of the stick shaker³ and stick nudger⁴ were also recorded. The Auto Pilot System and Auto-Throttle System of the aircraft were engaged during the time period, and the Auto Pilot System was switched from FLCH⁵ mode to ALT HOLD⁶ mode.

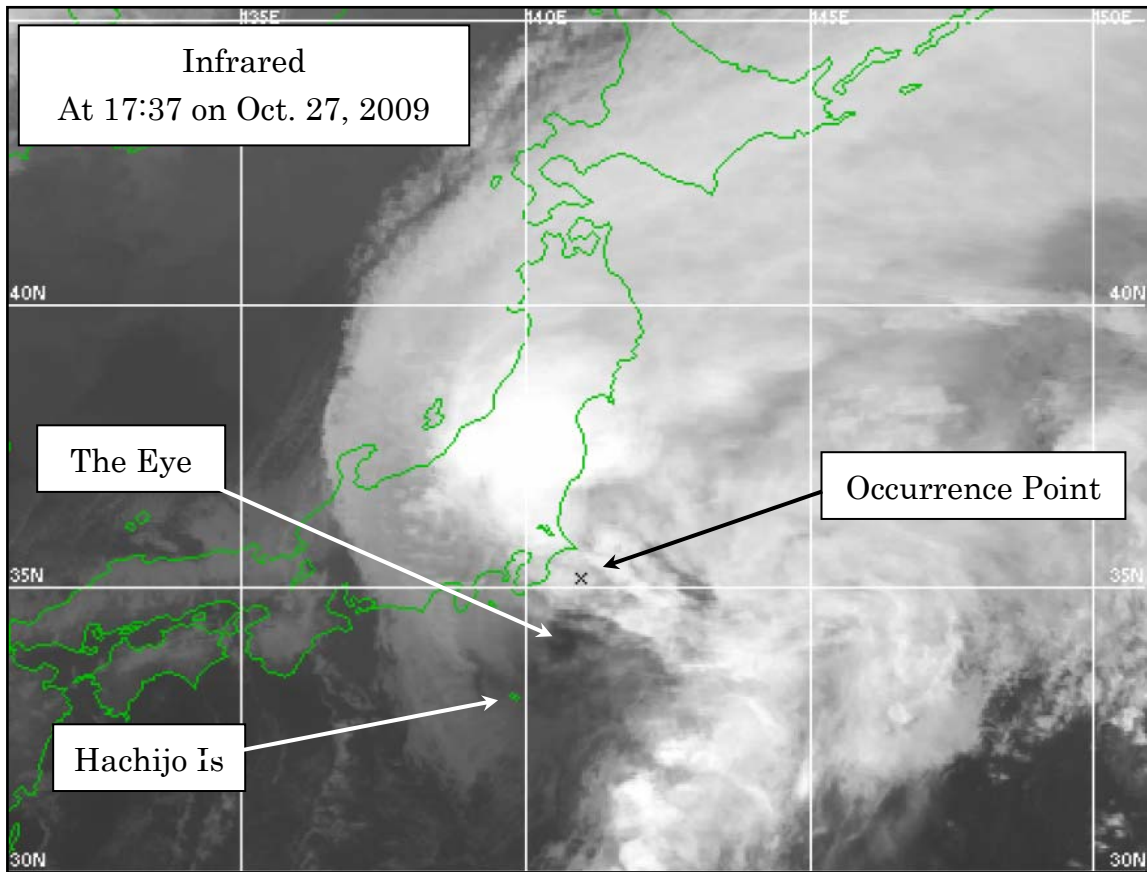
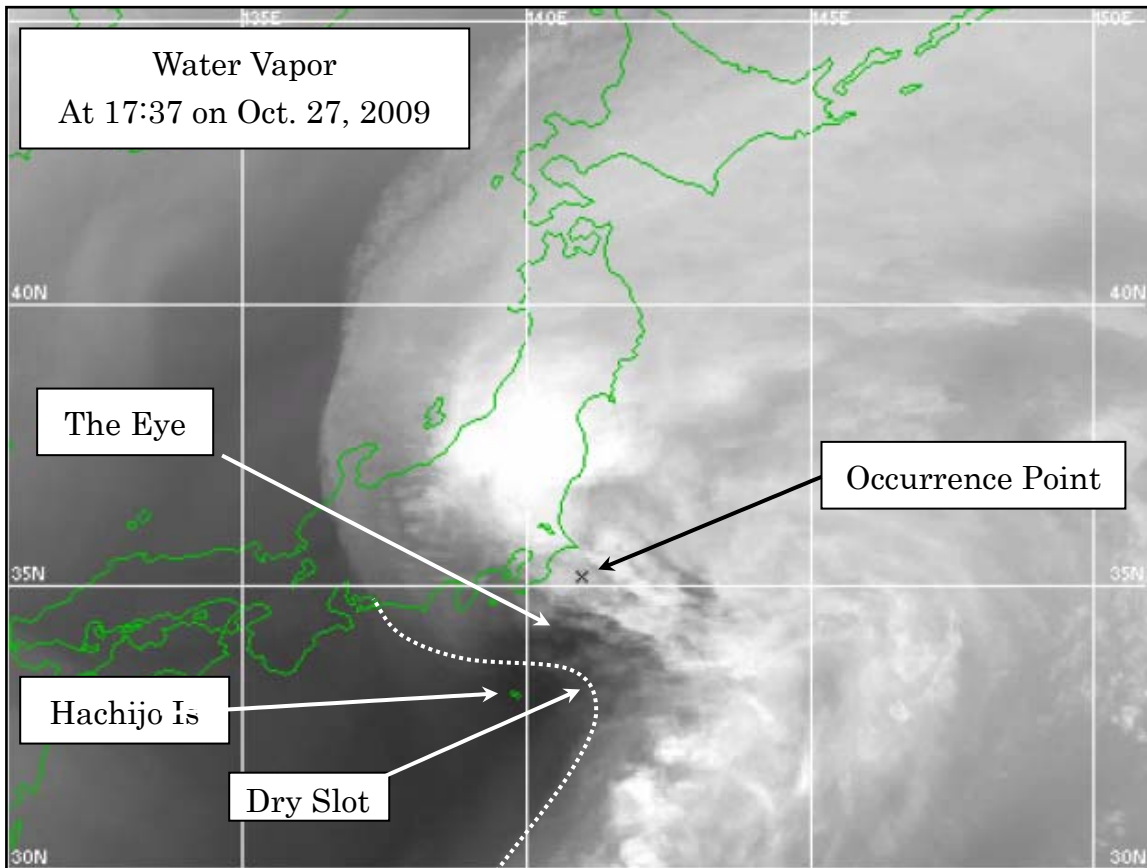
Figure 9 Weather Satellite Imagery

On the weather satellite infrared imagery at 17:37 that day, the eye of a typhoon, the typhoon's center could be observed, albeit obscurely, at approximately 133 kilometers south southwest from the occurrence point. The northern inland from the center of the typhoon was blanketed with convection cloud developed along the way to the upper layer. In addition, the water vapor imagery¹² at the same time that day showed a dry slot¹³, accompanied by the influx of cold air in the south of the typhoon's center, and the typhoon transforming into an extratropical cyclone. (See Figure 9.)

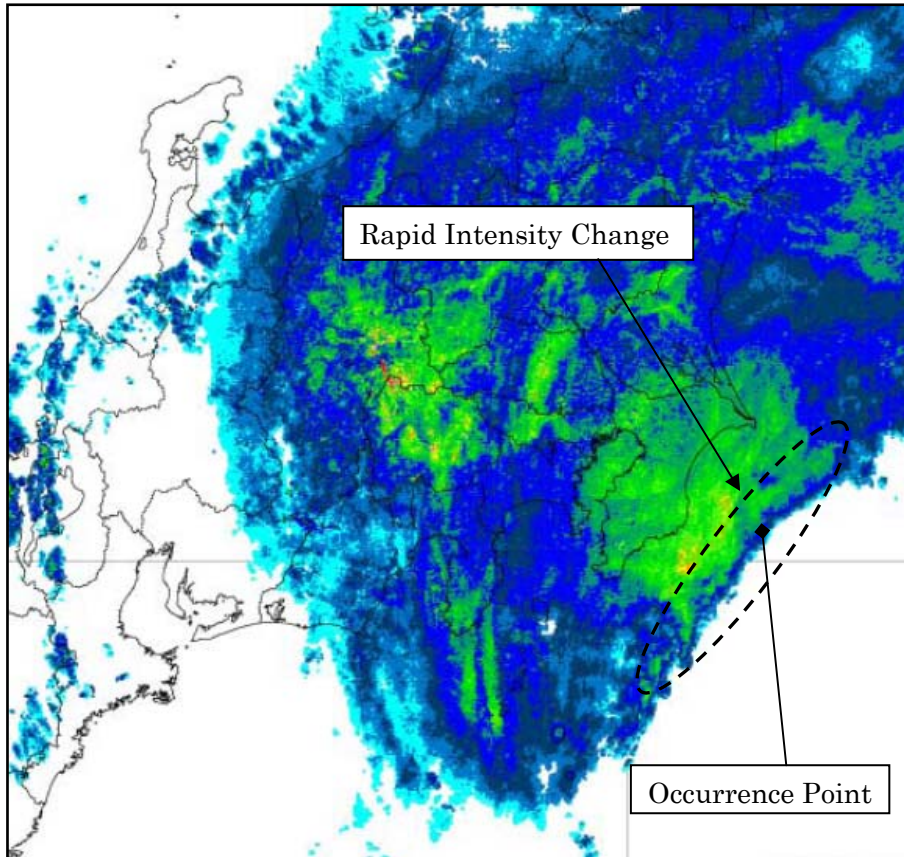
Figure 10 Radar Echo Intensity

The radar echo intensity¹⁴ forecast at 17:30 that day indicated a rainfall area spreading from the northern part of the Izu Islands to eastern Japan. A magnitude of heavy precipitation exceeding 32mm/h was observed in the echo's southeast quadrant, while the radar echo top altitude¹⁵ was reaching eight kilometers (26,246 feet) or higher. A marked linear color gradation change for precipitation intensity suggestive of a disturbance was stretching in the vicinity of the occurrence point. (See Attached Figures 10, and 11.)

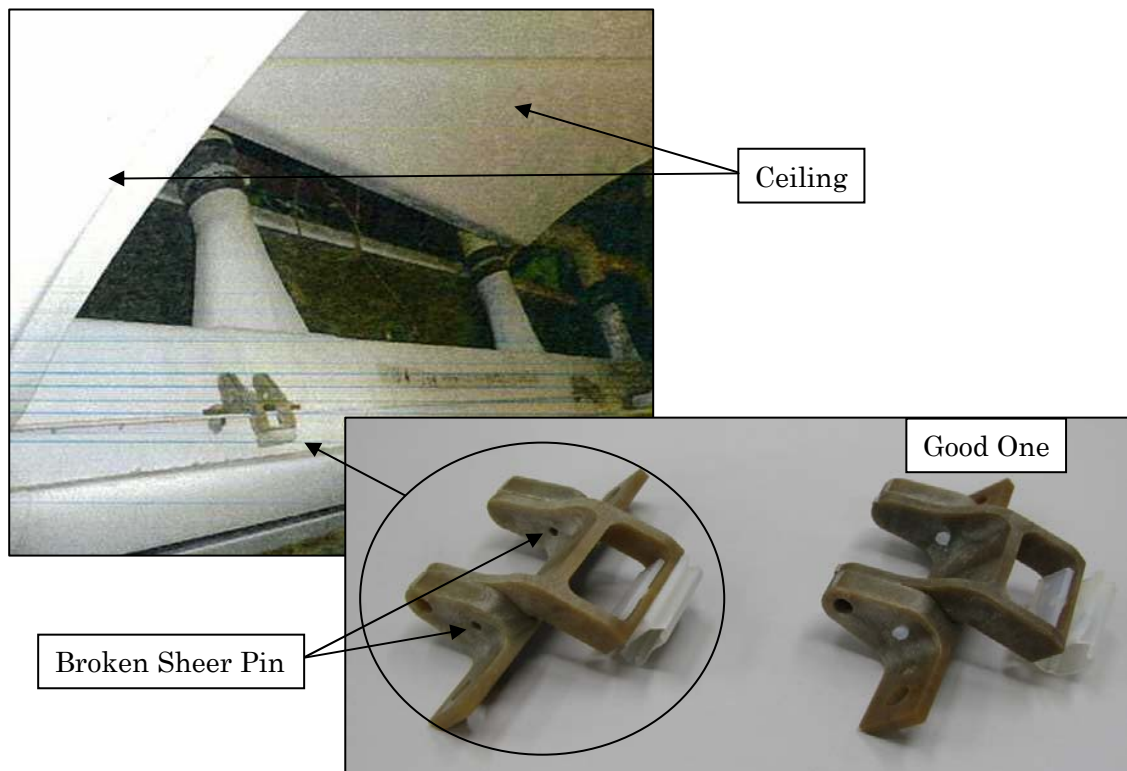
Photo 2 Destroyed Clamp

After arrival, the aircraft was conducted severe turbulence inspection. The following was found to be damaged.

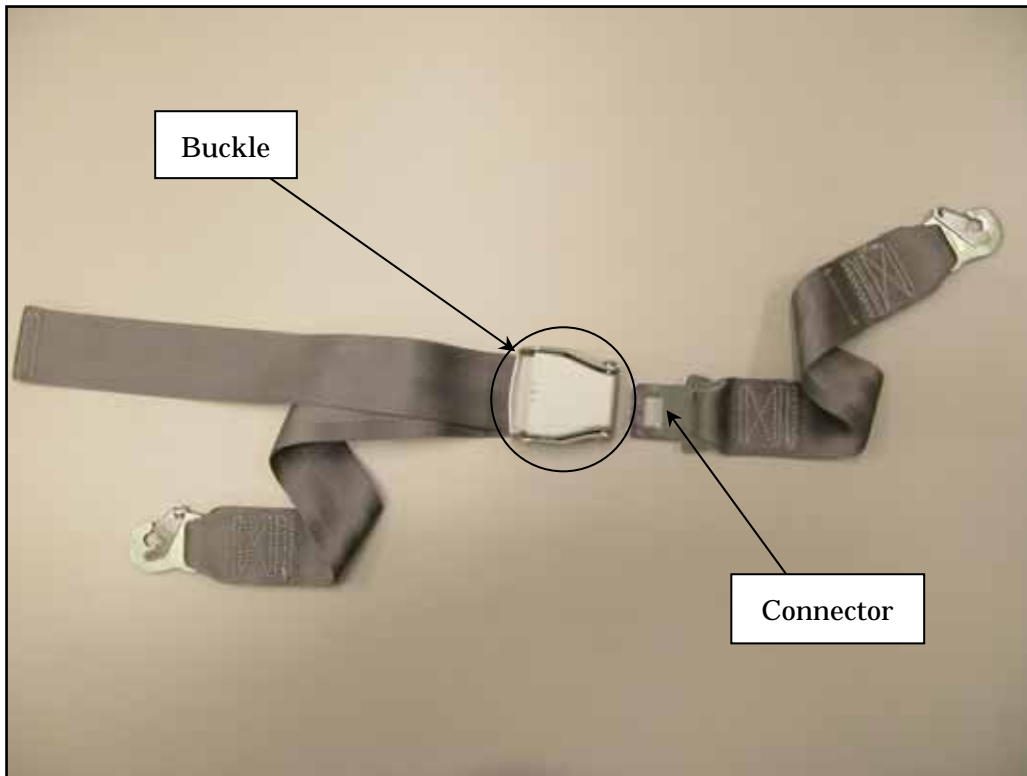
Photo 3 Sheet Belt of the aircraft

When the seatbelt of the seat in which passenger A was sitting was inspected, there was no external damage, and it was confirmed that the belt was functioning normally. (See Photos 3 and 4.)

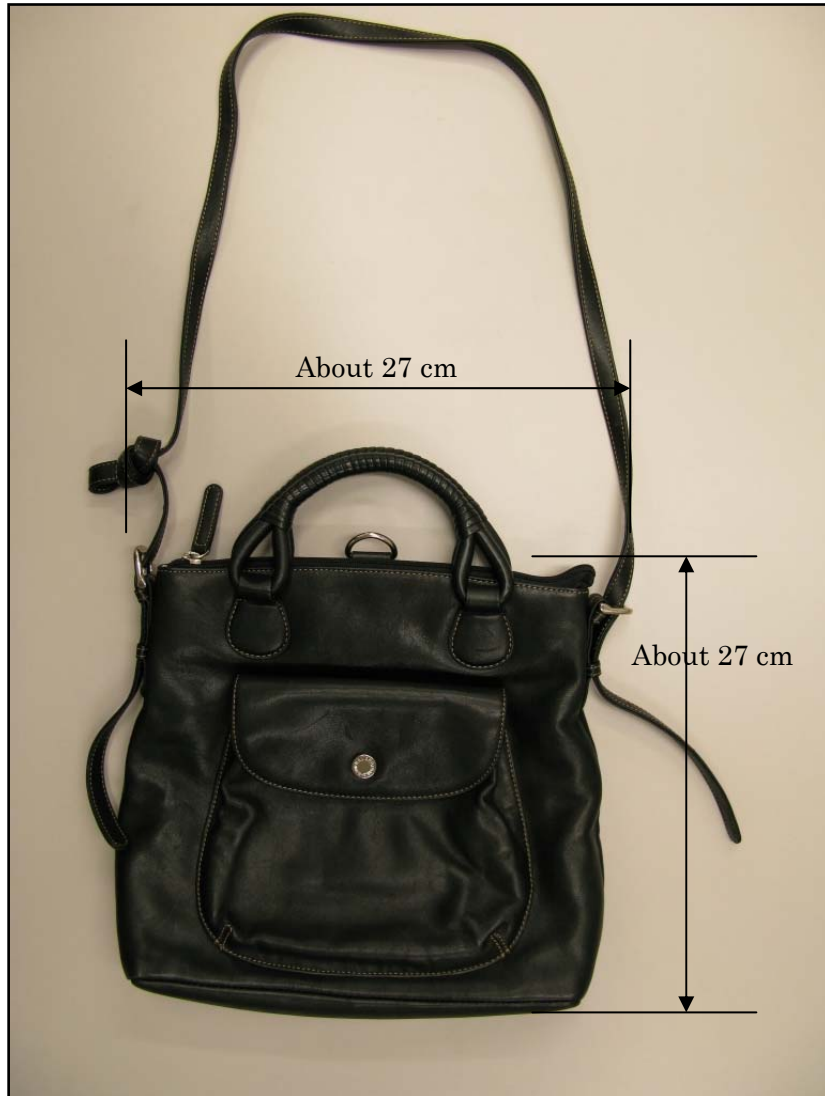
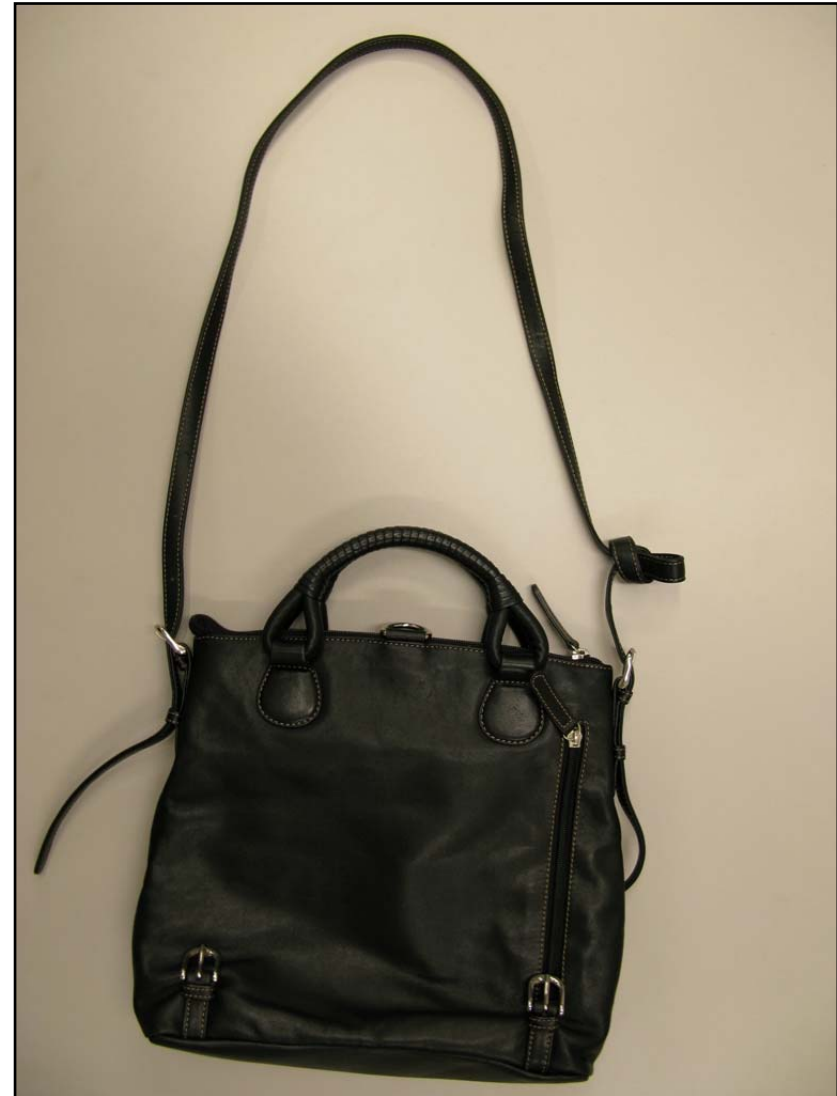
Photo 5 The Bag Carried by Passenger

With respect to the unfastening of the seatbelt, when the aircraft experienced the severe turbulence, it is estimated that the bag the passenger was holding on her lap touched the buckle of the seatbelt, causing the flap to be pulled upward.

Passengers are allowed to keep hold of personal belongings such as valuables. However, in order to ensure passenger safety during flight, the flight crew members and CAs should pay attention to the possibility of a seatbelt being disengagement by the personal belongings of the passenger if the aircraft encounters turbulence. When powerful turbulence is anticipated, it is necessary that they should give explanations on this matter to the passengers and recommend them to keep their personal belongings in the compartments in the cabin ceilings, beneath their seats or in the seat pockets, so as to prevent such an incident from occurring.

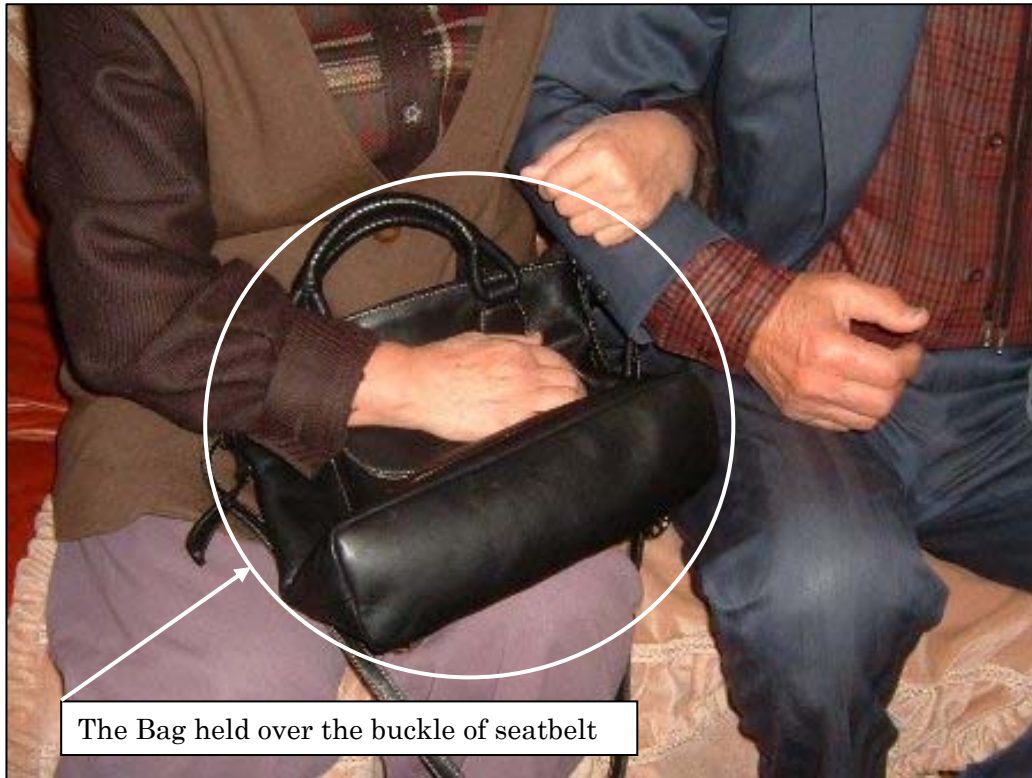
Photo 6 Situation of Holding the Bag (simulated)

A test was conducted by simulating the conditions of passenger A sitting in the seat in order to determine the possibility of the bag’s having released the seatbelt due to the turbulence of the aircraft. When the seatbelt was fastened, the passenger was stabilized on the seat, leaving no

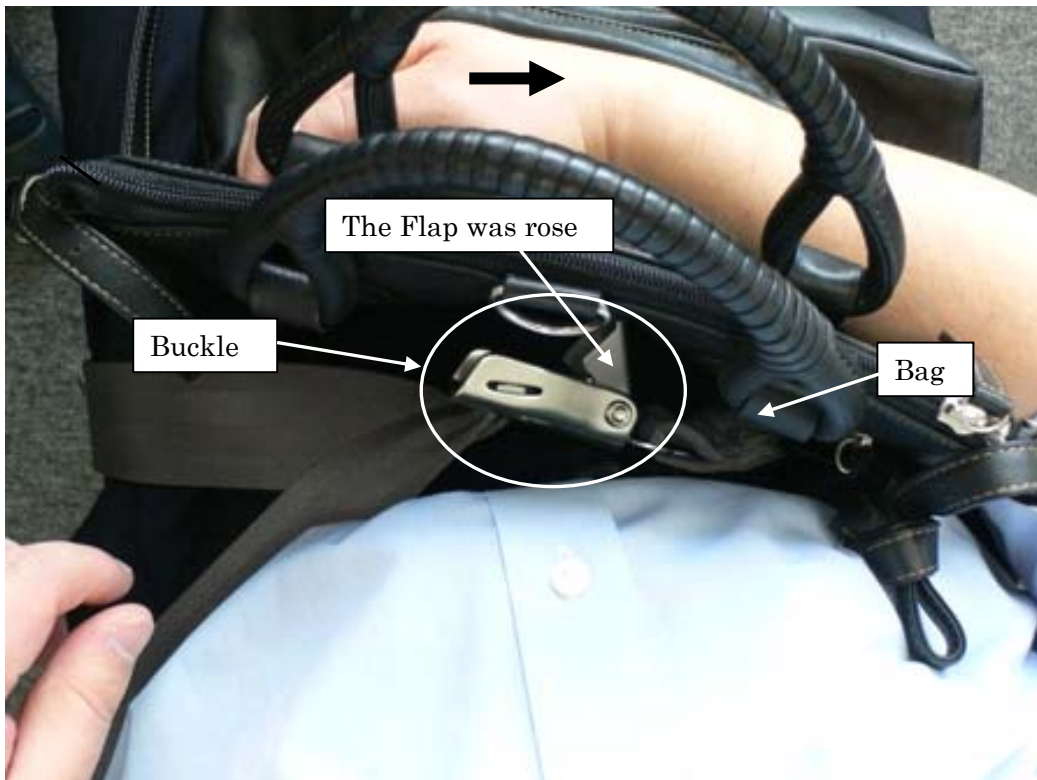
Photo 7 Verification of unfastening

(Moving the bag to the direction of the below Arrow)
