**AIRCRAFT SERIOUS INCIDENT
INVESTIGATION REPORT**

**Aero Asahi Corporation
J A 6 7 1 8**

Company	Aero Asahi Corporation
Type, Registration Mark	Aerospatiale AS355F2 (Rotorcraft) JA6718
Incident Class	Case equivalent to “Landing on an unassigned runway” Case equivalent to the item (ii), Article 166-4 of the Ordinance for Enforcement of the Civil Aeronautics Act of Japan (item (xviii) of same Article)
Date and Time of the Occurrence	At 09:03 Japan Standard Time (JST: UTC+9 hours), May 22, 2023
Site of the Serious Incident	Chubu Centrair International Airport

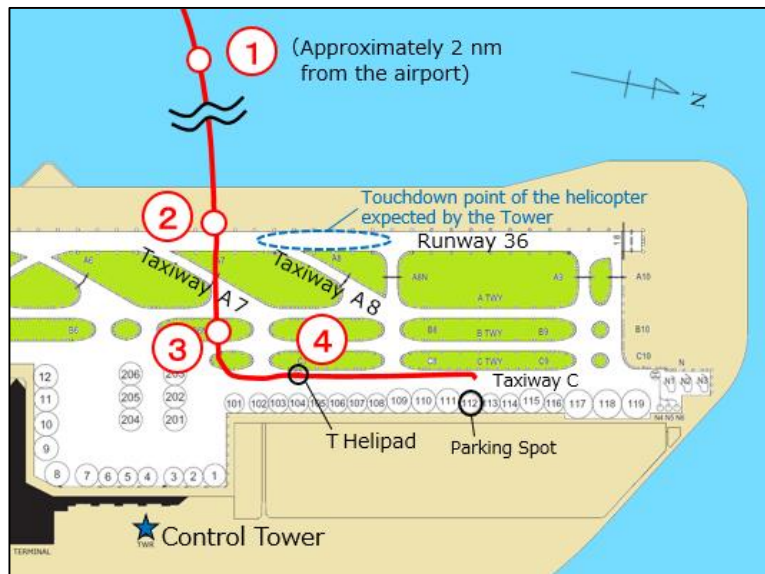
Figure 1: Estimated Flight / Taxiing Routes of the Helicopter

Visually recognizing the helicopter reaching approx. 2 nm (approx. 3.7 km) west of the airport, at 09:01, the Tower issued a landing clearance to the helicopter by transmitting more slowly than usual “RUNWAY 36, CLEARED TO LAND, NEARBY A8 ON THE ACTIVE” (Figure 1 ①). The captain read back and confirmed saying “ROGER. CLEARED TO LAND RUNWAY38*2, A7. CONFIRM A7?” The Tower replied “NEARBY A8.” The captain read back saying “A8, ROGER.”

After confirming that the helicopter reached over the vicinity of Runway 36, the Tower looked down at the air traffic control equipment terminal in order to input the landing time of the helicopter (Figure 1 ②). In the meantime, the helicopter crossed the runway near Taxiway A7 and headed toward T Helipad. A few seconds later, the Tower raised the eyes and visually recognized the helipad heading toward T Helipad (Figure 1 ③). Almost at the same time, the air traffic controller who was

next to the Tower and in charge of the ground control position advised the Tower that the helicopter had crossed the runway. After confirming that there was no other aircraft in the vicinity of T Helipad, at 09:03:14, the Tower called the helicopter saying, "YOU MISSED RUNWAY, AND YOU ARE LANDING AT T HELIPAD." The helicopter landed at T Helipad at 09:03:27 (Figure 1 ④).
