**AIRCRAFT SERIOUS INCIDENT  
INVESTIGATION REPORT**

CASE EQUIVALENT TO “AN ATTEMPT OF LANDING  
ON A RUNWAY BEING USED BY OTHER AIRCRAFT”

EUROCOPTER EC225LP (ROTORCRAFT), JA687A

AT KANSAI INTERNATIONAL AIRPORT

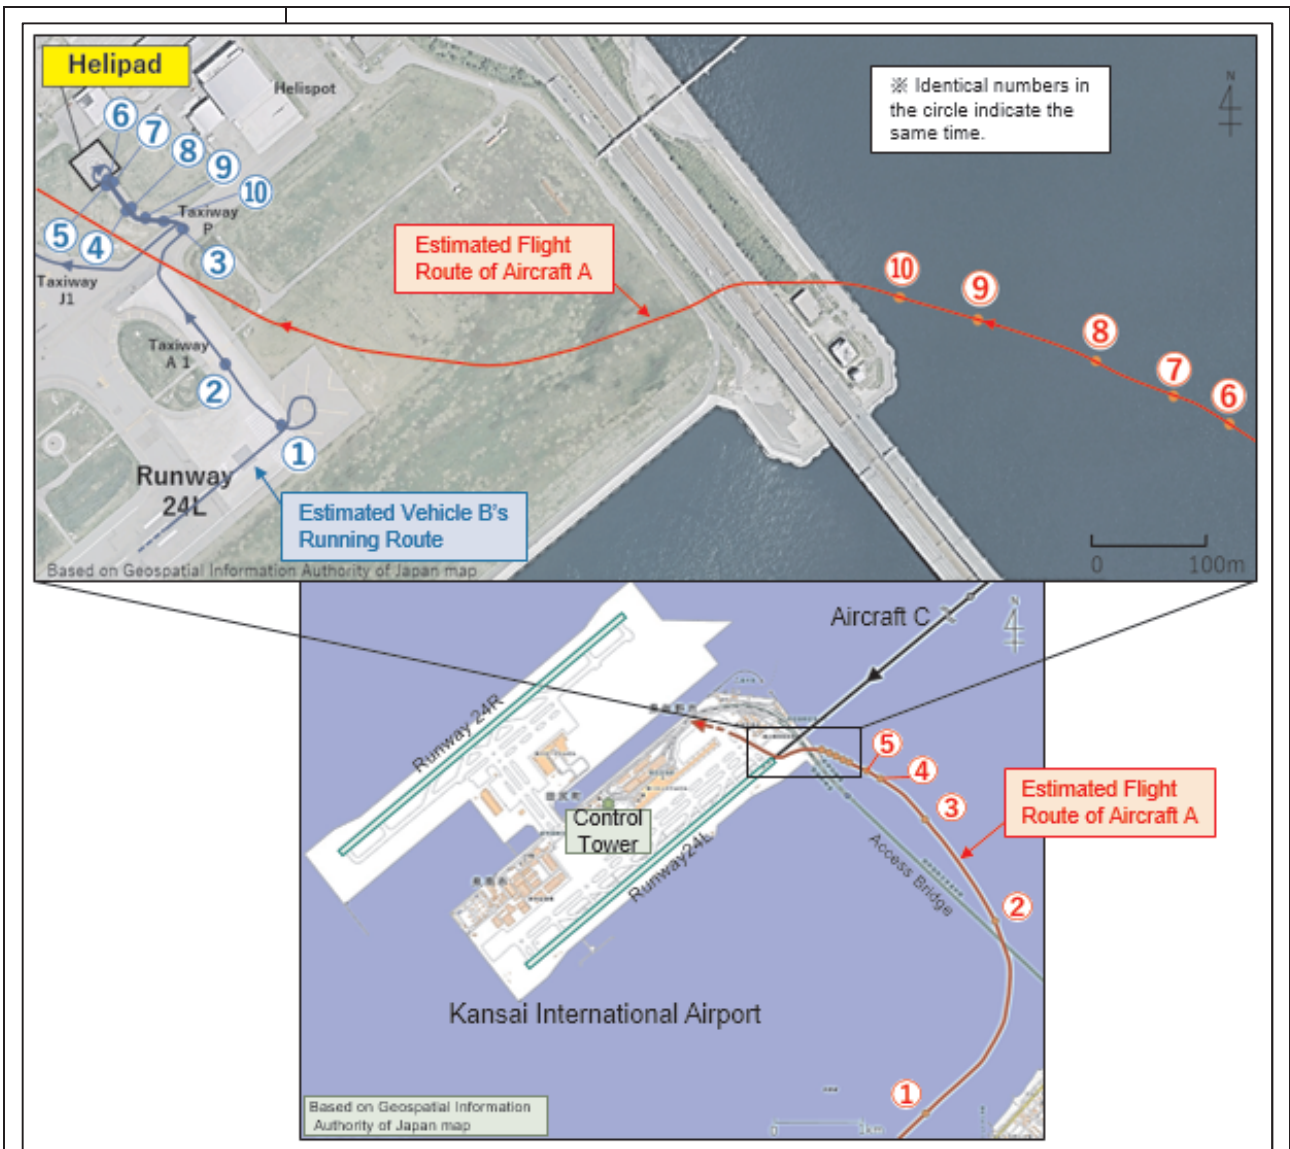
Figure 4: Situation at the Time of Occurrence of the Serious Incident

(3) At 12:11:57, Aircraft A made a position report over “RINKU”. At 12:12:01, the Tower issued a clearance for Aircraft A to land at the Helipad via the “BRIDGE ARRIVAL” (Approach course of flying along the Kansai International Airport Access Bridge (Position ① in the bottom figure of Figure 4). At the almost same time, the Ground provided Vehicle B with the reference information that the arriving aircraft (Aircraft C) was going to land in about two minutes, and did not notice that the Tower had issued a landing clearance to Aircraft A.

(Position ② in the left of the top figure of Figure 4). At this time, the Tower did not notice that Vehicle B was cleared to enter the Helipad.

(5) At 12:13:16, when Aircraft A turned to the direction of the Helipad for a final approach, the captain visually recognized Vehicle B which was entering the taxiway connected to the helipad from Taxiway P (hereinafter referred to as “Connected Taxiway”) (Position ④ in the bottom figure of Figure 4). In a short time, Vehicle B entered the helipad, therefore, at 12:13:25, the co-pilot informed the Tower that a vehicle was present at the helipad (Position ⑥ in the right of the top figure of Figure 4). Being hearing the assertion to the Ground and also paying attention to Vehicle B, the Tower just had decided to instruct Aircraft A to execute a go-around because Vehicle B entered the helipad after that. At 12:13:30, the Tower instructed Aircraft A to execute a go-around (Position ⑧ in the right of the top figure of Figure 4), and at 12:13:37, Aircraft A followed the instruction from the Tower and executed a go-around (Position ⑩ in the right of the top figure of Figure 4).

When receiving the information from the Ground that a helicopter was returning, Vehicle B had just entered Connected Taxiway (Position ③ in the left of the top figure of Figure 4). The driver and radio operator did not know where Aircraft A was, but judged that it was necessary to evacuate immediately. As taking into considering the risks of downwash\*2, the driver did not stop there. In addition, as thinking that with the narrow Connected

<p>Taxiway, it would not be appropriate to turn or go backward, the driver had Vehicle B continuously move forward, and at about 12:13:20, Vehicle B entered the helipad (Position ⑤ in the left of the top figure of Figure 4), promptly turned, and left (Position ⑦ in the left of the top figure of Figure 4) at about 12:13:26. At 12:13:33, the Ground instructed Vehicle B to evacuate to Taxiway J1 (Position ⑨ in the left of the top figure of Figure 4).</p> <p>Aircraft A flew toward the west side of the helipad after the go-around, then received a landing clearance from the Tower again and landed at the helipad at 12:18.</p>																
<b>2.2 Injuries to Persons</b>	None																
<b>2.3 Damage to the Aircraft</b>	None																
<b>2.4 Personnel Information</b>	<p>(1) Tower</p> <table> <tr> <td>Air Traffic Control Certificate</td> <td>April 1, 2008</td> </tr> <tr> <td>Aerodrome Control Service</td> <td>April 1, 2008</td> </tr> <tr> <td>Medical Examination Certificate</td> <td>Validity: June 30, 2022</td> </tr> </table> <p>(2) Ground</p> <table> <tr> <td>Air Traffic Control Certificate</td> <td>April 1, 1993</td> </tr> <tr> <td>Aerodrome Control Service</td> <td>April 1, 1993</td> </tr> <tr> <td>Medical Examination Certificate</td> <td>Validity: June 30, 2022</td> </tr> </table>	Air Traffic Control Certificate	April 1, 2008	Aerodrome Control Service	April 1, 2008	Medical Examination Certificate	Validity: June 30, 2022	Air Traffic Control Certificate	April 1, 1993	Aerodrome Control Service	April 1, 1993	Medical Examination Certificate	Validity: June 30, 2022
