AIRCRAFT SERIOUS INCIDENT INVESTIGATION REPORT

AN ATTEMPTED OF LANDING ON A RUNWAY BEING USED BY OTHER AIRCRAFT KAGOSHIMA AIRPORT

AT AROUND 11:25 JST, JUNE 2, 2022

August 2, 2024

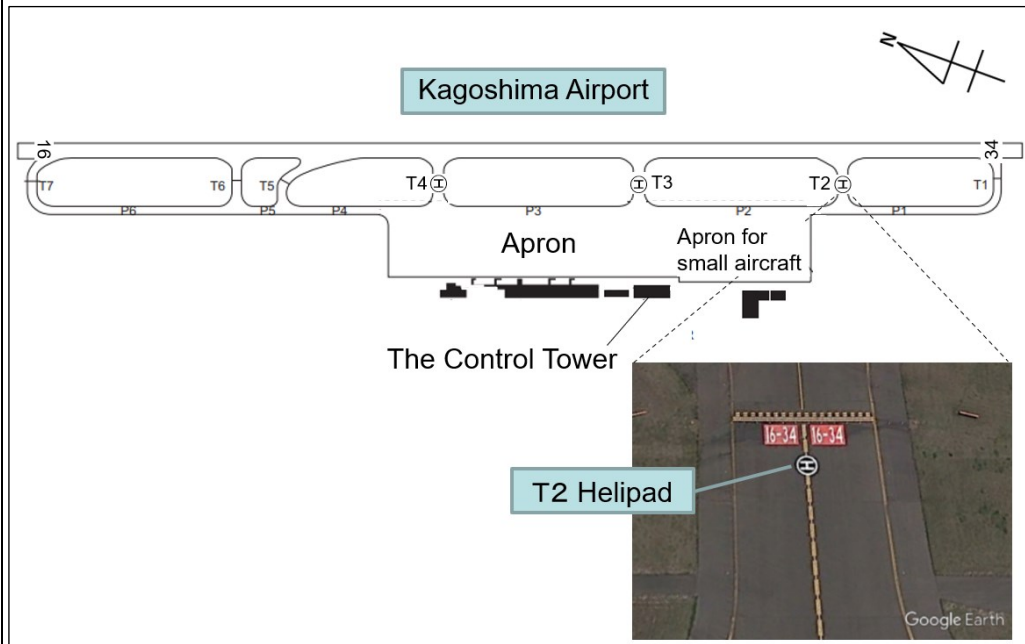
Figure 1: Layout of Kagoshima Airport and Photo of Taxiway T2

however, in case of traffic congestion on the runway, helicopters may use the Helipads set on Taxiway T2, T3 and T4.

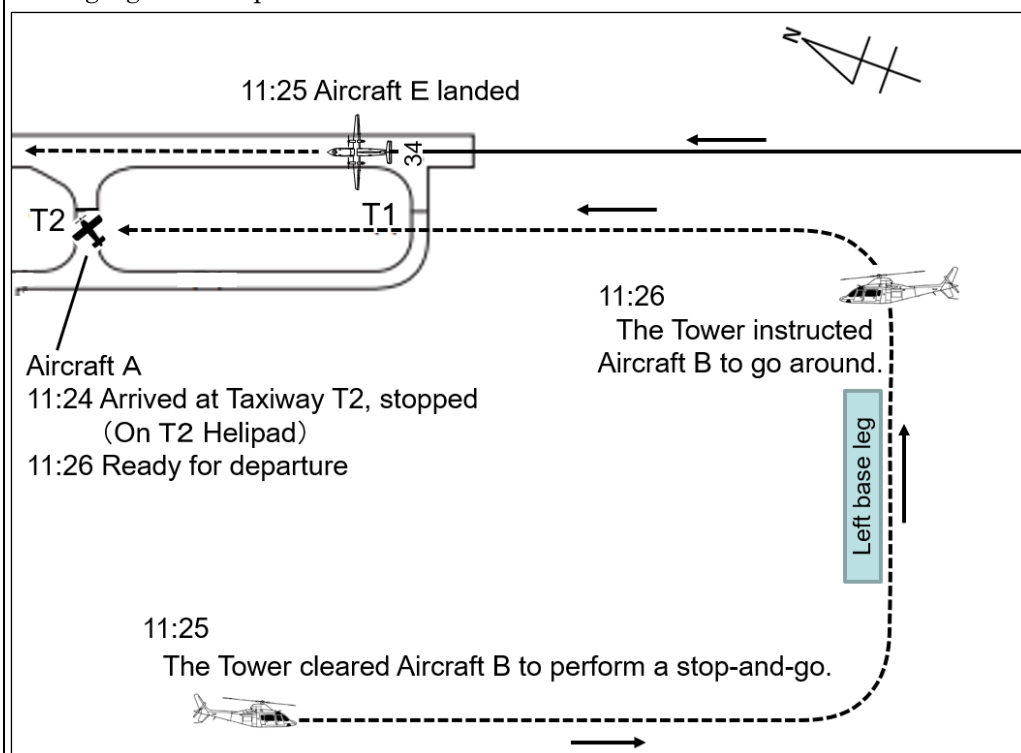
Figure 5: Position among Aircraft before and after the Occurrence of the Serious Incident

At 11:26, as receiving the report from Aircraft A that stopped on Taxiway T2 that it was ready for the take-off, the Ground instructed Aircraft A to establish communication with the Tower without informing the Tower about the presence of Aircraft A that was a departing aircraft. Upon the report from Aircraft A that it was ready for the take-off, the Tower recognized that Aircraft A was stopped on Taxiway T2. At that time, the PIC and the flight student of Aircraft B, who had listened to the radio communication from Aircraft A and visually confirmed Aircraft A that had stopped on T2 Helipad, had doubts about having been cleared to perform a stop-and-go by the Tower, and thought to check it. Immediately after that, the Tower instructed Aircraft B flying on the left base leg to execute a go-around.

The JTSC concludes that the distance between Aircraft A and Aircraft B was most likely approximately 1,420 m, when Aircraft B was instructed by the Tower to go around.
