**AIRCRAFT SERIOUS INCIDENT  
INVESTIGATION REPORT**

**PEACH AVIATION CO., LTD.**

**AIRBUS A320-214, JA802P**

**EMERGENCY OPERATION TO AVOID CRASH INTO WATER SURFACE**

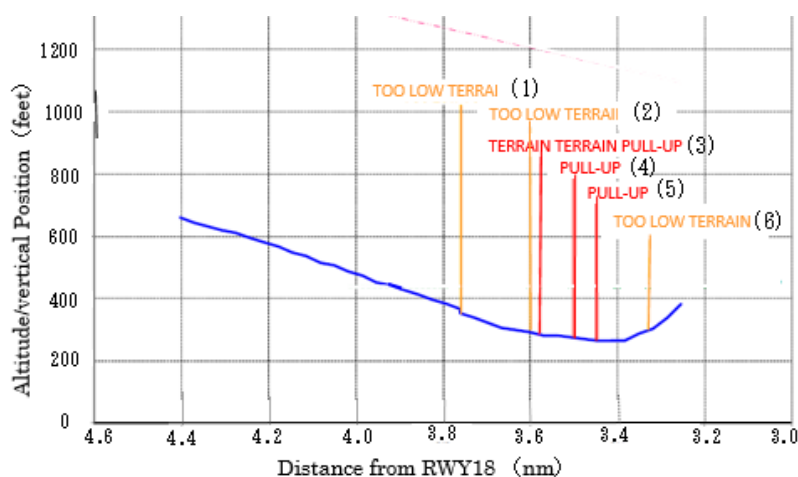
**Figure 12 Data Recorded in EGPWS (Distance Axis)**

Time Course	EGPWS	Number	Time
180000			11:47:25
190000	TOO LOW TERRAIN	(1)	11:47:26
200000			11:47:27
210000			11:47:28
220000			11:47:29
230000			11:47:30
240000	TOO LOW TERRAIN	(2)	11:47:31
250000	TERRAIN TERRAIN PULL-UP	(3)	11:47:32
260000			11:47:33
270000	PULL-UP	(4)	11:47:34
280000			11:47:35
290000	PULL-UP	(5)	11:47:36
300000			11:47:37
310000			11:47:38
320000			11:47:39
330000	TOO LOW TERRAIN	(6)	11:47:40
340000			11:47:41
350000			11:47:42

As described in 2.1.2 (1), the Captain stated that he did not hear the PULL-UP warnings when the serious incident occurred, but as described in 2.15.4, the FDR and EGPWS retained the records of the warnings and there is no system malfunction found; accordingly, it is highly probable that the warnings were issued.

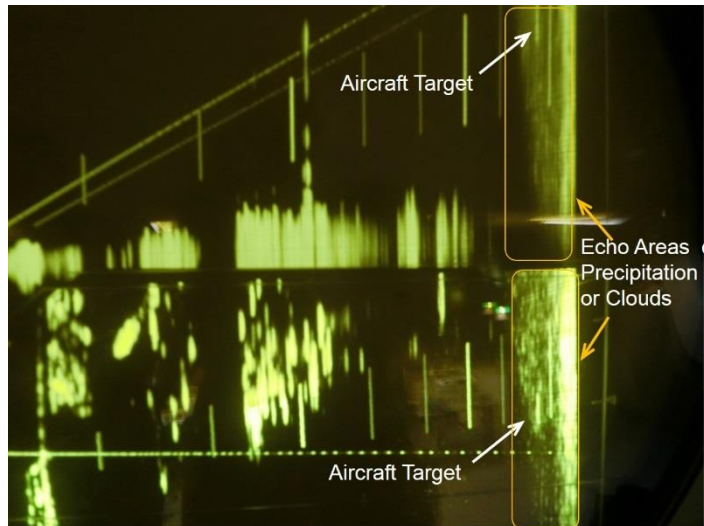
Photo 2-2. Example of PAR Screen in Bad Weather.

Moreover, since the final approach area of PAR approach was a bad weather condition when the serious incident occurred as described in 2.6, it is probable that some radar echoes of precipitation areas like Photo 2-2, Section 2.19.2 (4) was appeared in the PAR Screen. It is probable that advanced skills were required for the Final Controller to identify the aircraft target depending on weather conditions.

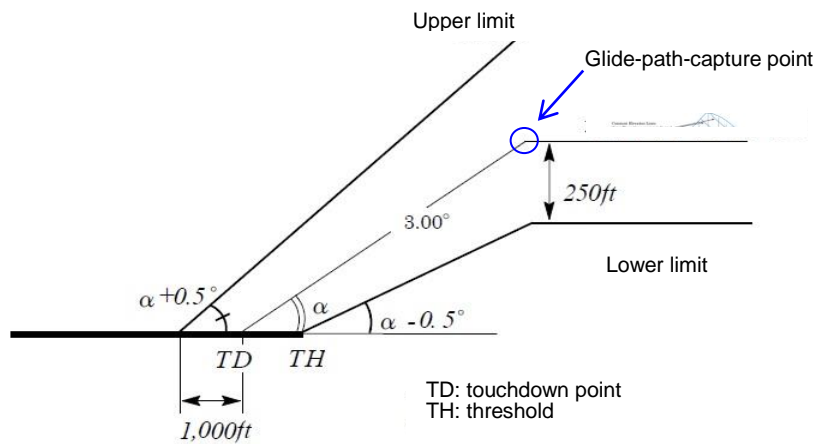
**Figure 15 Radar Safety Zone**

As described in 3.10.1, it is probable that depending on weather conditions at that time, it was not easy for the Final Controller to instantly notice that the Aircraft was descending and deviating below the Radar Safety Zone. As described in 3.10.2, Standards for Air Traffic Control Procedure stipulates that a final controller should take necessary actions in case that he or she notices aircraft under his or her control of deviating from the Radar Safety Zone. Nevertheless, the Naha Ground Controlled Approach Facility did not provide any educations or trainings to prepare for an event in which an aircraft before meeting glide-path-capture point began descent without any Controller's instruction. In addition, as described in 3.10.3, since any procedures taken by the Controllers are not stipulated when an LA issued to aircraft in Zone B, it is probable that when the serious incident occurred, the Controllers at the Naha Ground Controlled Approach Facility dealt with an unregulated and unexpected event based on their own immediate judgment. However, it is probable that the phrase the Final Controller used for the Aircraft was not appropriate for notifying it of deviation of the altitude.

(2) Adding a line on the PAR screen in the newly developing system which shows the lower limit of Radar Safety Zone in the part before beginning final descent is in the process.

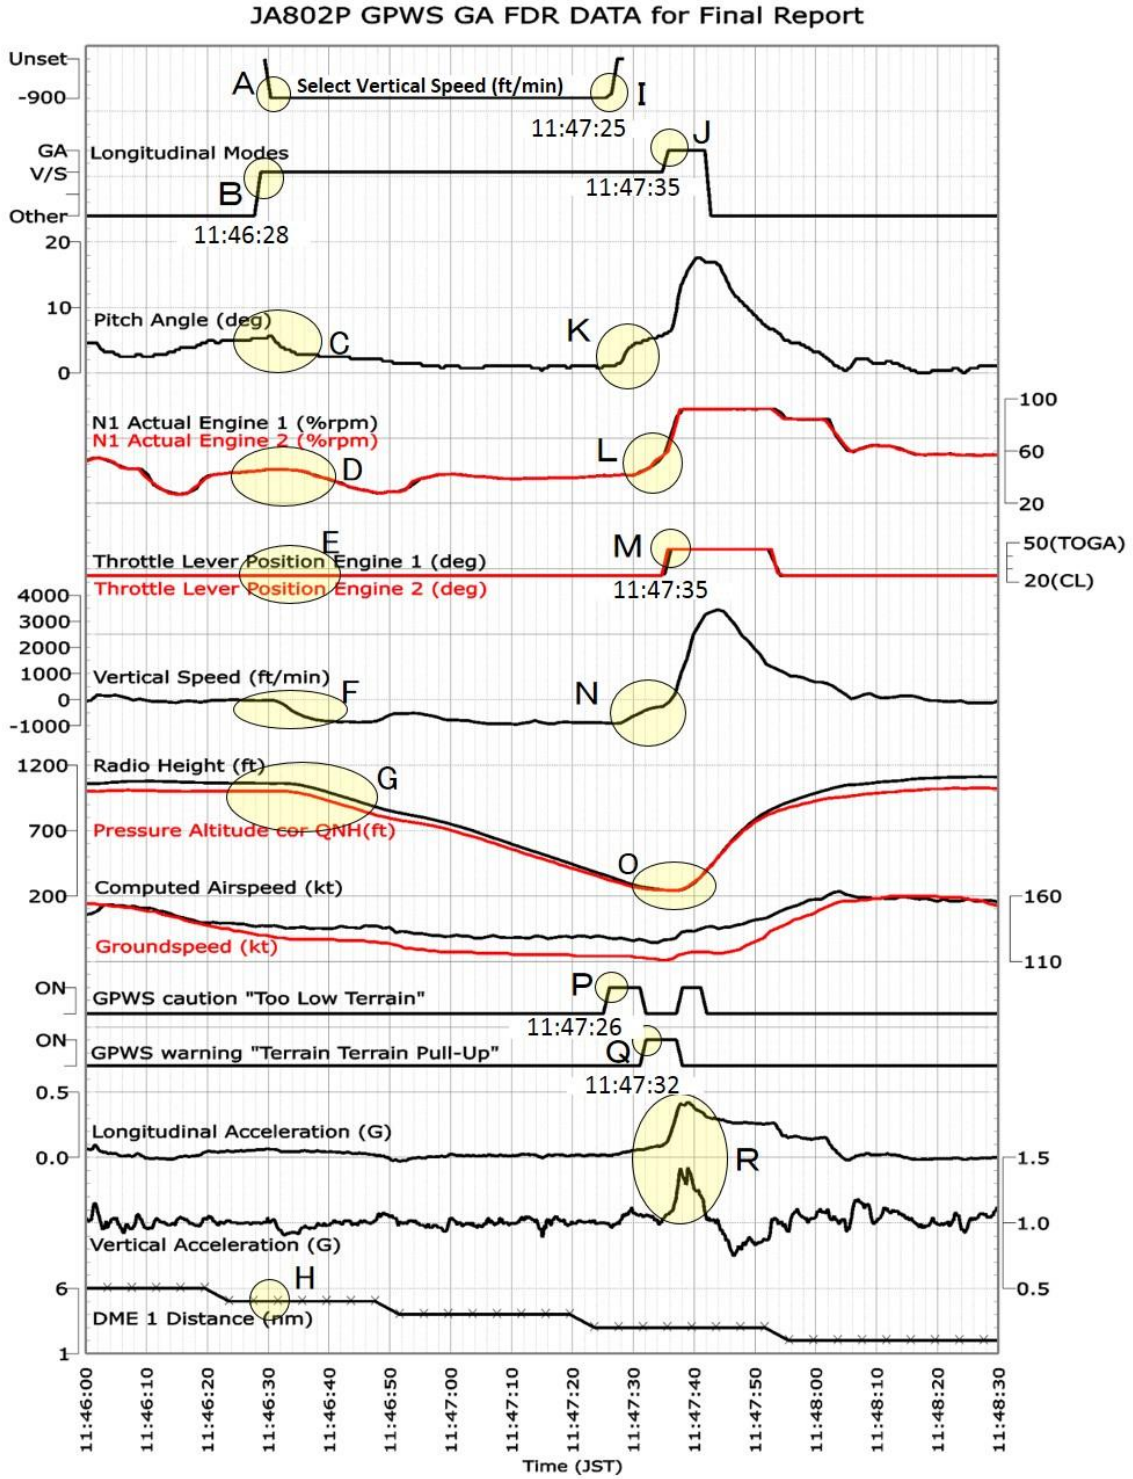
# Appended Figure 3 FDR Records

Afterward, as shown in **Table 1**, the Selected Vertical Speed - 900 fpm which was kept until 11:47:25 changed to - 800 fpm at 11:47:26, 0 fpm at 11:47:27. According to the manufacturer, the changes of the Selected Vertical Speed probably caused by pushing VS knob. After that, the pitch of the Aircraft began to increase [K], the vertical speed began to decrease [M], and the thrust of the Aircraft began to increase [L].

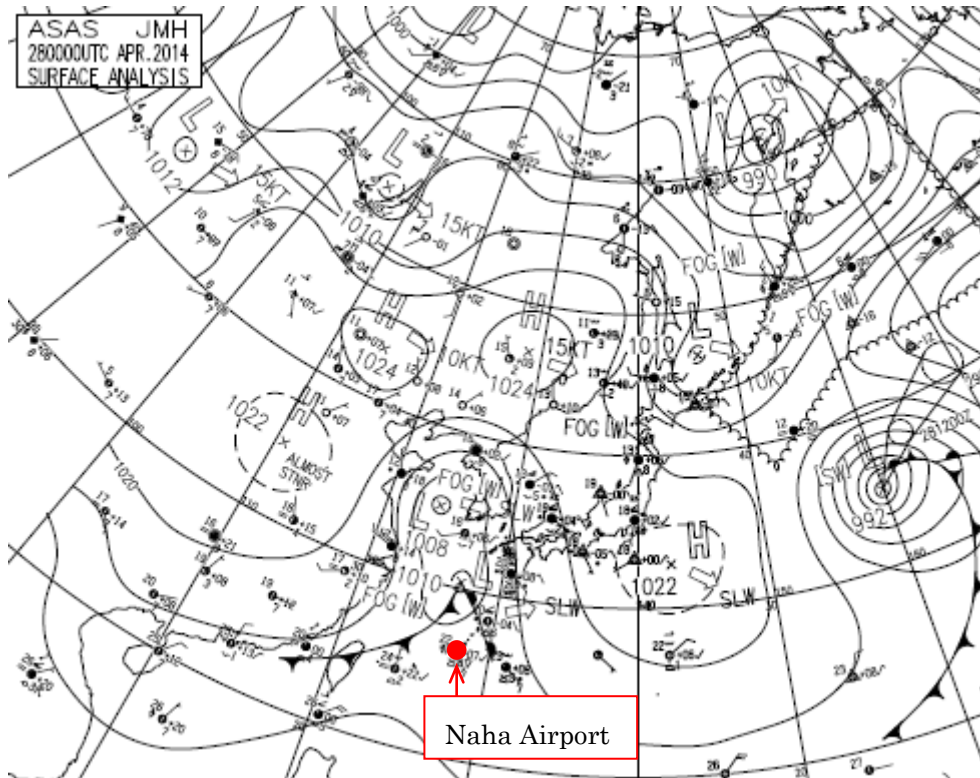
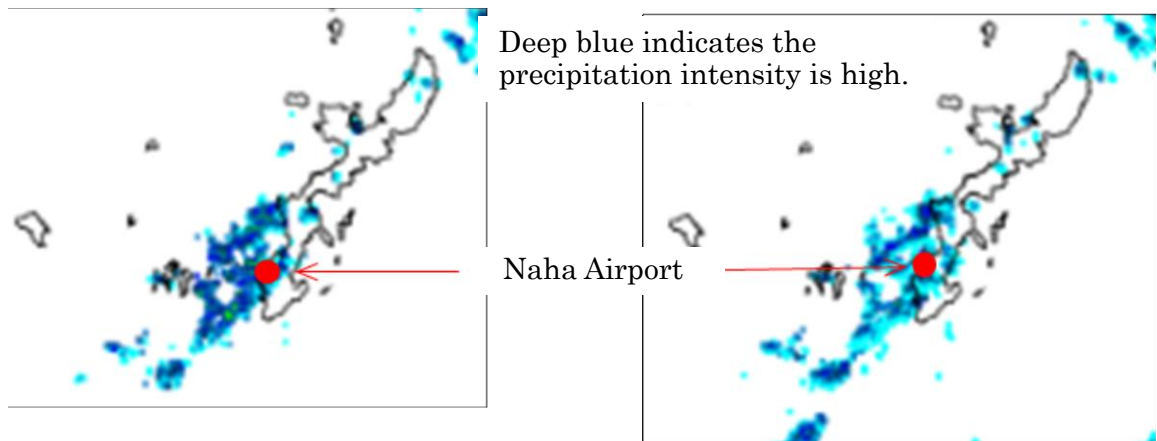
## Appended Figure 4 Meteorological Information

As described in **Appended Figure 4**, it is probable that the front system lay around the main island of Okinawa and the final approach course of RWY 18 at the Airport was covered with radar echoes at the time of occurrence of the serious incident. As described in 2.6.2 regarding the weather condition at the Airport around 11:30 through 12:00, the visibility was getting worse, clouds were growing and cloud bases were coming lower.

Consequently, when the serious incident occurred, it is somewhat likely that the meteorological conditions at that time was one of contributing factors for delay in the recognitions of the Captain and the First Officer of the Aircraft's descent.
