**AIRCRAFT SERIOUS INCIDENT
INVESTIGATION REPORT**

ALL NIPPON AIRWAYS CO., LTD.

J A 8 0 4 A

**EMERGENCY EVACUATION USING SLIDES
ALL NIPPON AIRWAYS CO., LTD.
BOEING 787-8, JA804A
TAKAMATSU AIRPORT
AT 08:49 JST, JANUARY 16, 2013**

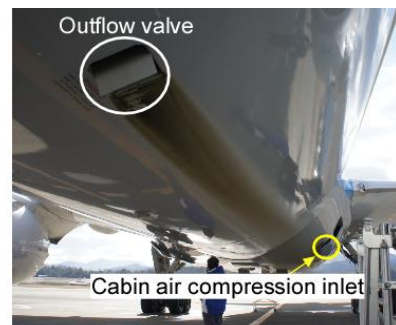
Fig. 2.8.3-1: Conditions Downstream of Outflow Valve

Dark green/black deposits coated inside wall of air ducts downstream of forward EE bay and fuselage skin downstream of the Override Valve and Outflow Valve. There was no trace of fire

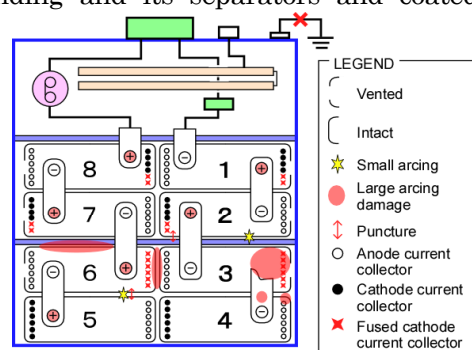
Fig. 2.8.3-4: Battery Damage

Fig. 2.8.3-4 illustrates the summary of battery damage. Cathode current collectors were fused except cells 4 and 5. All cell windings were heat-damaged and this denied to identify the

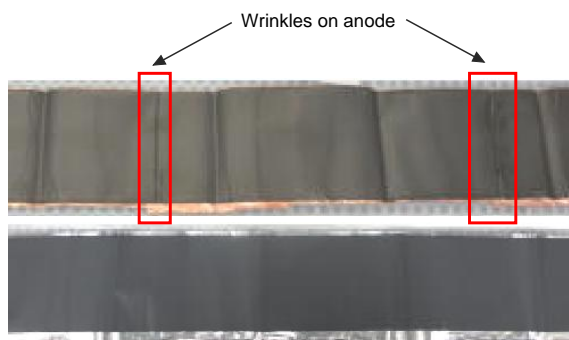
Fig. 2.11.2: Anode (top) and Cathode (bottom) from a Dismantled Cell

It is noted that wrinkles were found in the anode of dismantled cells, but not on the cathode.

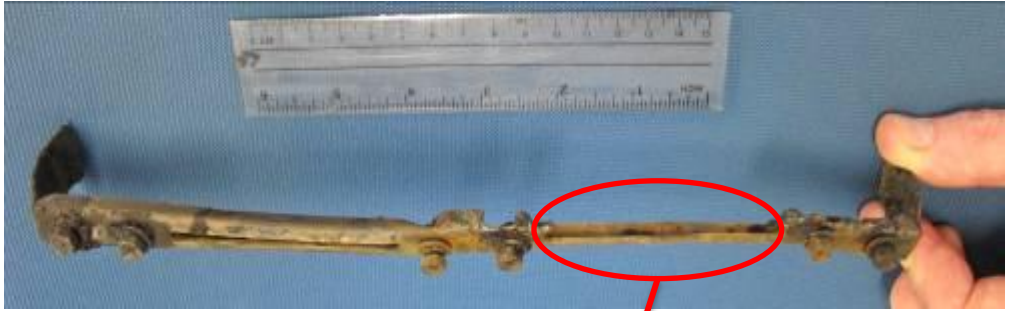
Part of this portion was welded to the cell case.

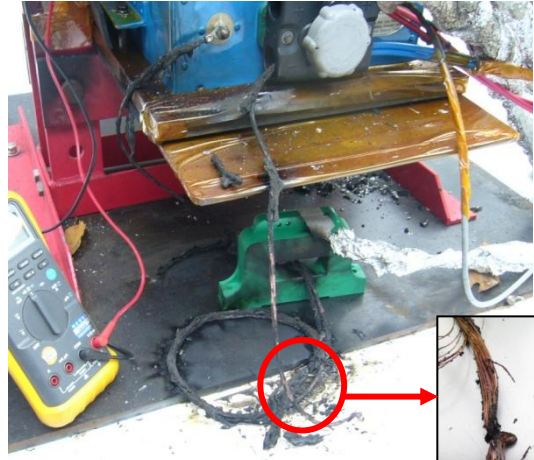
Fused ground wire
