December 2, 1994

**Aircraft Accident  
Investigation Commission  
Ministry of Transport  
Japan**

AIRCRAFT ACCIDENT  
INVESTIGATION REPORT

All Nippon Airways  
Boeing 747-400, JA8096  
Tokyo International Airport  
May 2, 1993

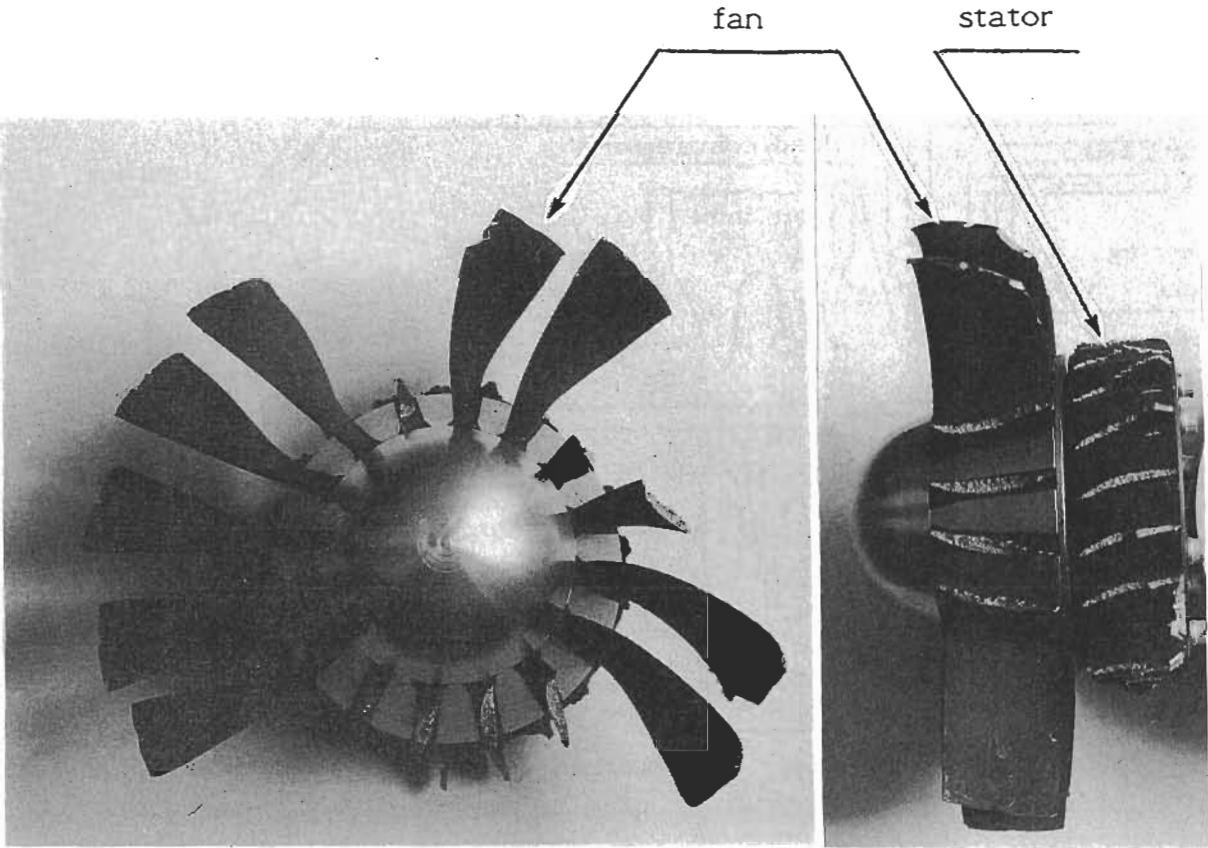
Photo. 1 Fractured Turbo-fan (right-side Turbo-fan of upper air chamber of upper-deck right-side escape slide)

- (1) The stator of the right turbo-fan of the upper air chamber was found fractured and fan and turbine separated from each other. (see Photo.1 )
- (2) The fractured fan is rotatable not being stuck.

- (3) Investigation of fractured surface of the fractured fan and the stator showed no evidence of fatigue.
- (4) 17 brakes (maximum 8 cm in length) and more than 10 pin holes were found on the upper air chamber near the place where the right turbo-fan which was fractured is connected.

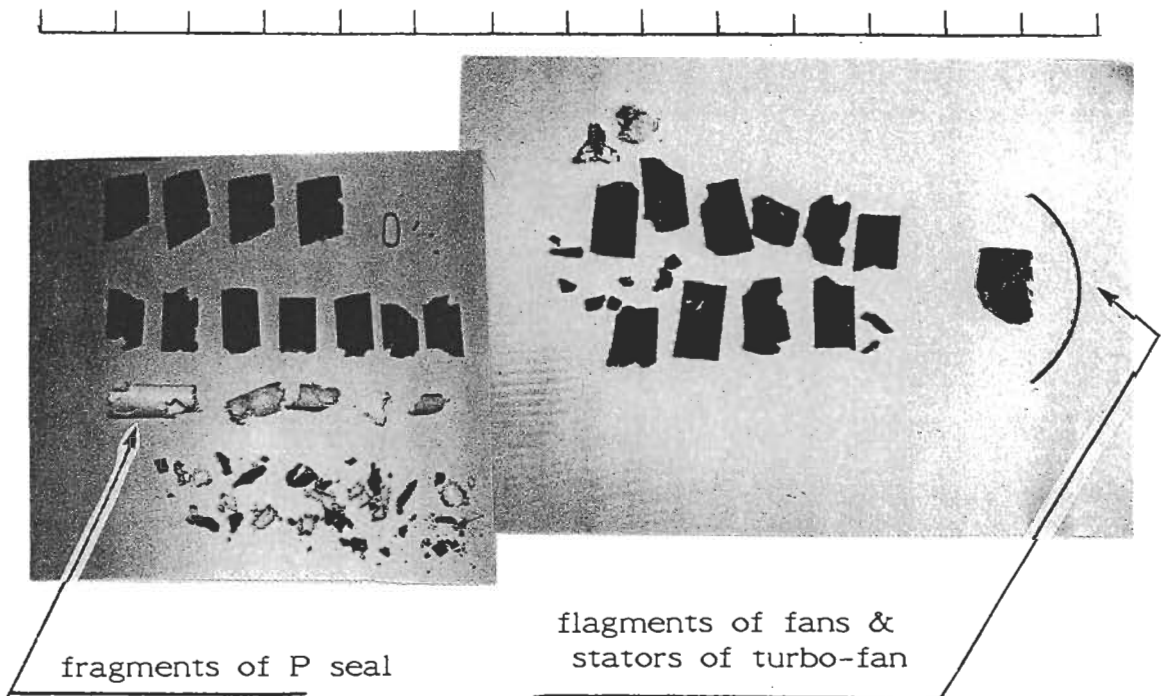
Photo. 2 Fragments of fractured Turbo-fan  
found in the upper air chamber

- (5) Inside of the upper air chamber were found fragments of fan, fragments of stator, and fragments of P seal (P-shaped seal of silicon rubber) attached to the bottom of the facial panel on the side of the cabin side of the escape slide. (see Photo.2 )  
Investigation of the facial panel indicated loss of the P seal.

fragments of P seal

fragments of fans &  
stators of turbo-fan

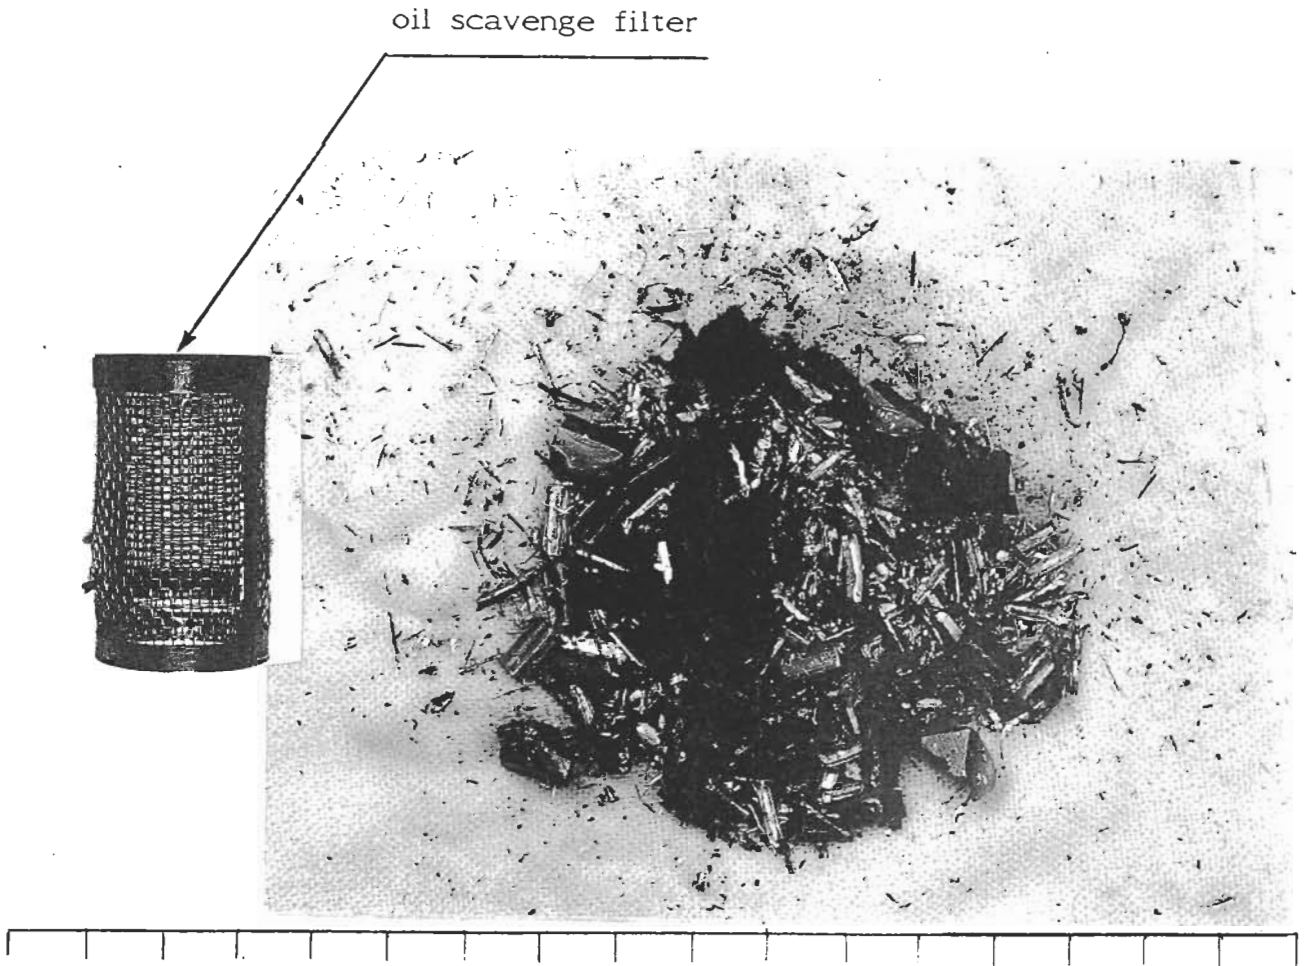
Photo. 4 Metal Fine Flakes found on Oil  
Scavenge Filter of APU Load Gearbox

(1) The input drive gear, the cooling fan idler gear, and the cooling fan drive gear were found fractured. Metal chips and flakes were found on the oil scavenge magnetic chip detector located at the bottom of the gearbox case. The oil scavenge filter at the bottom was found clogged by a lot of metallic fine flakes and whiskers accumulated on it. A small amount of metallic flakes gathered in the gearbox, and there were scratches found on the inner wall.

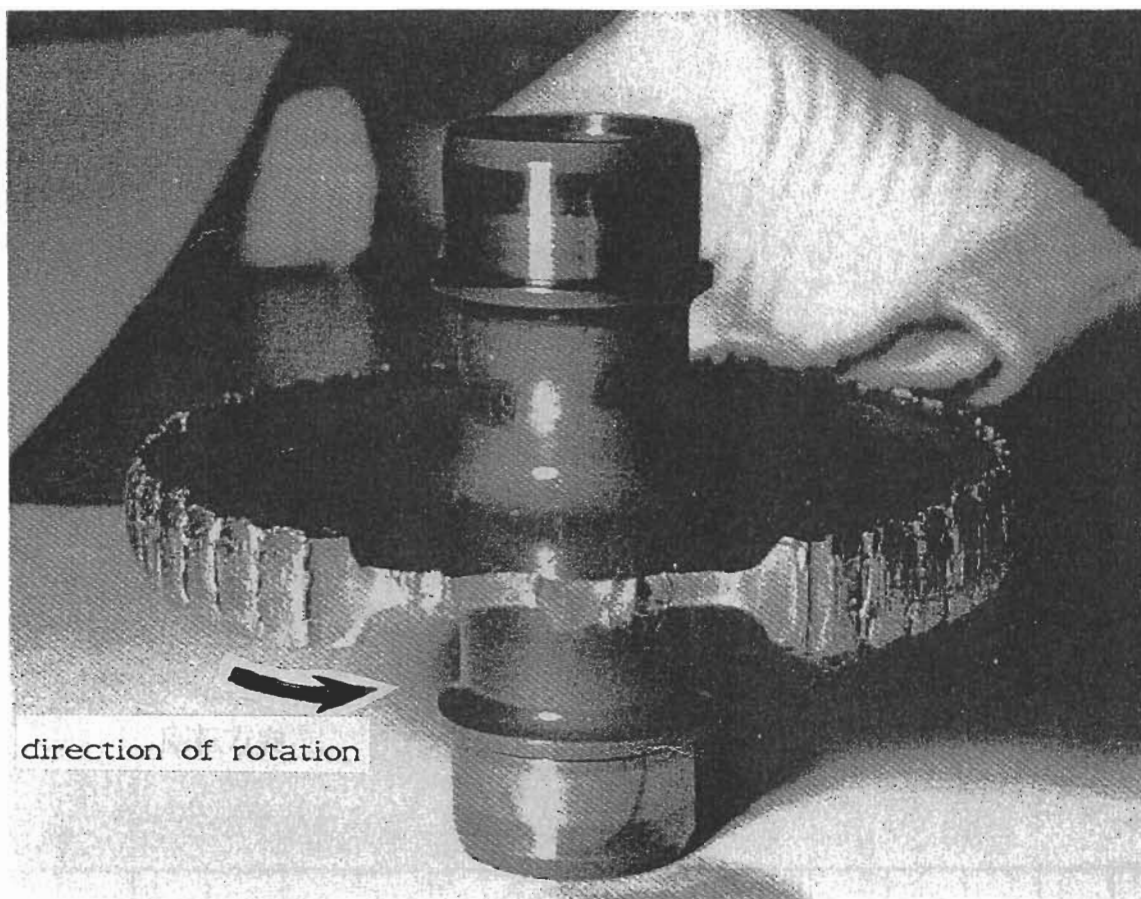
Photo. 5 Fractured Cooling Fan Idler Gear

(3) An outer part of the cooling fan idler gear (47 teeth) web was fractured

circumferentially for the length of 5 cm, or equivalent of 8 teeth. Seven of the missing 8 gear teeth were found in the metal flakes on the scavenge filter or those within the gearbox.

(4) Three bolts attaching the retainer of the roller bearing at the forward side of the cooling fan idler gear shaft were found loosened, but there were no irregularities on the bearing or the tab washers securing the bolts.

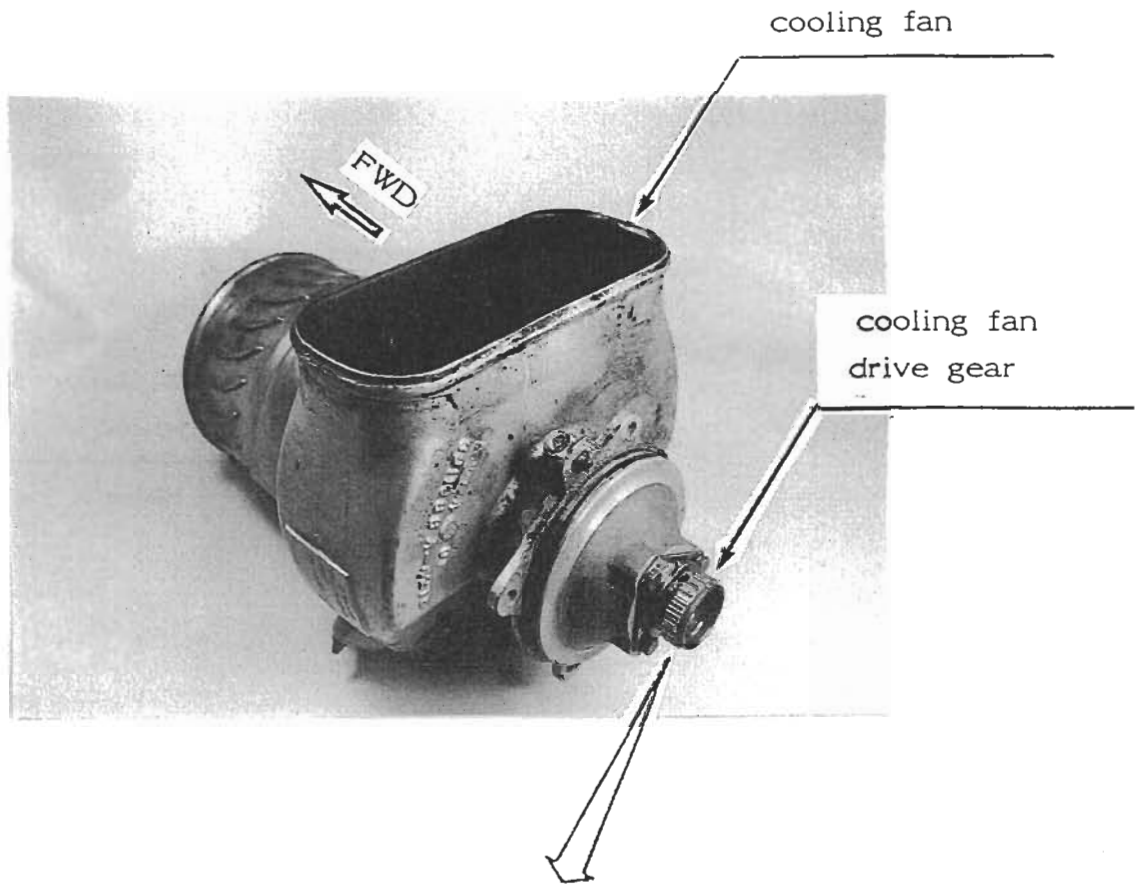
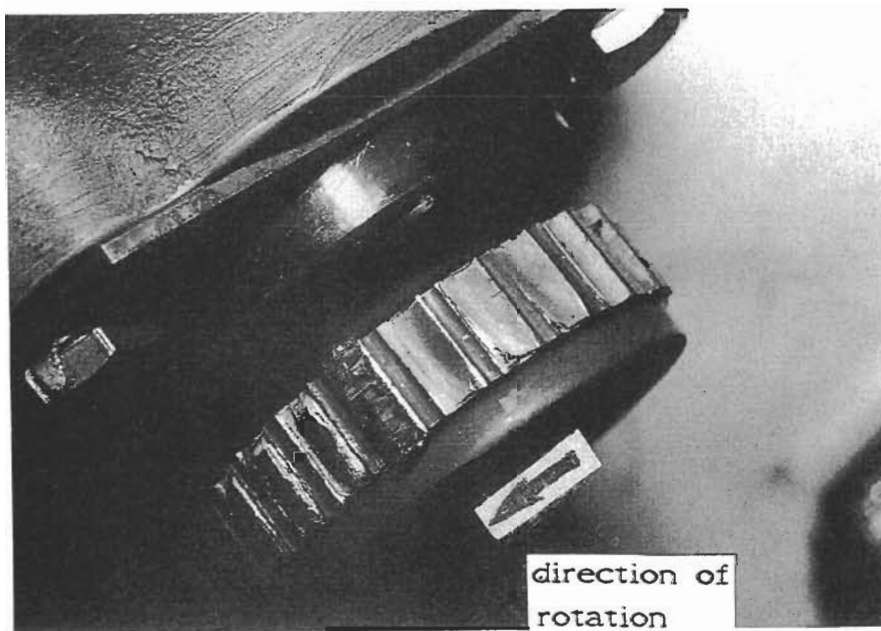
Photo. 6 Fractured Cooling Fan Drive Gear

(5) All the teeth (24 each) of the cooling fan drive gear, which meshes with the cooling fan idler gear, were found fractured at their root. Twenty flakes corresponding to 20 out of the 24 teeth were found in the flakes either on the scavenge filter or in the gearbox case.

(6) Two out of the three bolts attaching the aft roller bearing retainer at the aft end of the cooling fan drive gear shaft were found loosened, but there were no irregularities on the bearing itself or the tab washers securing the bolts.

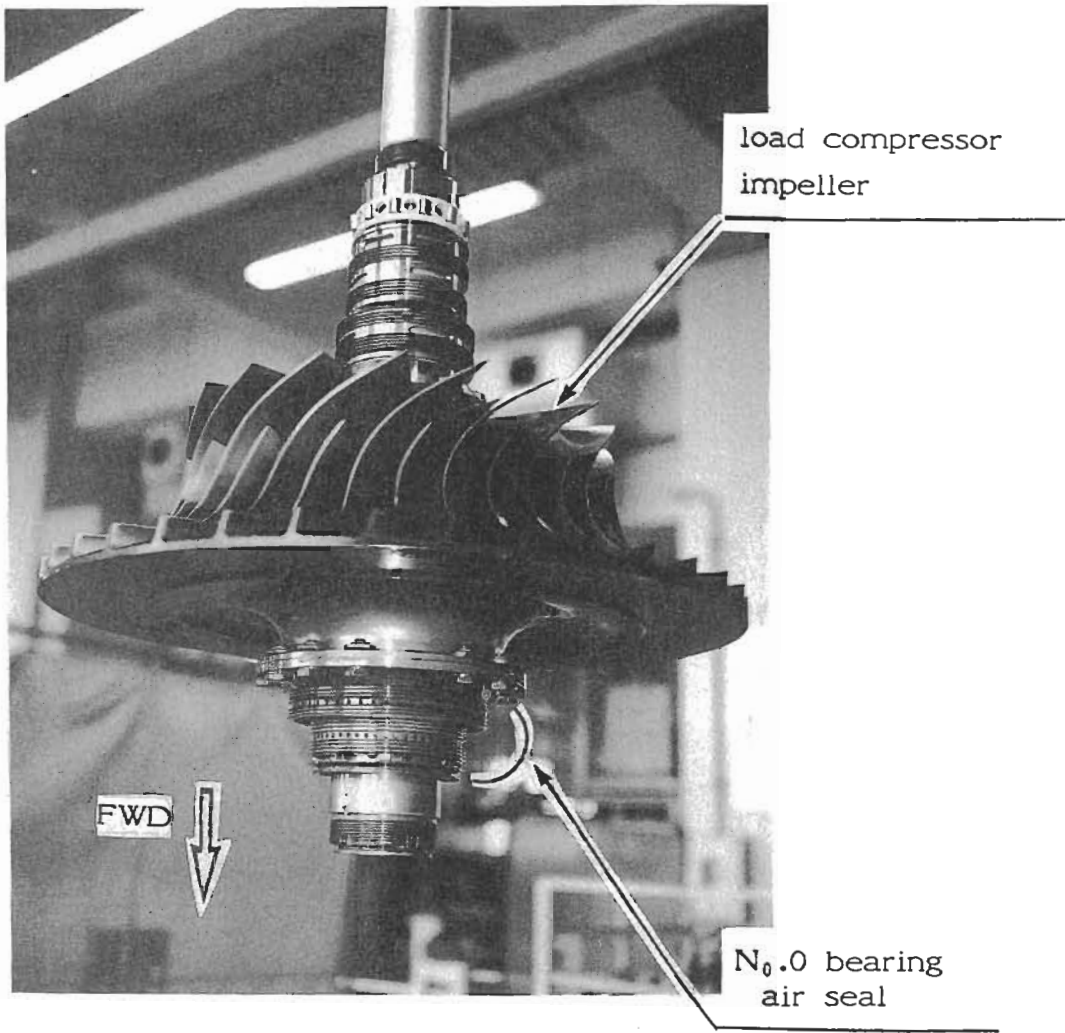
Photo. 7 No.0 Bearing Air Seal

(1) The No.0 bearing air seal located between the load gear box and the load compressor was found intact but was heavily wetted with oil. (see Photo.7)

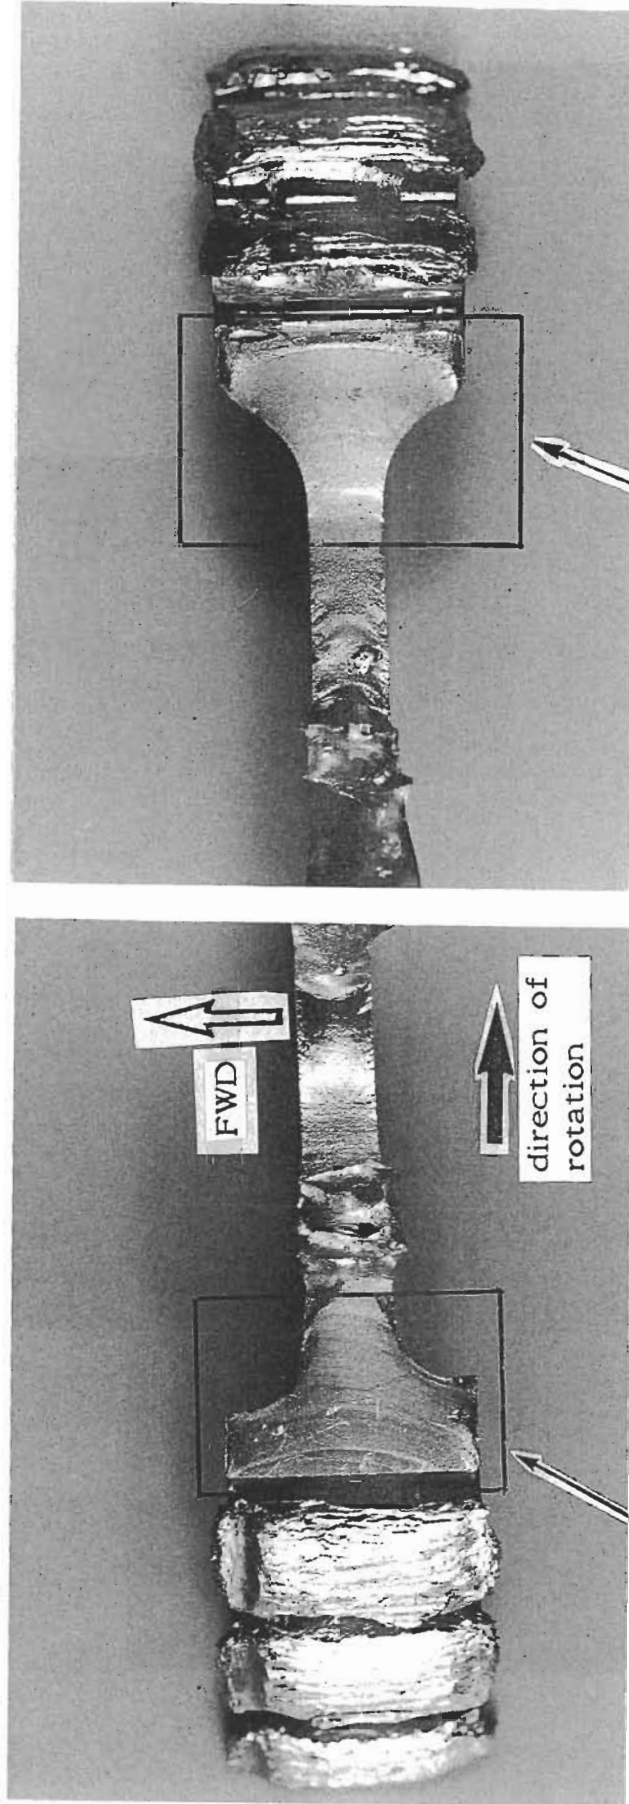
Photo. 8 Fractured Cooling  
Fan Idler Gear

Beach marks were found in two locations on the fracture surface of the gear web as well as of the corresponding teeth separated from the gear. The beach marks were found originated from the trough of the tooth and propagated to the direction of rotation.

Evidence of fatigue (with and without beach marks), having propagated toward the direction of rotation, were found at seven areas on the gear at the roots of fractured teeth. The same was found on the corresponding surface of the separated teeth. Other parting surfaces were either scored circumferentially or crushed/smeared.

The insufficient hardness is presumed to have been caused by an improper surface hardening process.

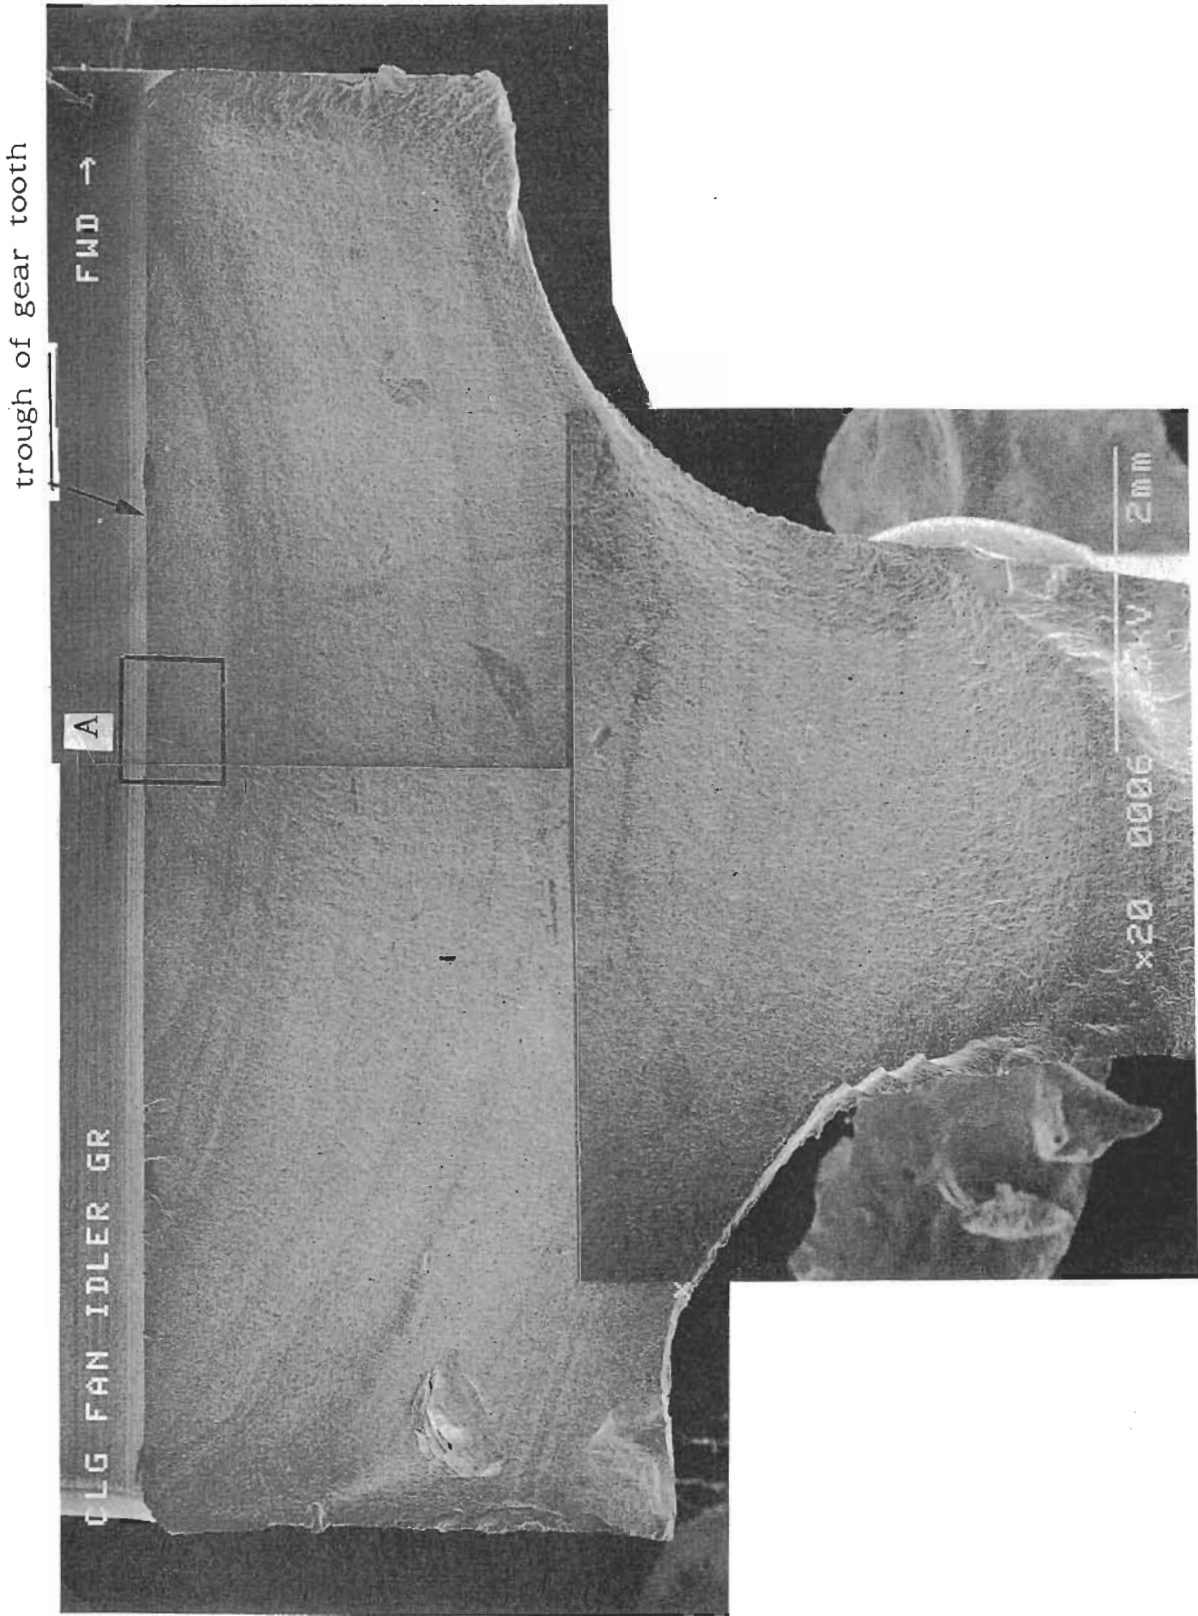
Photo. 9 SEM View of Fractured  
Cooling Fan Idler Gear

Defects in machining, material or other kinds was not found by SEM inspection at and around the points of origin.

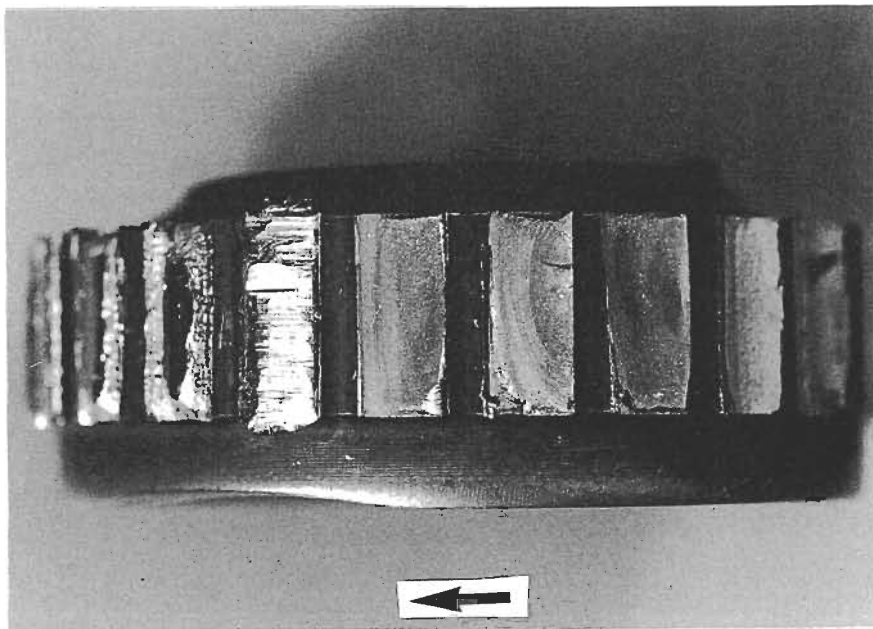
Photo.14 Fractured Cooling Fan Drive Gear

Defects in machining, material or other kinds was not found by SEM inspection at and around the points of origin.
