**AIRCRAFT SERIOUS INCIDENT
INVESTIGATION REPORT**

PEACH AVIATION CO., LTD.

J A 8 1 1 P

**PEACH AVIATION CO., LTD.
AIRBUS A320-214, JA811P
ATTEMPTED LANDING ON A CLOSED RUNWAY
ABOUT 5 NM EAST OF TOKYO INTERNATIONAL AIRPORT
AROUND 480FT AT 00:39 JST, DECEMBER 22, 2016**

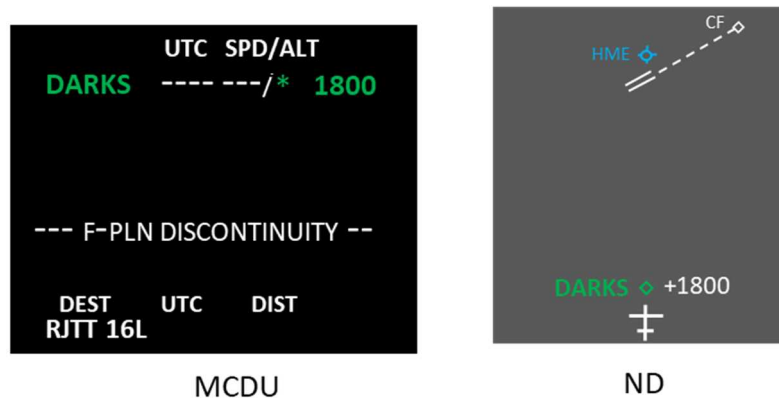
Figure 8 Estimated indication of MCDU and ND when passing DARKS
 (This drawing is for illustrative purpose only)

On the other hand, it is probable that the Captain and the FO ended up starting an approach without FMGC setting because VOR A approach procedure was not registered in Database. According to the statement of the FO, it is somewhat likely that when the Aircraft passes DARKS possible indications of MCDU and ND were imaged as shown in Figure 8.
