AI2005-3

AIRCRAFT SERIOUS INCIDENT INVESTIGATION REPORT

BETWEEN
JAPAN AIRLINES (present-JAPAN AIRLINES INTERNATIONAL)
FLIGHT 933
BOEING 747-100B SUD, JA8176
AND
US PACIFIC AIR FORCES, 5th AIR FORCE, 18 WG
McDONNELL DOUGLAS F-15C
(ONE OF A TWO-SHIP FORMATION)
A NEAR COLLISION OVER THE SEA APPROX. 12NM NORTH OF
NAHA AIRPORT, OKINAWA, JAPAN
NOVEMBER 5, 2003

May 27, 2005

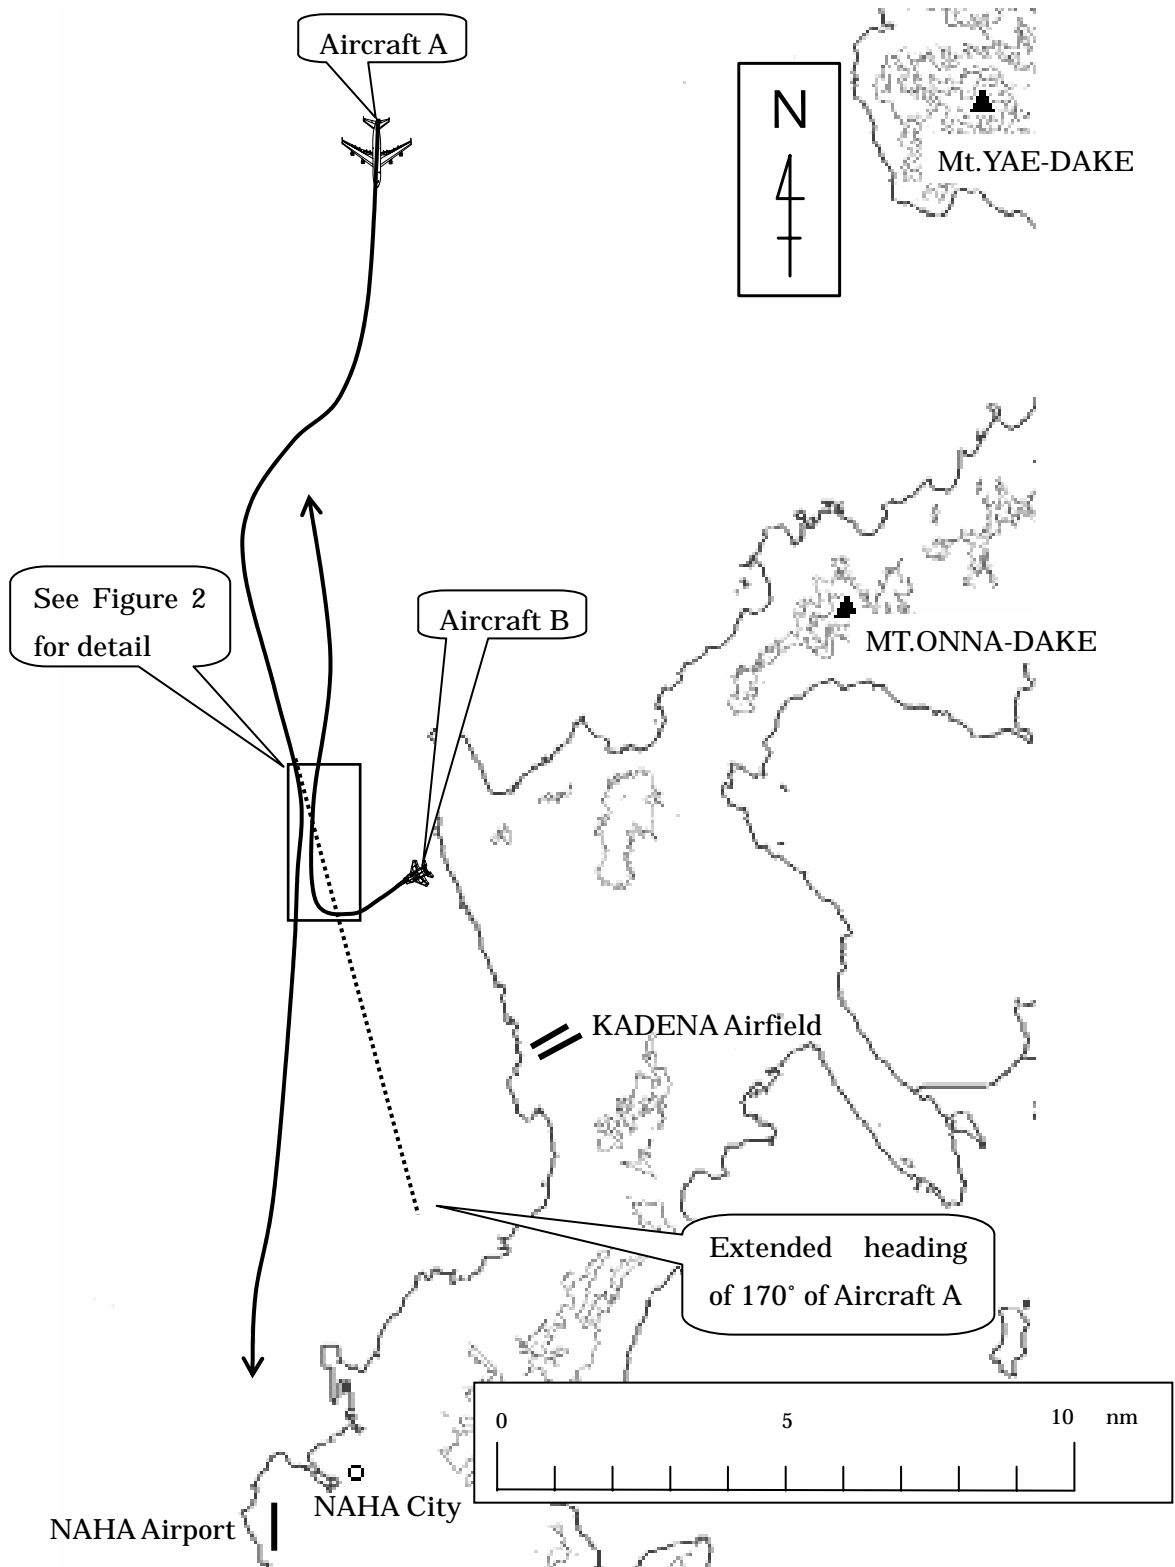
Figure 1-1 Presumed Flight Path

Note 1: Since Aircraft-A was flying on a heading of 170°, it is considered that the other aircraft appeared for Aircraft-A to be slightly right of straight ahead during a period since just before it started turning until it completed its right turn (see Fig.1-1.)

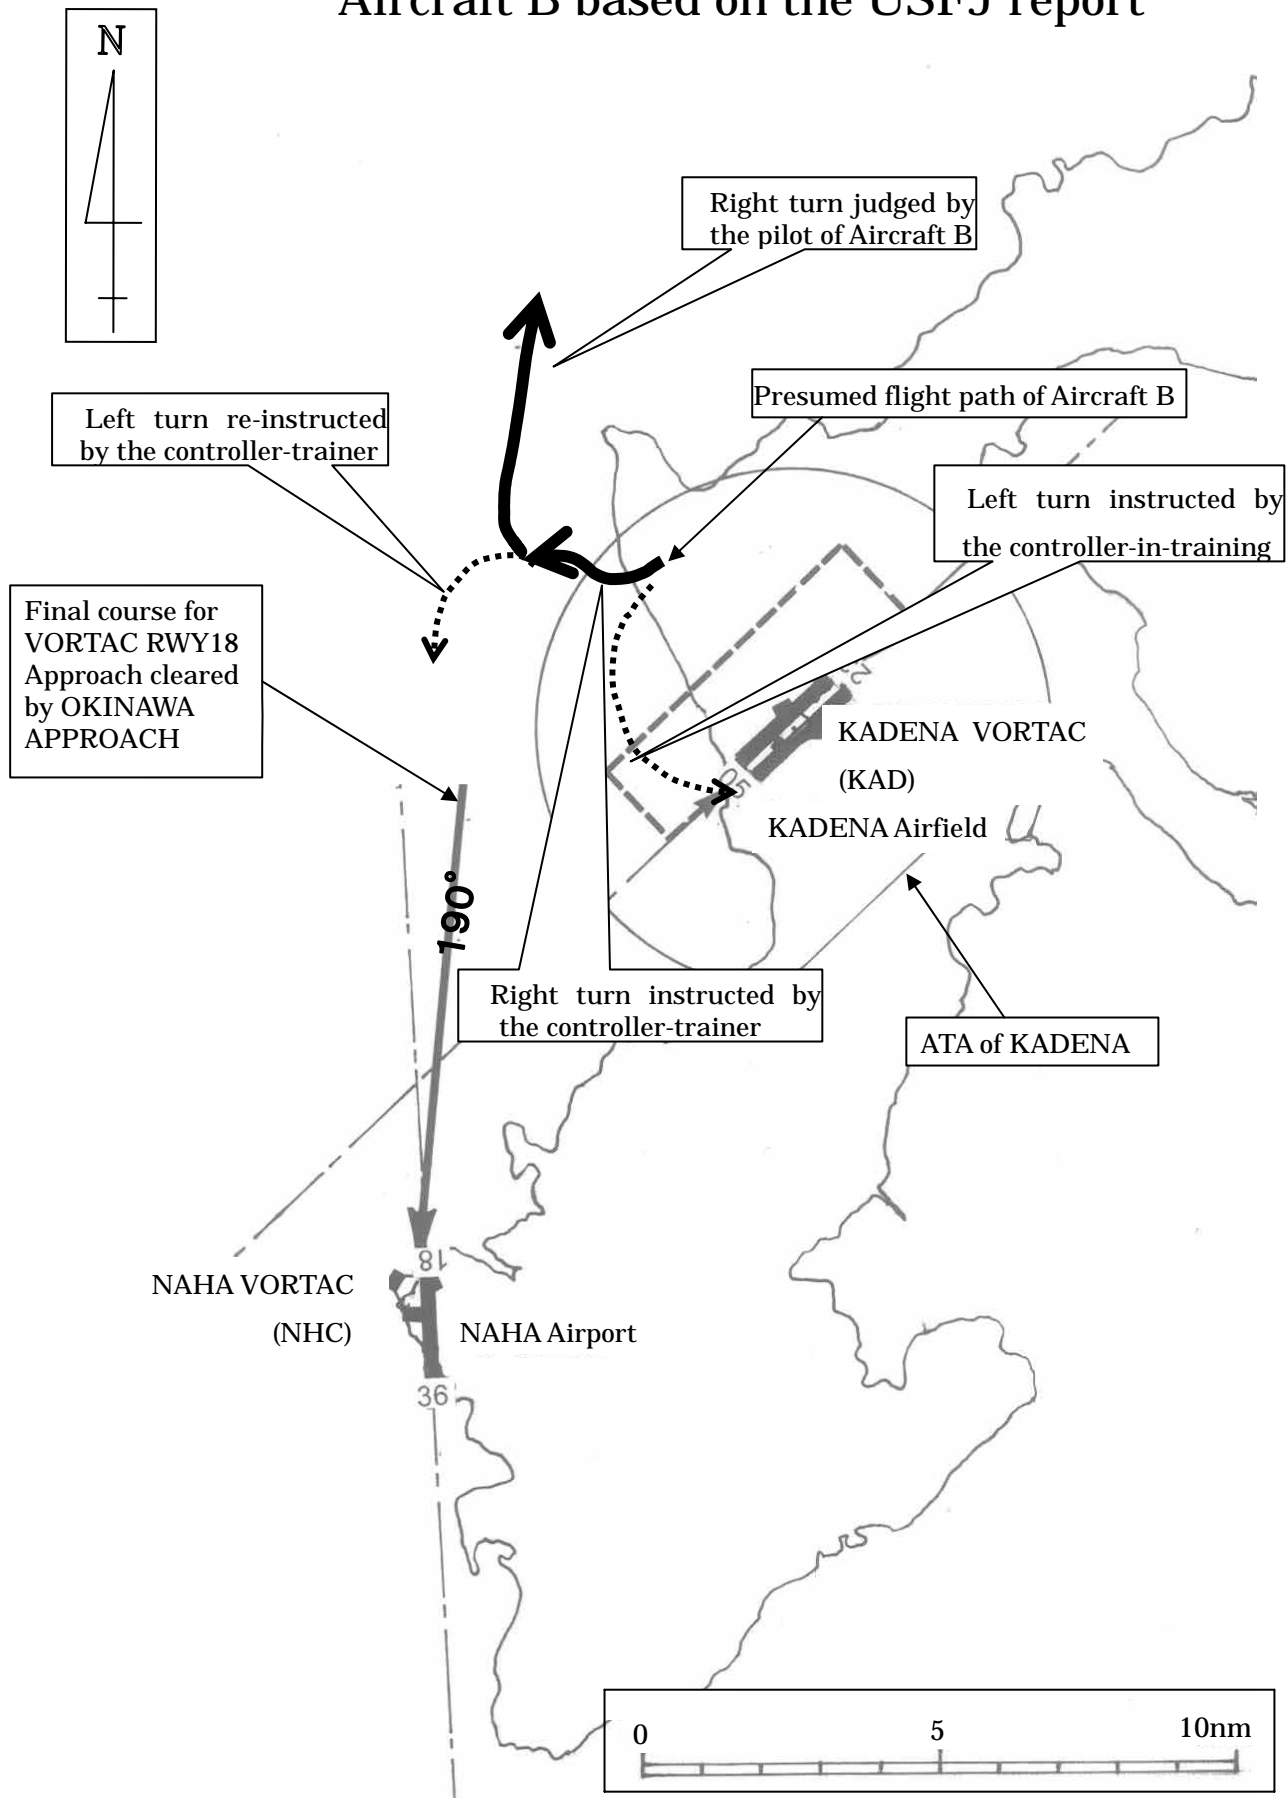
Figure 1-2 Detail of the presumed flight path of Aircraft B based on the USFJ report

According to the USFJ report, at around the time that Aircraft-B approached Aircraft-A, Aircraft-B made a left turn followed by a right turn and then a right turn again in a short period as instructed by the controller of Kadena Tower and by the pilot's own judgment. However, the flight path of those turns could not be clarified because there were no detailed radar data to verify those turns.

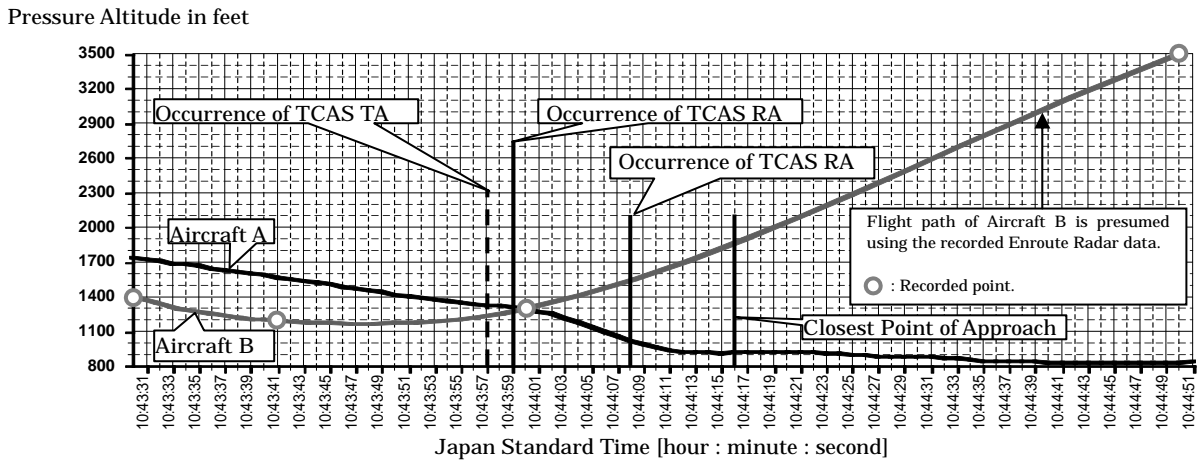
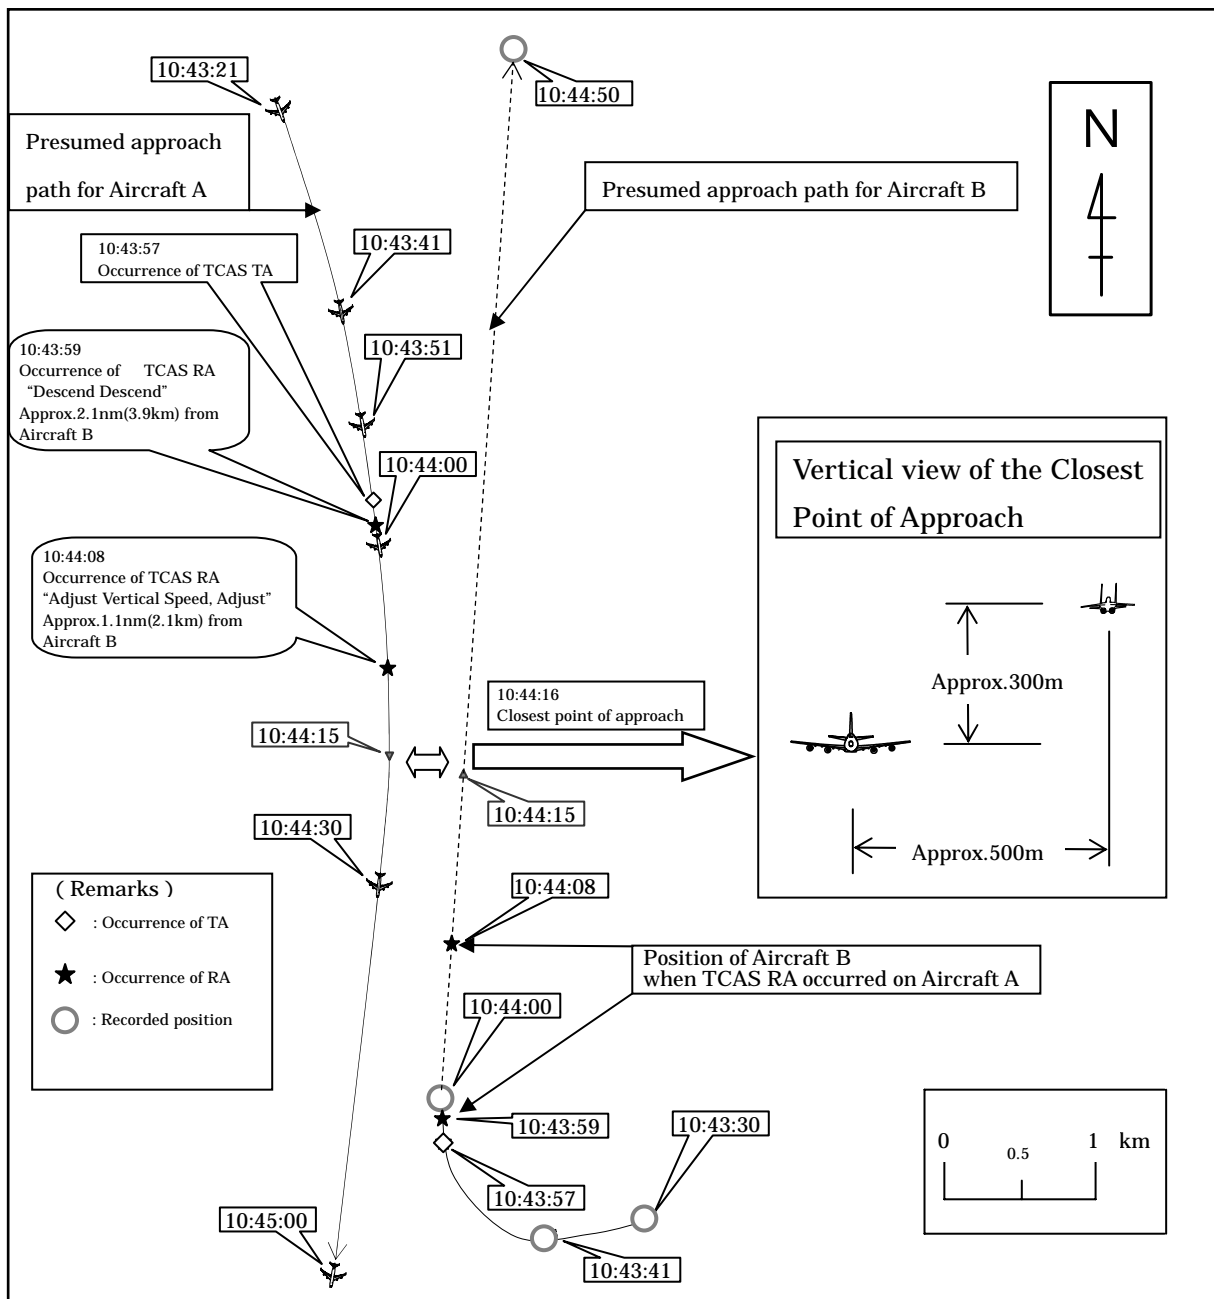
Figure 2 Presumed approach path for Aircraft A and Aircraft B based on ARSR and AIDS data

Altitudes and tracks for Aircraft-A were reconstructed based on the ARSR data and the corrected AIDS data. Altitudes and tracks for Aircraft-B were reconstructed based on the ARSR data. (See Figure 2)

At around 10:43:59 hrs, an RA 'descend, descend' was issued on Aircraft-A, and it is estimated that the distance between both of the aircraft was around 2.1 nm (around 3.9 km) at that time. According to the statement of the first officer, the time interval between the TA and the RA was short. According to the AIDS recordings, the RA was issued 2 seconds after the issuance of the TA. It is considered that this was because Aircraft-B had made a right turn in front of Aircraft-A to avoid it and so the condition for an RA to be issued was satisfied short time after the TA was issued.
