AA2006-3

AIRCRAFT ACCIDENT INVESTIGATION REPORT

JAPAN AIRSYSTEM FLIGHT 979
DOUGLAS DC-9-81, JA8297
STOPPED ON RUNWAY DUE TO LEFT MAIN LANDING
GEAR COLLAPSE
JANUARY 1, 2004

July 28, 2006

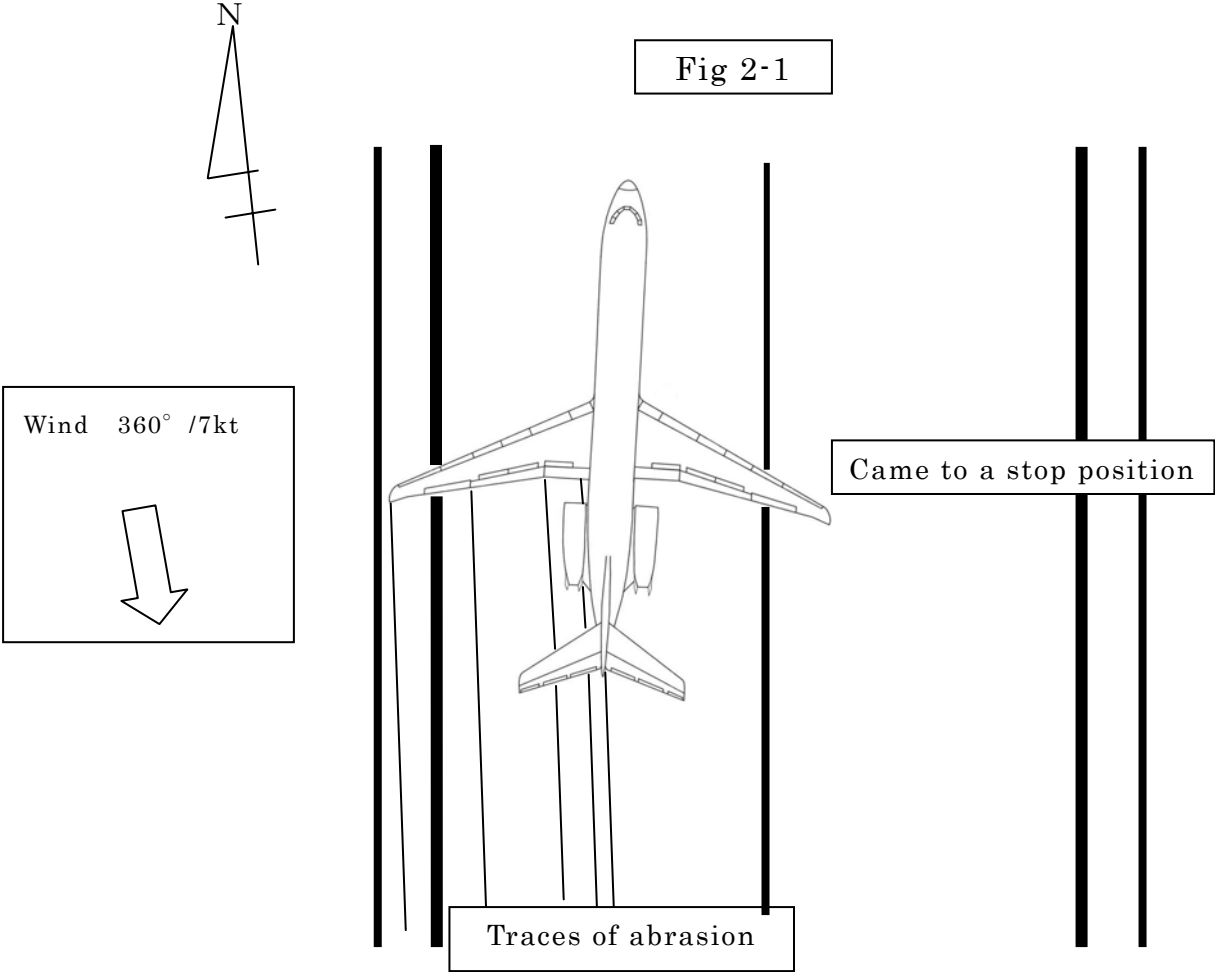
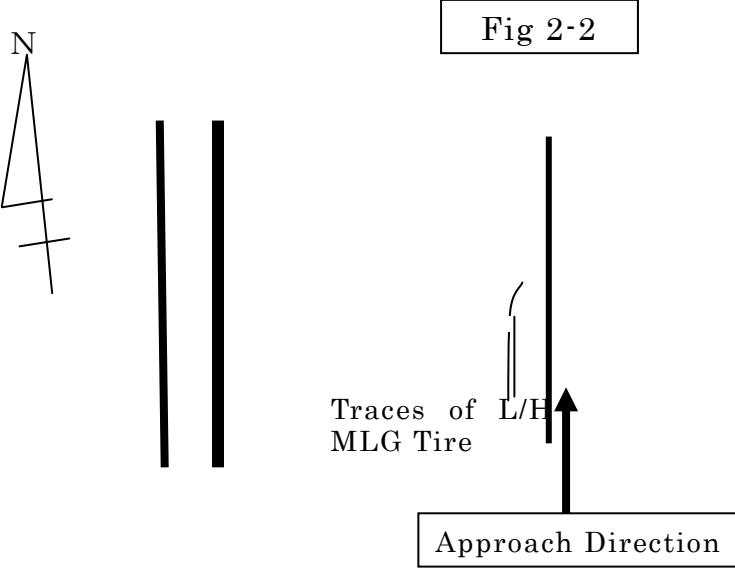
Figure 2 Traces on the Runway

The site of the accident was on the runway at Tokunoshima Airport. The aircraft came to rest around 1,750m from the threshold of runway 01. Traces of the left wheel tires of the left MLG were found on the runway around 570m from the threshold of the runway 01, and appeared as if they had been twisted to the right. One hundred meters further along, traces of the nose wheel tires and of left wing tip contact with the runway were found, and traces of the wing tip continued to the point at which the aircraft came to rest.

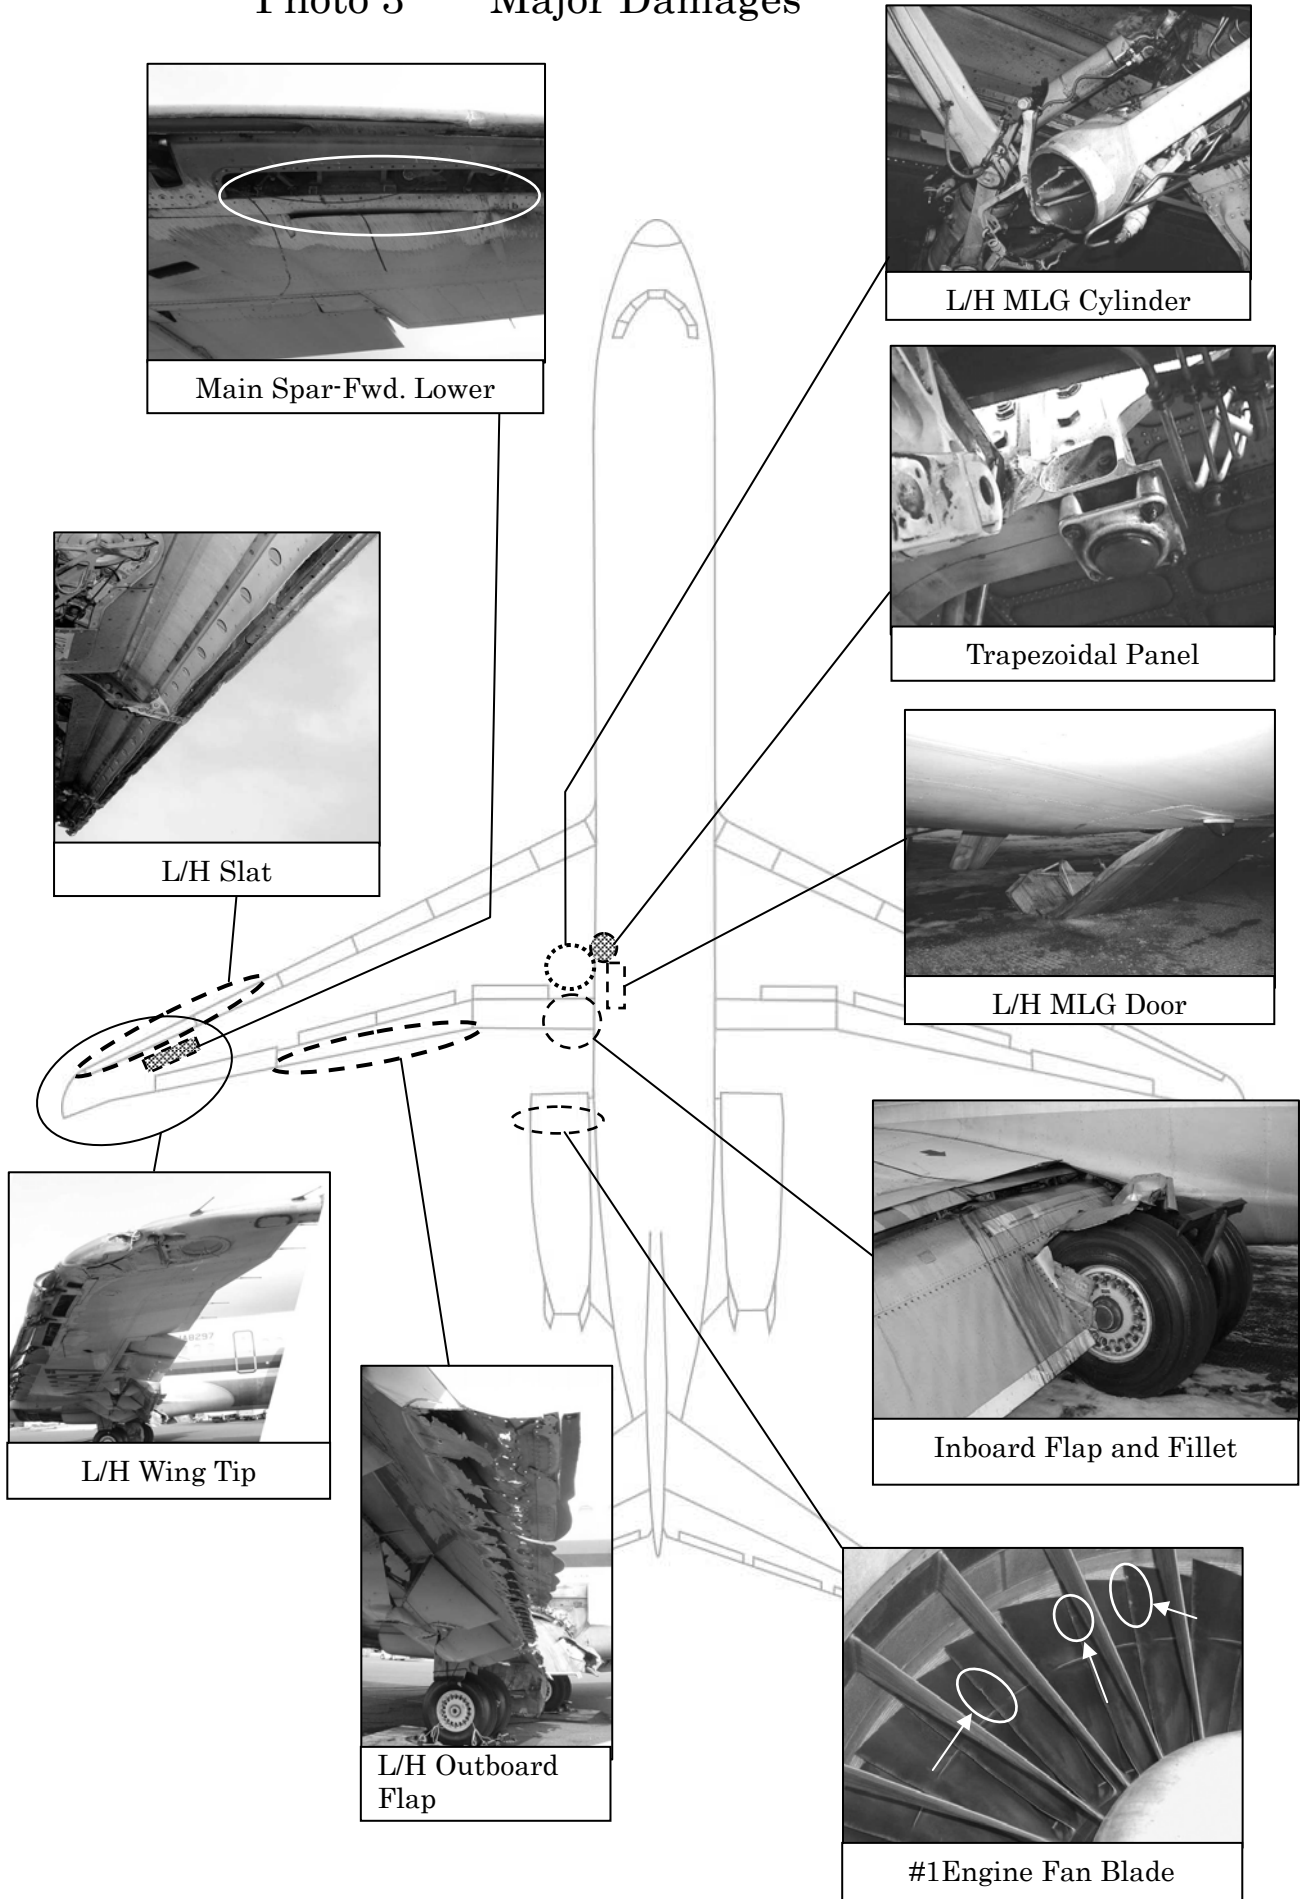
Photo 3 Major Damages

(1) Fuselage	
Trapezoidal panel *2	Damaged
Fillet between wing and fuselage	Damaged
(2) Left wing	
Front spar	Deformed
Leading edge slat, Flap, Lower skin, and Wing tip	Damaged
(3) Left main gear and surrounding area	
Shock strut cylinder	Broken into two pieces
Retract actuator, side brace	Deformed
Main wheel well inboard door	Damaged
(4) Left engine fan blades	Damaged
(5) Tail cone	Damaged

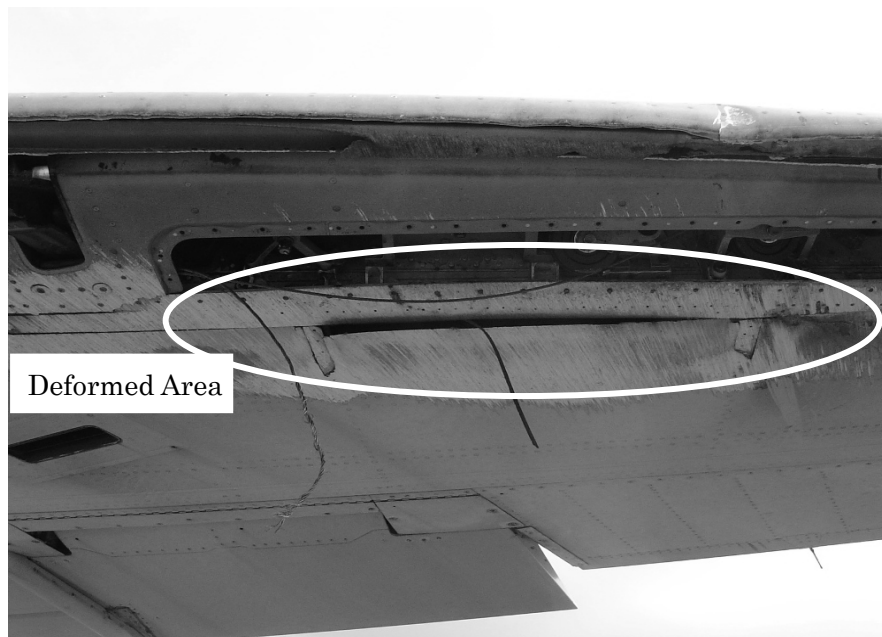
Photo 4 Deform of L/H Fwd Lower Spar

Because the left wing tip traveled in contact with the runway, parts of the left navigation light, wing lower skin panels, access panels, slat leading edge, flap trailing edge, flap track fairings, main wheel well inboard door etc. were damaged. Part of the front spar was deformed into a convex shape over an approximately 85cm area, with a maximum deformation of 9mm at a point 3m inboard from the wing tip.

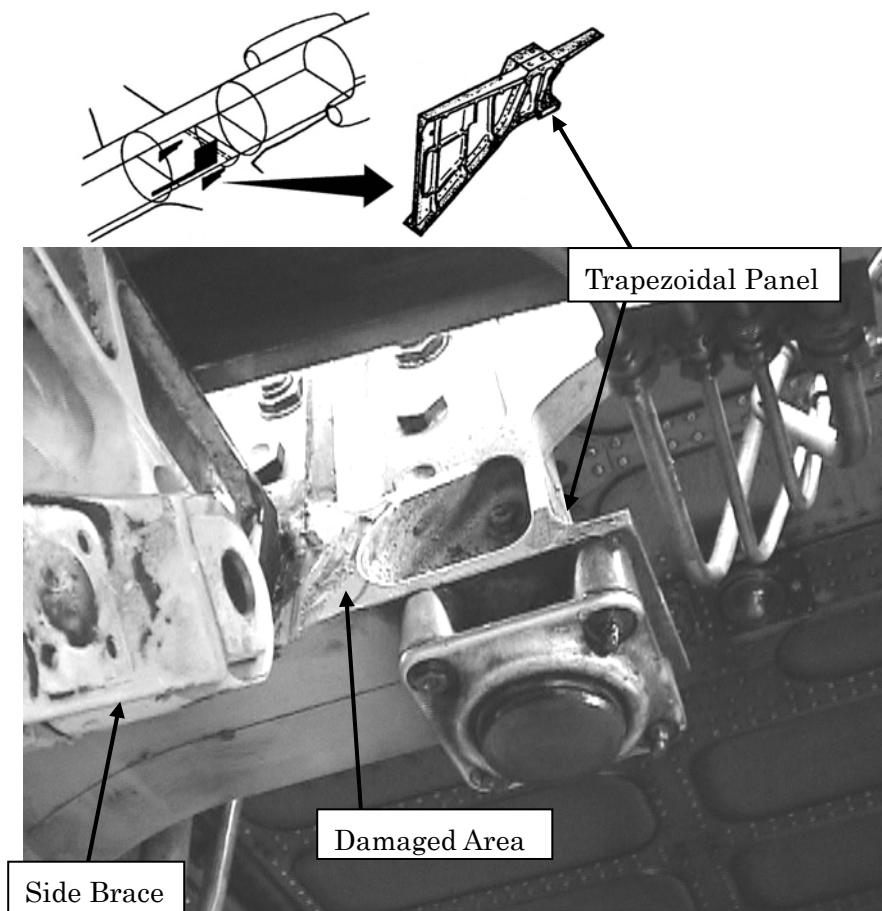
Photo 5 Damage of Trapezoidal Panel

Due to the lower portion of the cylinder being dragged along, the side brace was pulled aft-wards, and the trapezoidal panel structural component was damaged. Further, the left wing flap and the fillet between the wing and fuselage were damaged.

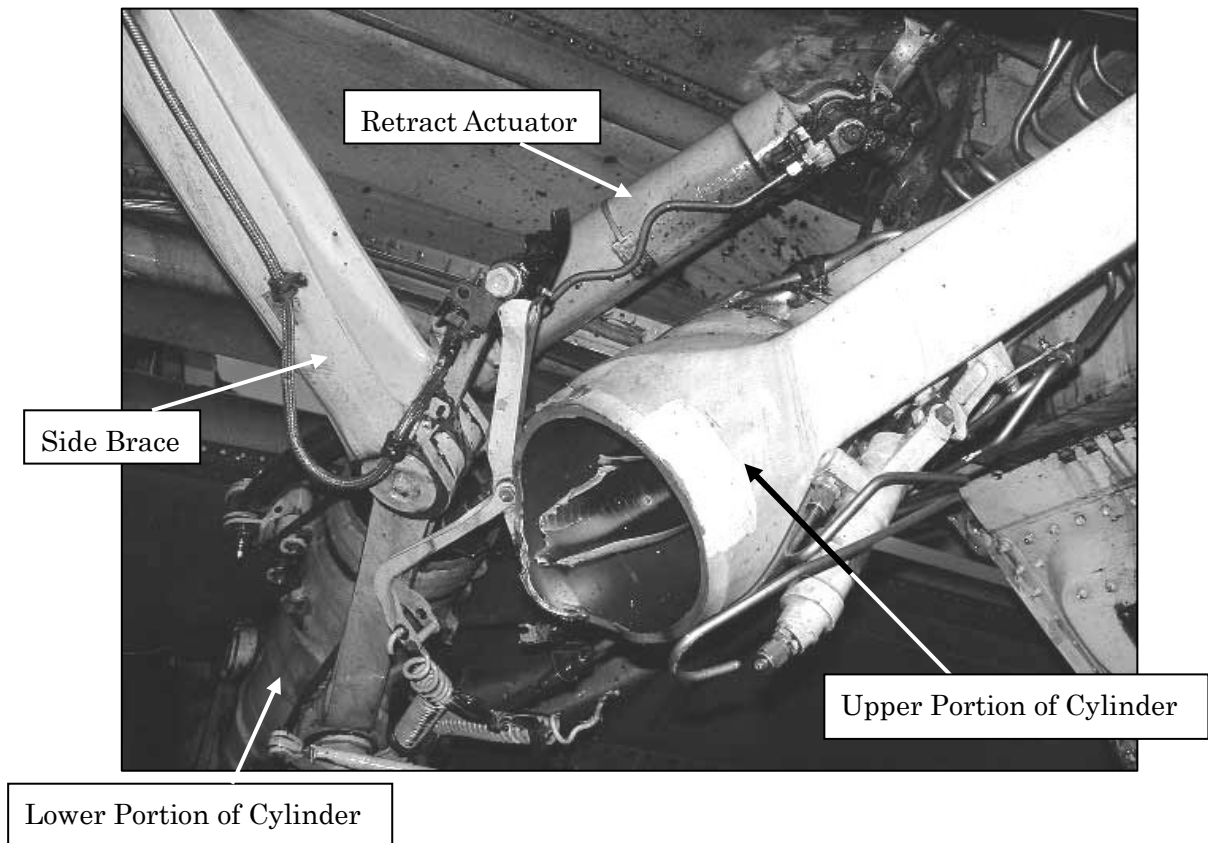
Photo 6 Fractured of L/H MLG Cylinder

The left MLG shock strut cylinder was broken into two pieces by a circumferential fracture approximately 21 inches from its top end (approximately 30 inches from the bottom end). The lower portion of the cylinder did not separate from the aircraft but was retained by the retraction actuator and side brace, and was pulled along by them.

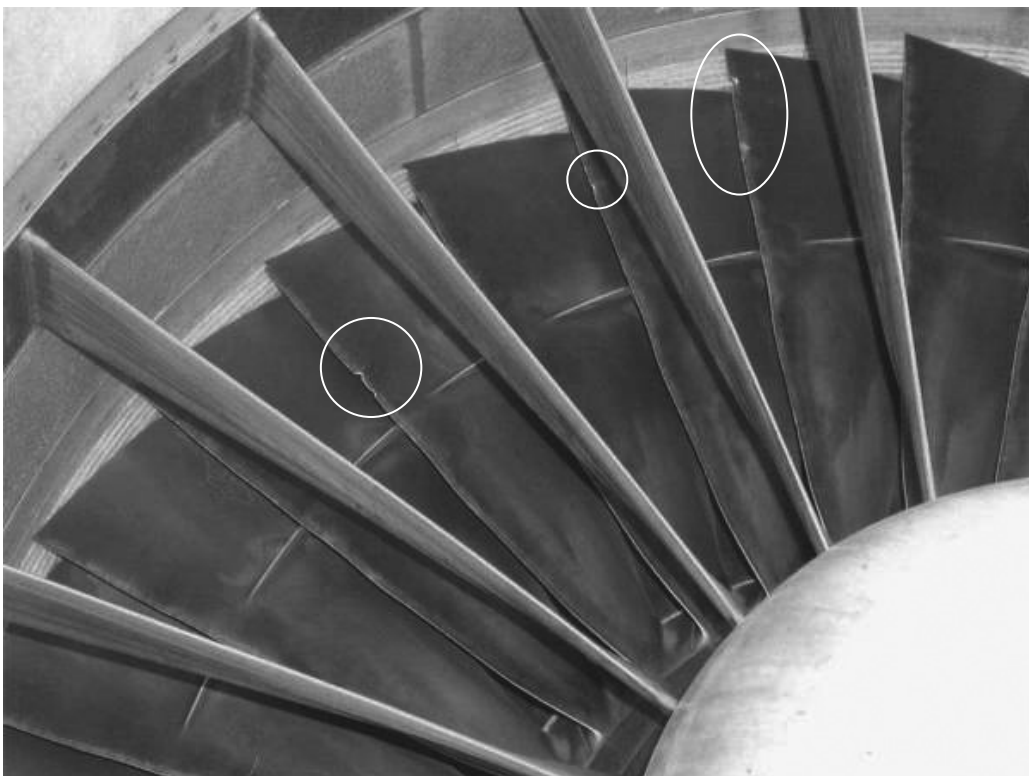
Photo 7 Fan Blade Damages

Dents and nicks were found in the leading edges of several fan blades of the left engine.

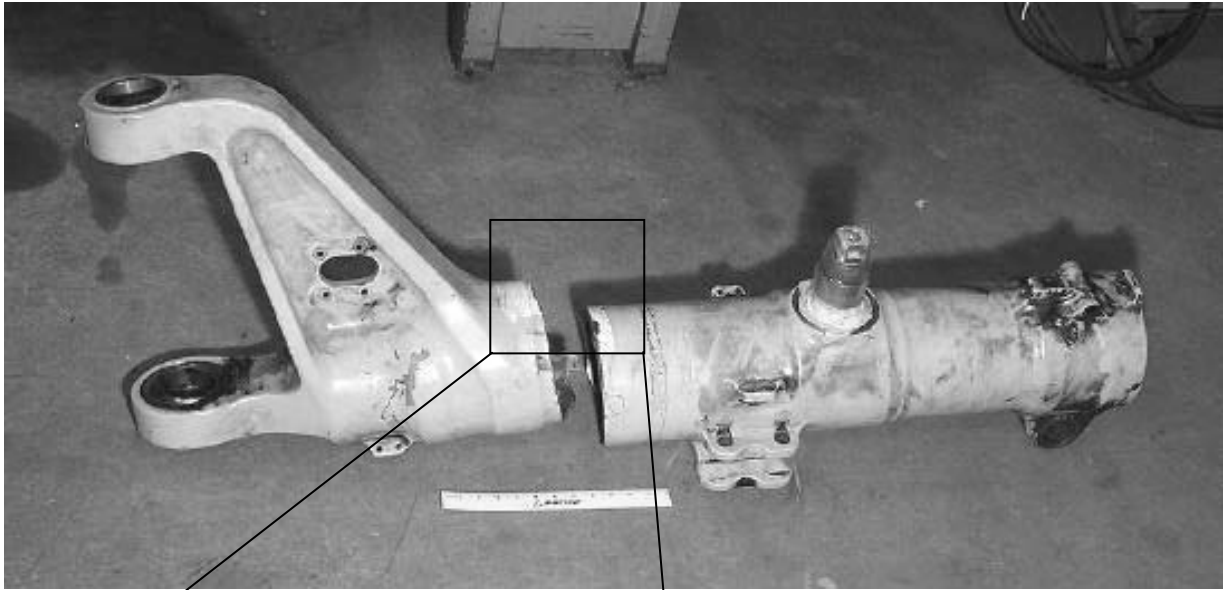
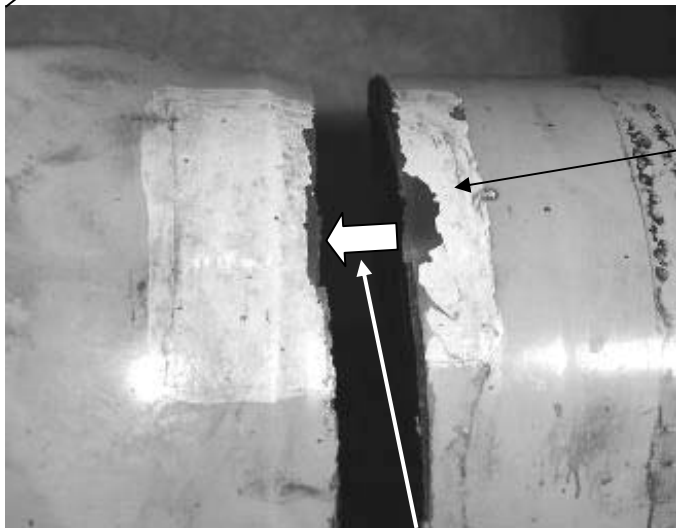
Photo 8 Fractured Cylinder

The MLG cylinder was fractured at the fuse section ^{*3} around 21 inches below the top of the cylinder. Fatigue origins were found more than five locations on the fracture surface.

Painted portion after performed NDI by the company

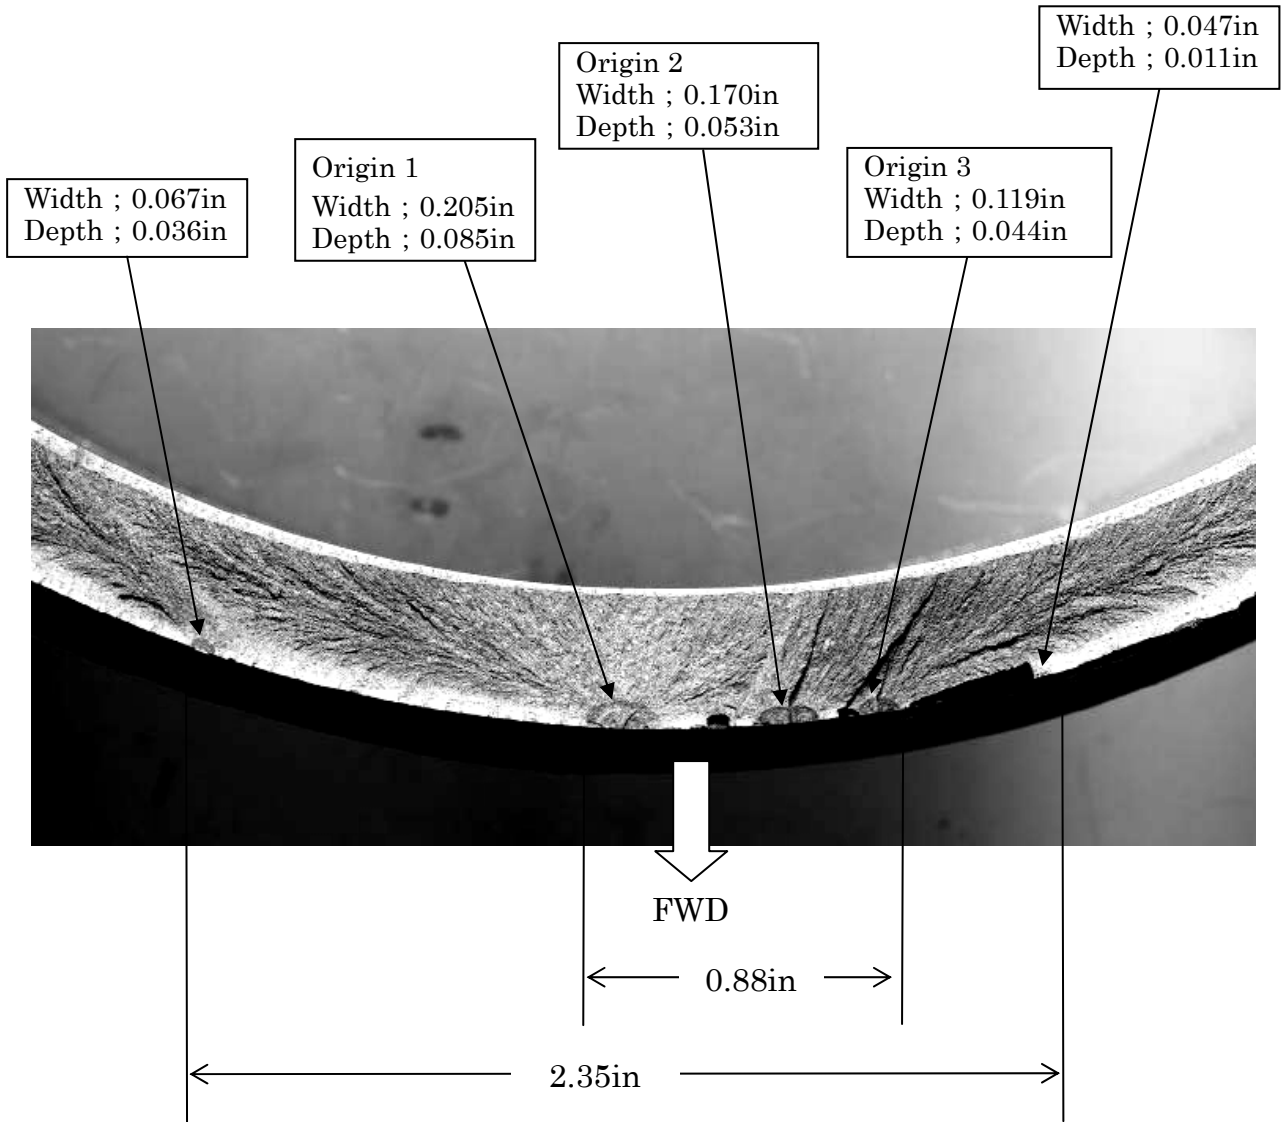
Large five fatigue origins within the fatigue origins mentioned above were found along a circumferential length of 2.35 inches. Of these, three largest fatigue origins which were the origins of the collapse fracture were located along a circumferential length of around 0.88 inches. The largest of these three fatigue origins is referred to as Origin 1 in the following discussion. (See Photograph 9)

The Origin 1 was around 0.205 inches in width, and the total crack length of the five locations was around 0.61 inches. The depth of the Origin 1 was reached 0.085 inches from the cylinder surface, and it was deepest fatigue trace than other traces.

(The observation from the direction of the bold arrow shown in photograph 8)

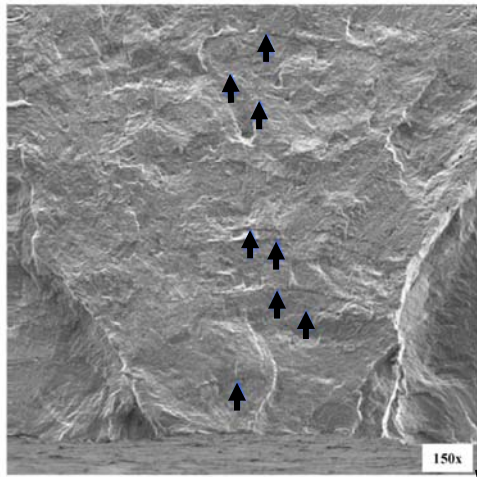
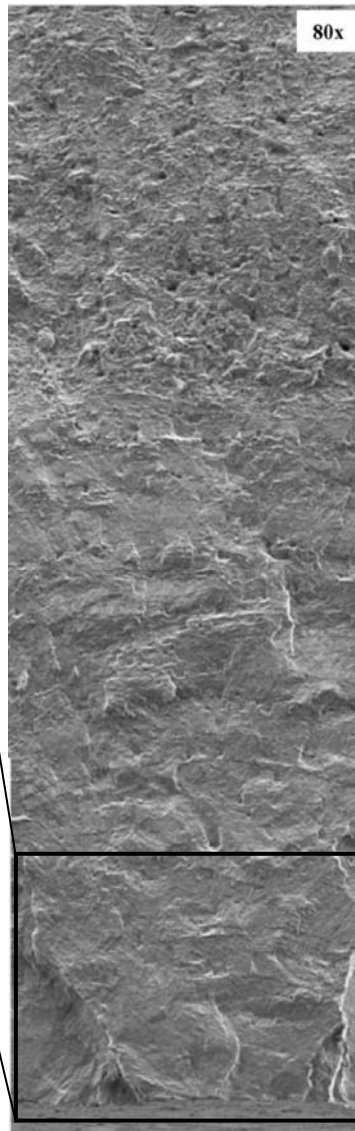
Photo 10 SEM Fractograph of Origin 1

As a result of SEM inspection of the Origin 1, fatigue striations were found that showed a fatigue crack propagated within a depth of 0.050 inches of the cylinder surface, but no evidence of dimple ^{*5} rupture was found in this depth range.

Between depths of 0.050–0.085 inches, the propagation of a crack had resulted in the cylinder material becoming more susceptible to cracking, and the primary crack front displayed increasingly wide bands of dimple rupture only, indicating momentary periods of crack instability.

Beyond depths of 0.085 inches, the remaining rapid fracture displayed a predominant dimple mode of rupture. (See Photograph 10)

The arrow shows irregularly spaced bands found within the stable fatigue.

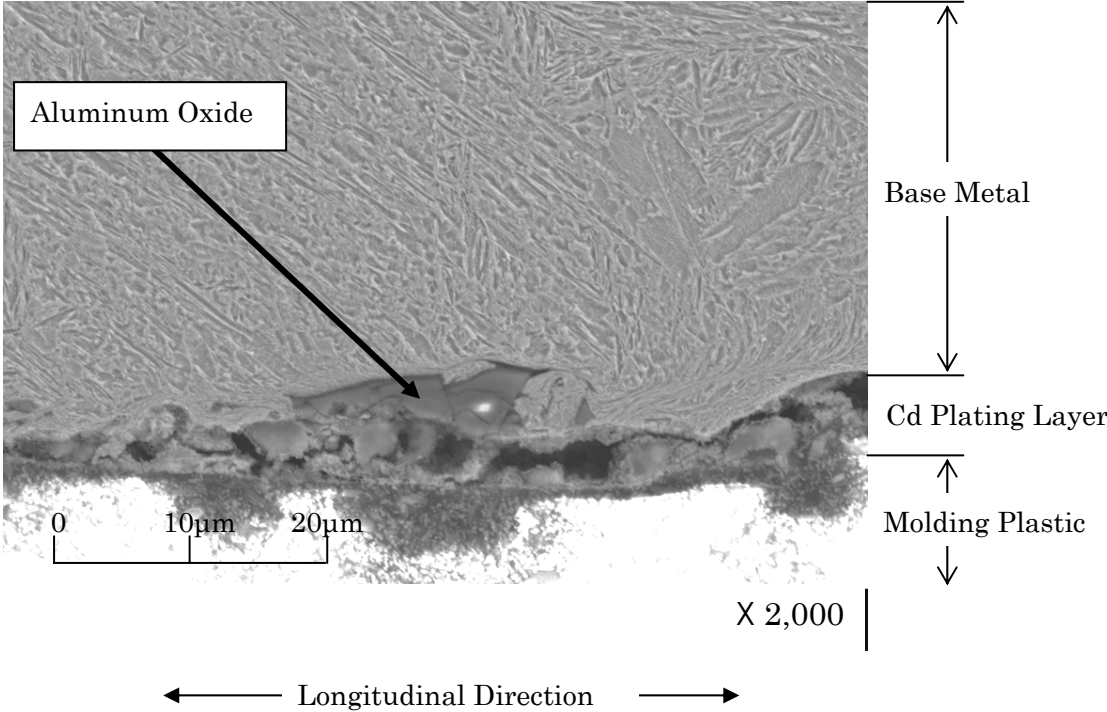
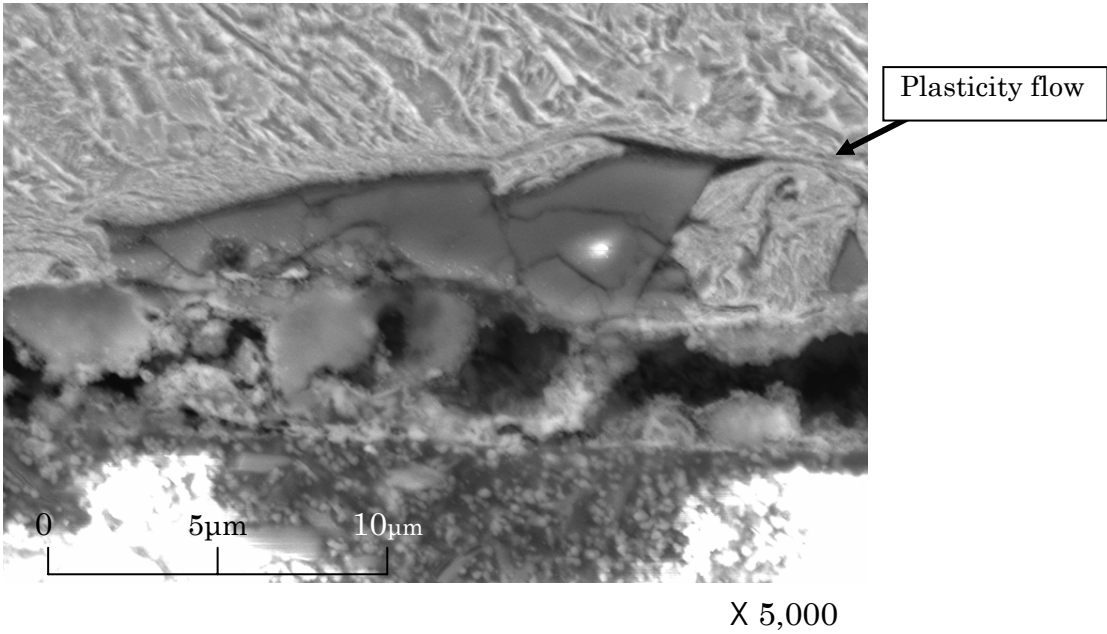
Trapped Aluminum Oxide in the Cylinder Surface

Apart from the above roughness and flaw, other portion of the cylinder than the fractured surface was cut longitudinally and the cut surface was polished, and the material near the surface was examined. The examination found roughness of the surface and grains of aluminum oxide used in grit-blast were found embedded in the surface. Also, plastic deformation (plastic flow) features were found where the grit of aluminum oxide embedded on the surface.

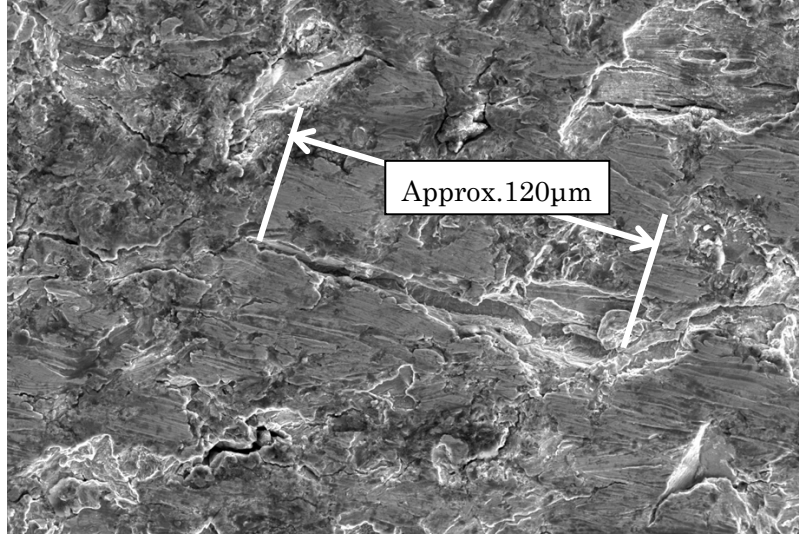
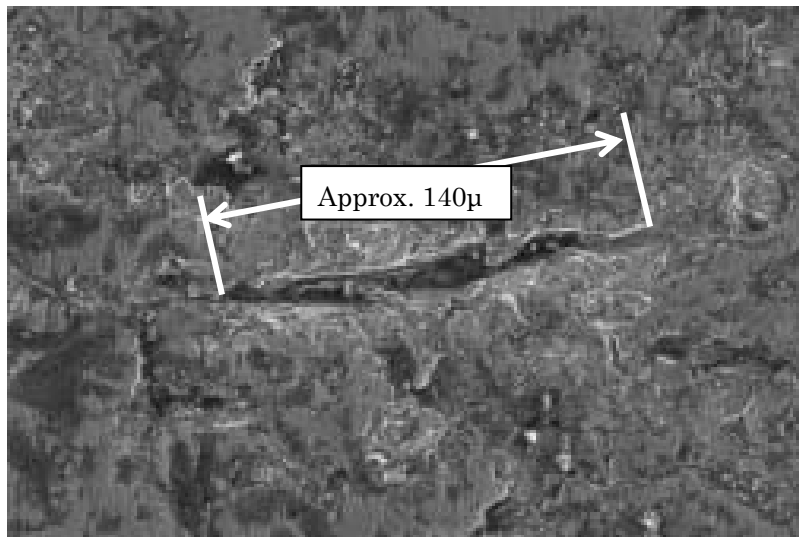
Photo 12 Surface Flaw of Cylinder

As a result of the observation around the fractured cylinder surface after Ni-Cd plating was stripped, roughness and flaw were found on the surface. Also, there were similar flaw on the surface of the lower part of the cylinder as described in (5) below although the number of flaw is small compared with the area around the fractured surface.

Surface Flaw of Rupture Area X 500

Surface Flaw of Cylinder Lower Portion X 500
