**AIRCRAFT ACCIDENT  
INVESTIGATION REPORT**

**ORIENTAL AIR BRIDGE CO., LTD.  
J A 8 4 5 A**

**DAMAGE TO AIRFRAME FROM TAIL STRIKE**  
**ORIENTAL AIR BRIDGE CO., LTD.**  
**BOMBARDIER DHC-8-402, JA845A**  
**FUKUE AIRPORT, NAGASAKI PREFECTURE, JAPAN**  
**AT 09:24:32, OCTOBER 23, 2020**

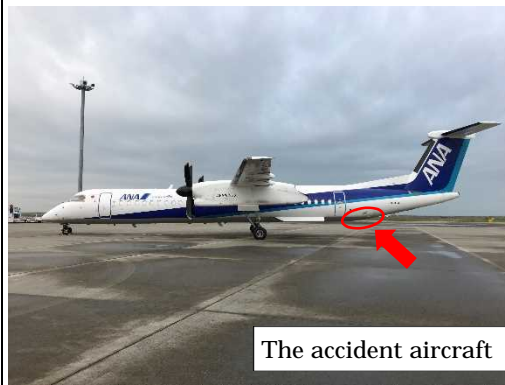
Figure 4 Location of damage to the airframe damage

Skin abrasion (including cracks) was found in an area about the overall length about 2.1 meters and a maximum of about 0.6 meter wide on the lower aft fuselage. The partial structural members inside this part were damaged and deformed.

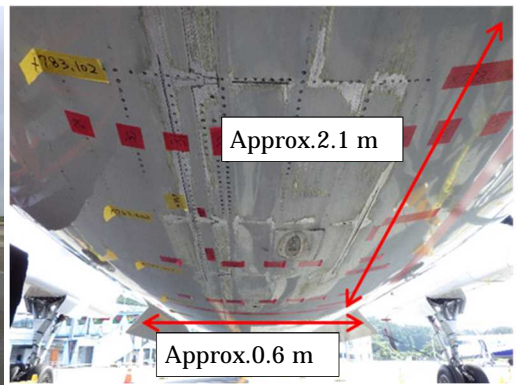
Figure 5 Damage to lower aft part of the airframe (viewing the fuselage from aft to forward)

In this accident, the JTSA concludes that the probable cause of this accident was that the Aircraft was most likely in an excessive nose-up attitude and the lower side of its tail contacted the runway because the captain continued the nose-up operation until moments before the touchdown since the Aircraft did not stop descending due to the airspeed reduction caused by turbulence during the landing flare.

- i. In order to take advantage of the PM's monitoring and assertion, the Company revised the AOR (Airplane Operations Reference) and specified that the PM should call, "PITCH" when the pitch angle exceeds 5° after passing the runway threshold.
- ii. The Company analyzed the meteorological characteristics at remote islands airports where its service is provided and documented precautions for aircraft operations.
- iii. In regard to flight operations for the same type of aircraft, the Company documented precautions for landing and approaching including technological considerations.

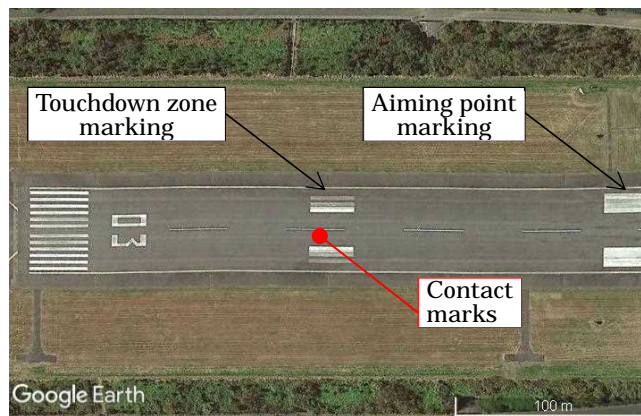
Figure 6 Location of contact marks on runway

Fukue Airport was at 251 ft elevation and has a runway 03/21 (magnetic bearing 033°/ 213° with a length of 2,000 m and a width of 45 m). The on-site investigation found contact marks in an area about 7.7 meters long and a maximum of about 0.6 meter wide from a point about 152 meters from the threshold of Runway 03. In addition, judging from the position relation between the tire marks of the Aircraft and the contact marks, it was found that the Aircraft touched the ground in the following order with slight time difference, although those parts touched down almost simultaneously.

1. left main wheel
2. right main wheel and
3. lower surface of the fuselage

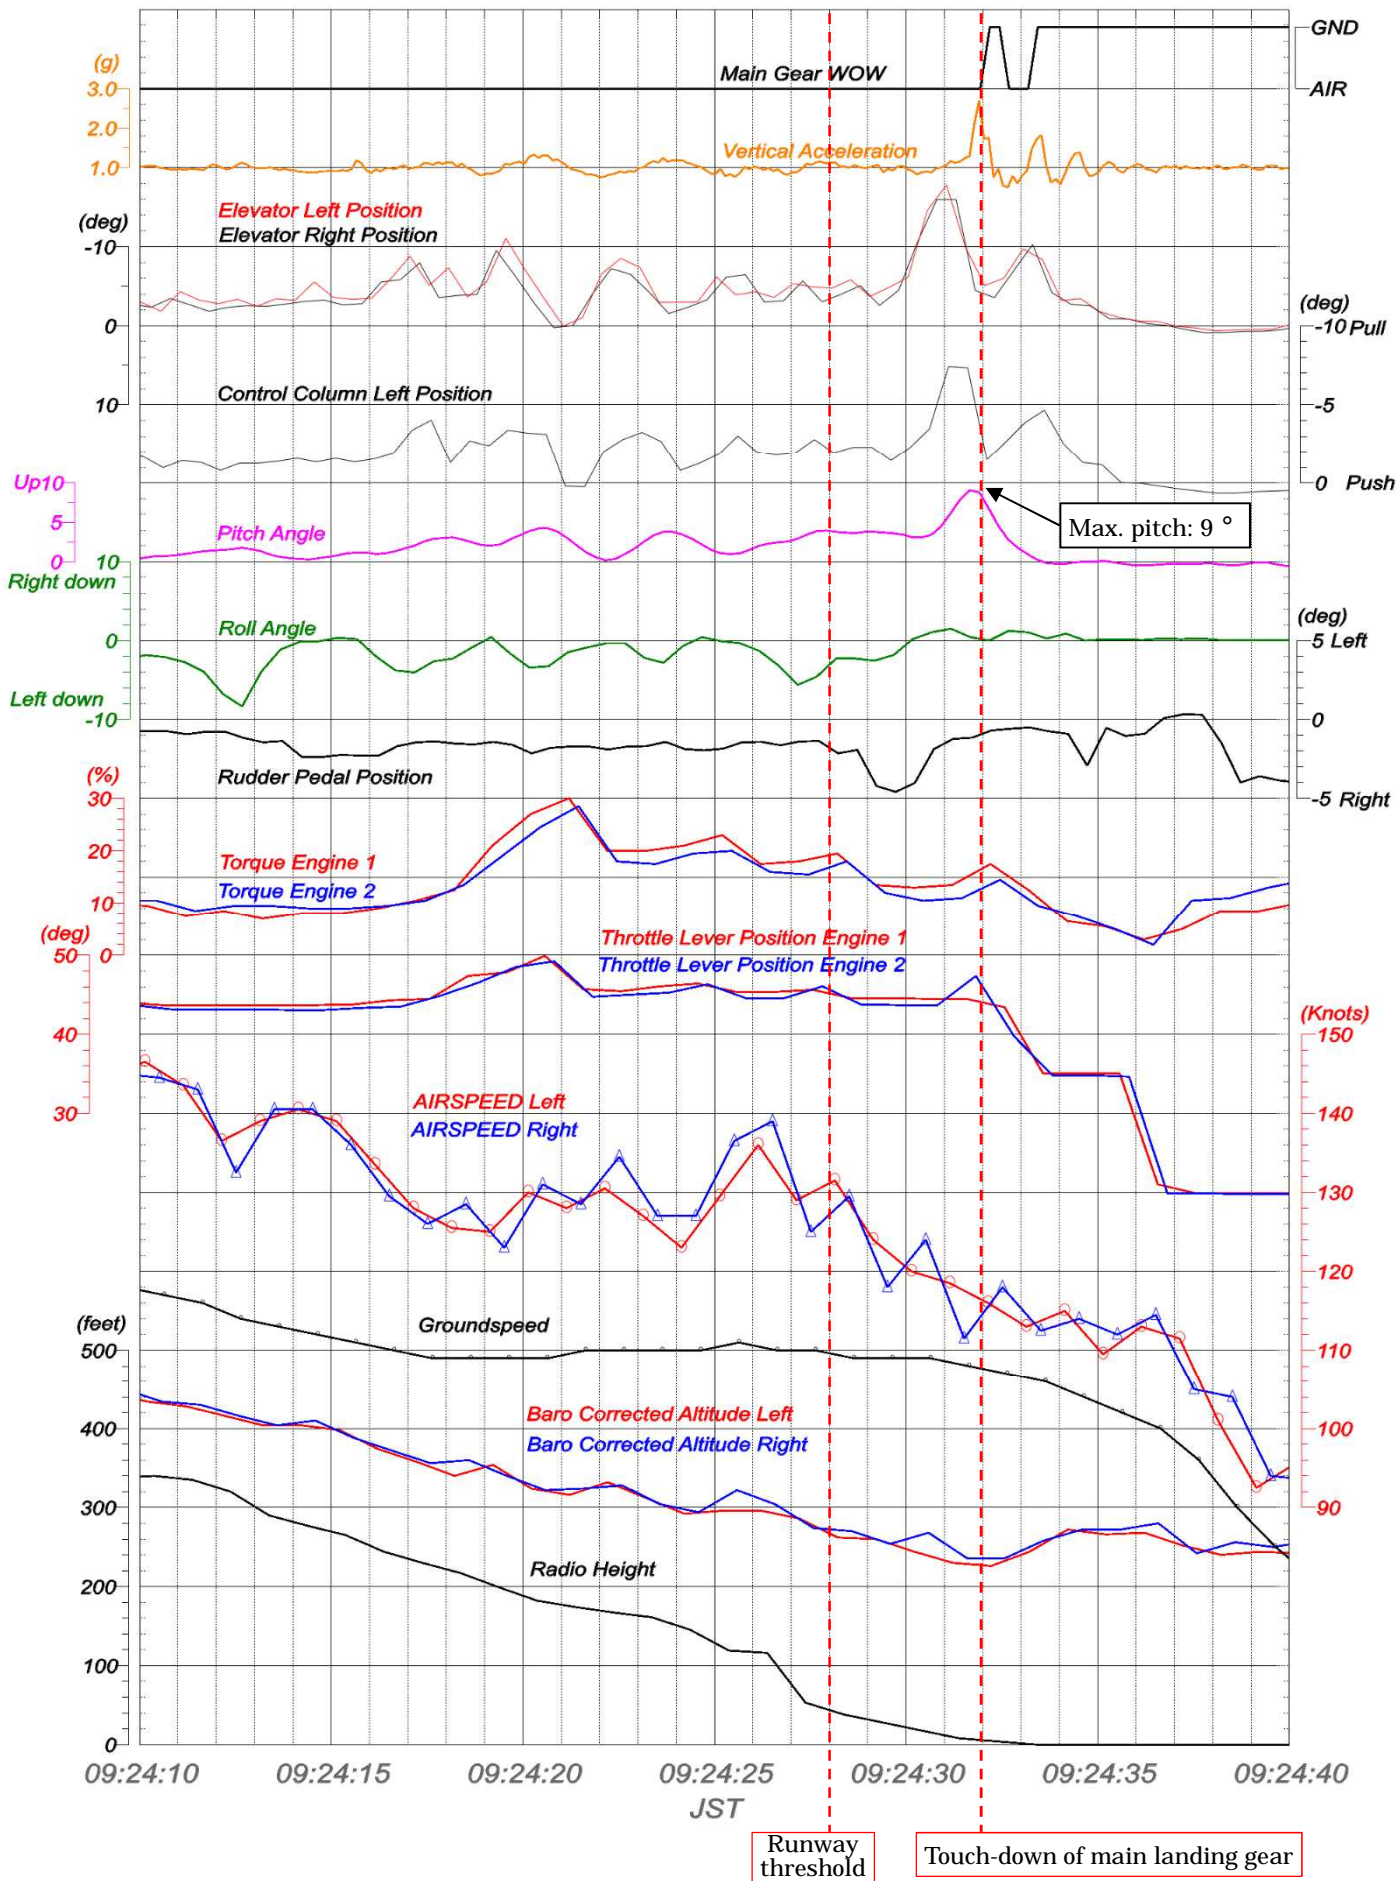
Appended Figure 1: FDR Records (09:24:10 to 09:24:40)

According to the FDR records (Figure 1), the engine torque dropped from about 19 to 12 % after the Aircraft passed the runway threshold. And the airspeed in the left seat (captain's side) was 131 kt ( $V_{REF} + 12$  kt) when it passed the runway threshold but decreased to 116 kt ( $V_{REF} - 3$  kt) at the time of touchdown. As the airspeed of the Aircraft dropped 15 kt in speed in the left seat and 11 kt in the right seat for four seconds from when the Aircraft reached the runway threshold to when it touched down, the airspeed decreased most likely at the deceleration rate of about 3 kt/sec from when the Aircraft passed the runway threshold to when it touched down. This airspeed reduction was most likely caused by the decrease in headwind component because the change in ground speed was small. However, the deceleration rate of about 3 kt/sec was too large for the speed change after passing the runway threshold, therefore, it is highly probable that the Aircraft was flaring while greatly decreasing the airspeed.

Most likely the lift of the Aircraft decreased as the airspeed decreased, and therefore, probably the control column input during flare operations was not enough to stop descent. For this reason, it is probable that as the captain continued to pull the control column to stop the descent, the Aircraft was in an excessive nose-up attitude with the pitch angle reaching a maximum value of 9° immediately before touchdown, the Aircraft touched down before stopping descent, and the lower side of its tail contacted the runway.
