**AIRCRAFT SERIOUS INCIDENT
INVESTIGATION REPORT**

JAPAN AIR COMMUTER

J A 8 4 8 C

**JAPAN AIR COMMUTER CO., LTD.
BOMBARDIER DHC-8-402, JA848C
ON RUNWAY A AT OSAKA INTERNATIONAL AIRPORT, JAPAN
AT 16:27 JST, AUGUST 12, 2008**

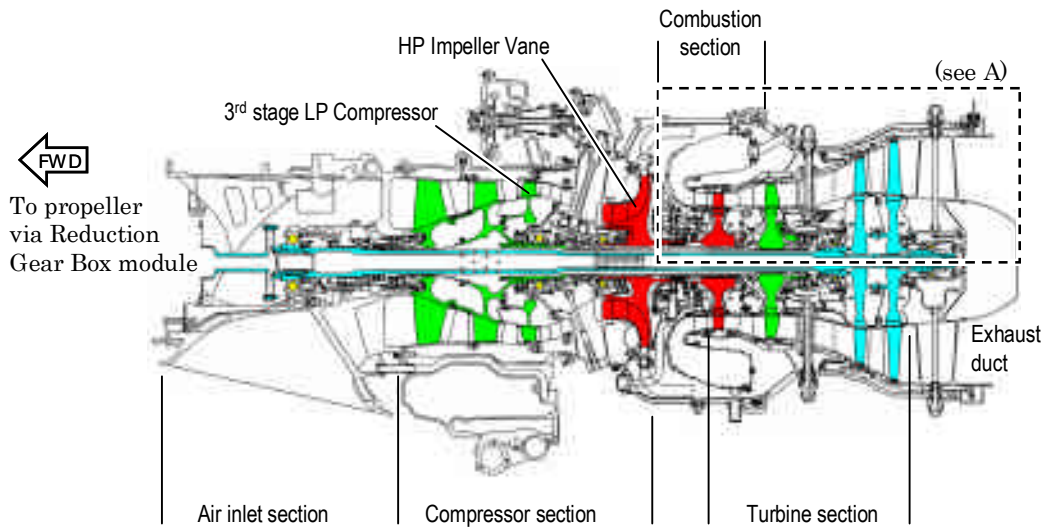
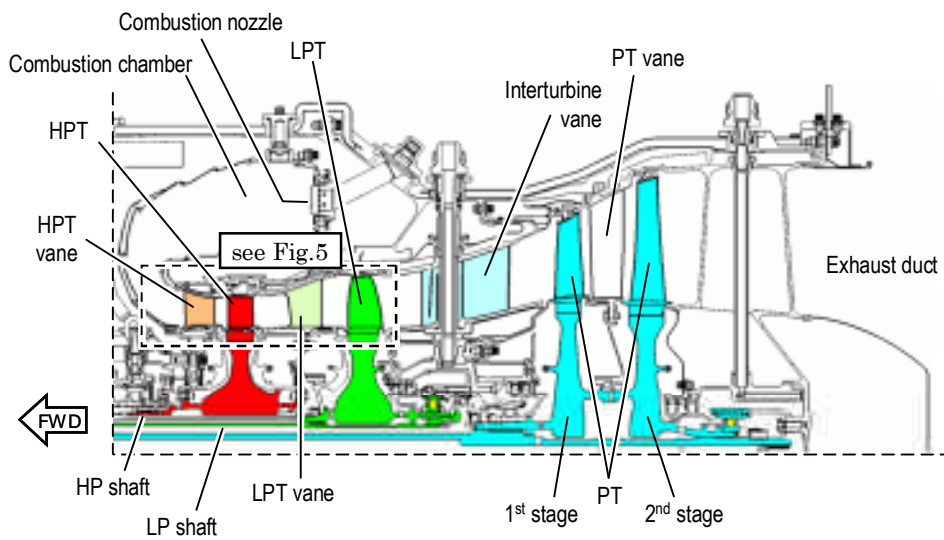
Figure 4 PW150A Engine

- (1) The external appearance of the engine case did not show anything abnormal.
- (2) The compressor section had no special conditions suggesting any abnormalities. (See Figure 4.)

- (16) The HP shaft showed signs of rubbing against the LP shaft, but the inspection conducted after removal of the cold section showed no major rubbing damage. Light rubbing marks were found in the HP impeller vane exducer area and on the 3rd stage LP compressor blade tips. (See Figure 4.)

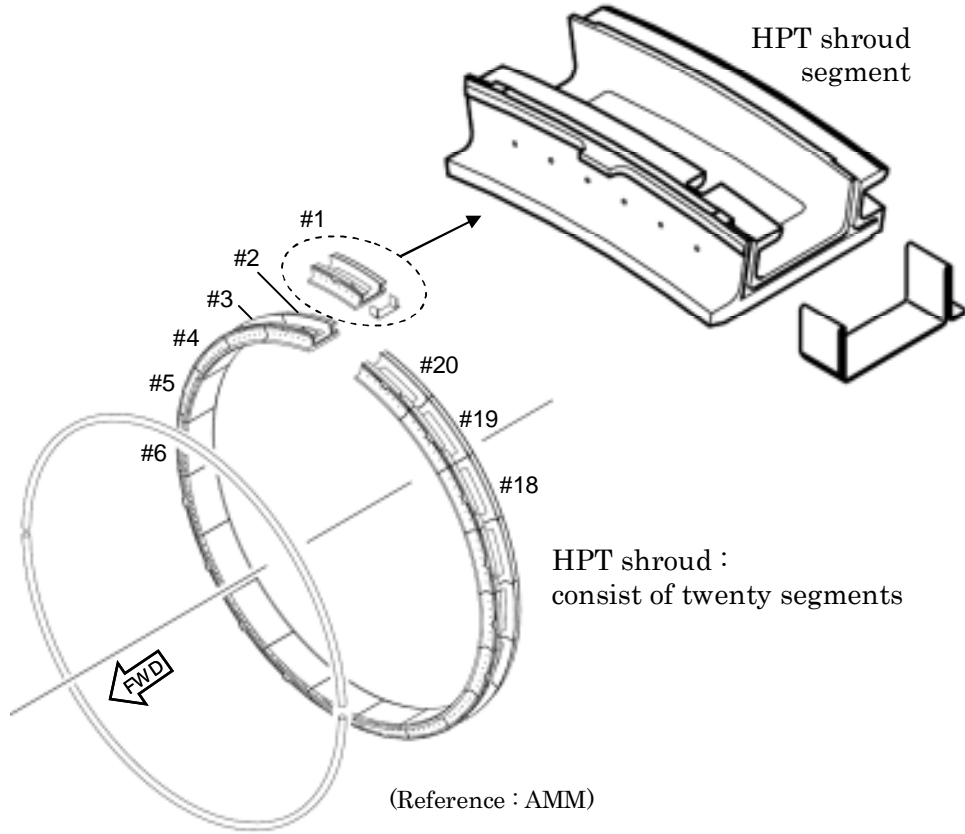
Figure 6 HPT Shroud Segment

- (6) Of a total of 20 HPT shroud segments, those located approximately between the 11 o'clock^{*6} and 4 o'clock positions were successively fractured. (See Figure 6 and Photo 4.)

- (10) The HPT shroud had four consecutive segments (#20, #1, #2 and #3) completely burnt away. Two segments (#4 and #5) next to one end of these consecutive segments had their surfaces completely burnt away and the surfaces of two other segments (#19 and #6) were partially lost. (See Figure 6 and Photos 24, 25, 26.)

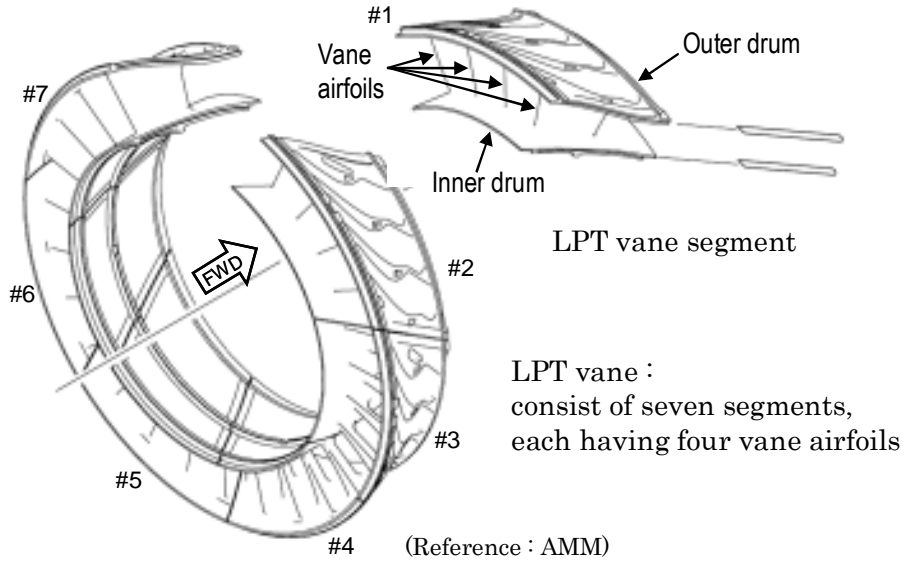
Figure 7 LPT Vane Segment

- (8) The LPT vane assembly showed severe heat distress in the area approximately between the 10 o'clock and 4 o'clock positions, while the vanes located between the 12 o'clock and 2 o'clock positions were completely burnt away. All four vane airfoils on the #2 LPT vane segment were missing and the inner drum had detached and fallen off. Three vane airfoils on the #1 LPT vane segment were missing but one vane airfoil remained on the segment with half of it lost due to heat erosion. The missing vane airfoil side of the #1 segment's inner drum was lifted towards the gas path. Two vane airfoils on the #3 LPT vane segment were missing due to heat erosion. (See Figure 7 and Photos 18, 19, 20.)

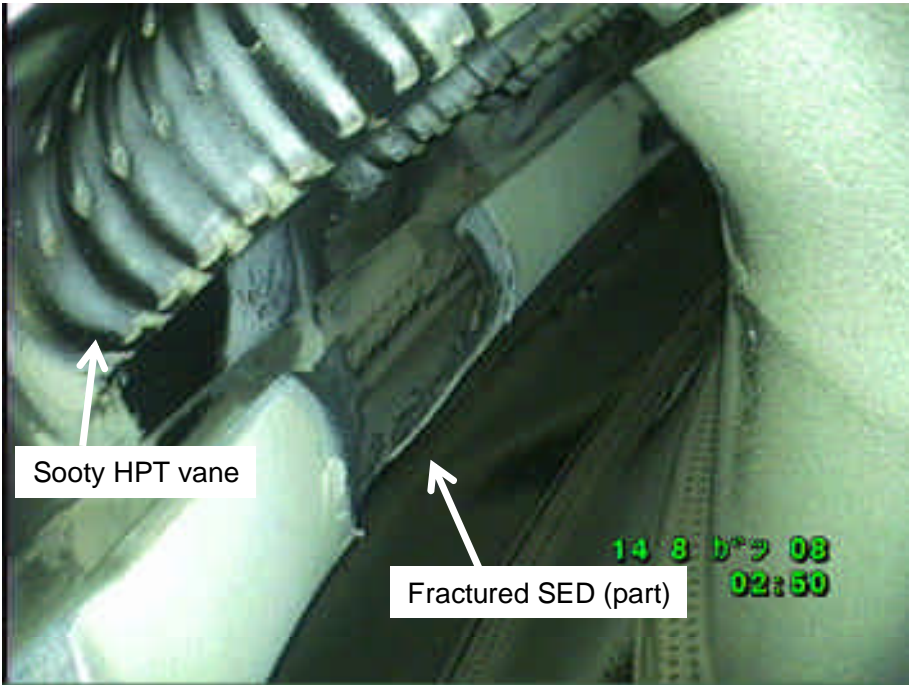
Photo 2 SED and HPT vane (BSI view)

- (3) The inside surface of the SED at the outlet of the combustion chambers were damaged in multiple locations. (See Figure 4 and Photo 2.)
- (4) The HPT vane showed no major damage but had black soot deposits on its surface. (See Figure 4 and Photo 2.)

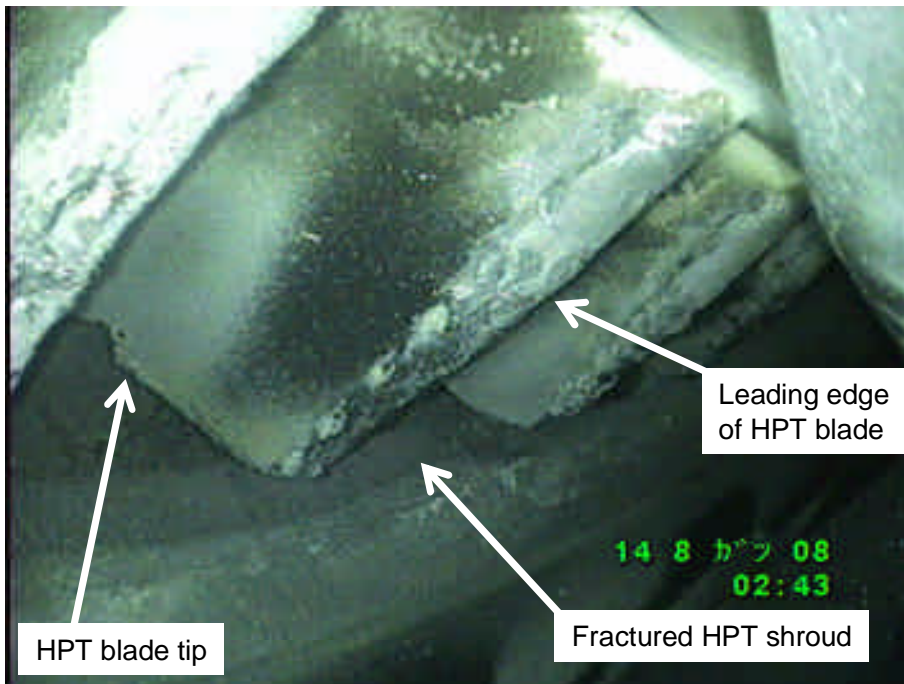
Photo 3 HPT blades (BSI view)

- (5) The blades on the entire circumference of the HPT showed no significantly fractured material even though there was apparent deterioration on their leading edge and tip. There were soot deposits on the downstream end surfaces of the HPT blades. (See Photos 3, 4, 5.)

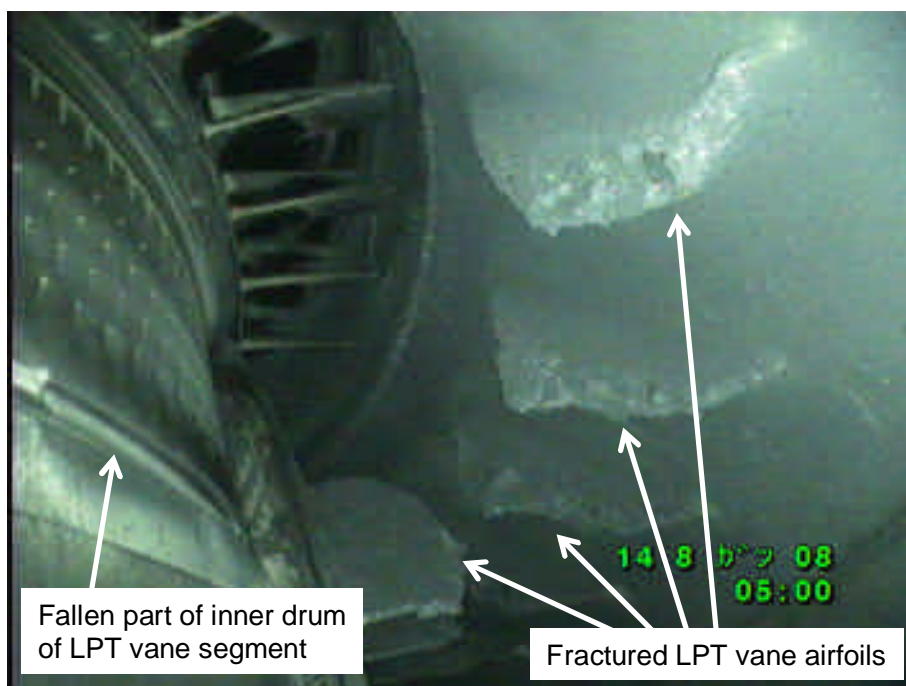
Photo 6 Fractured LPT vane airfoils (BSI view)

- (7) Of a total of seven LPT vane segments, one segment's inner drum had detached and fallen off. This inner drum was rhomboidal in shape and found near the 2 o'clock position with one sharp-angled edge against the LPT vane and the opposite edge against the inter-turbine vane. (See Figure 7 and Photos 5, 6, 9, 10, 20.)
All four vane airfoils of the LPT vane segment with the detached and fallen inner drum were fractured and multiple vane airfoils in the vicinity of the segment were significantly deteriorated. (See Photos 6, 7, 19, 20.)

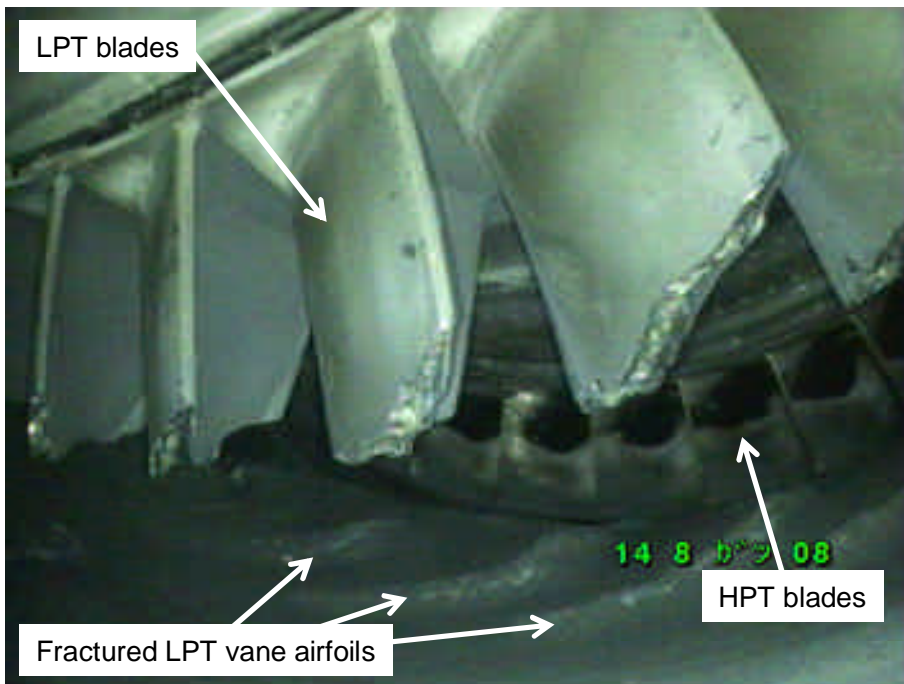
Photo 8 LPT blades (BSI view)

- (8) The outer halves of all the LPT blades had broken off to almost the same length on the entire circumference of the LPT, each at about the midpoint along the length. When rotated by hand, the LPT dragged against the detached and fallen inner drum of the LPT vane segment from time to time. (See Photo 8.)

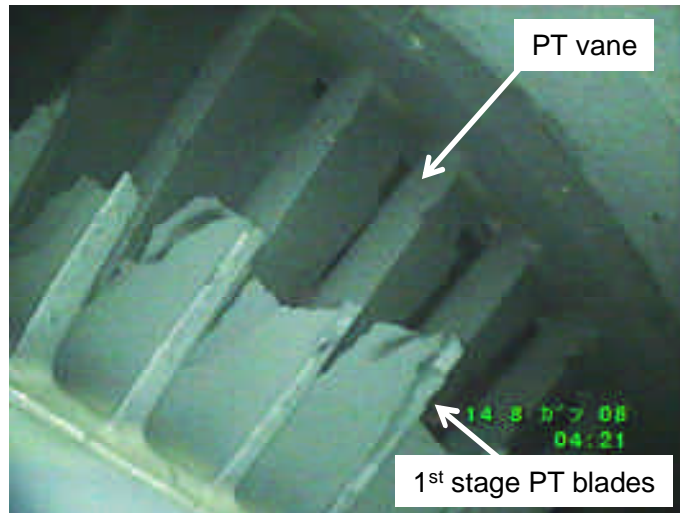
Photo 11 PT blades and PT vane airfoils (BSI view)

- (9) The blades on the entire circumference of the 1st and 2nd stage PTs had broken off at various heights. The PT vane airfoils also showed edge damages on the entire circumference. (See Photos 11, 12.)

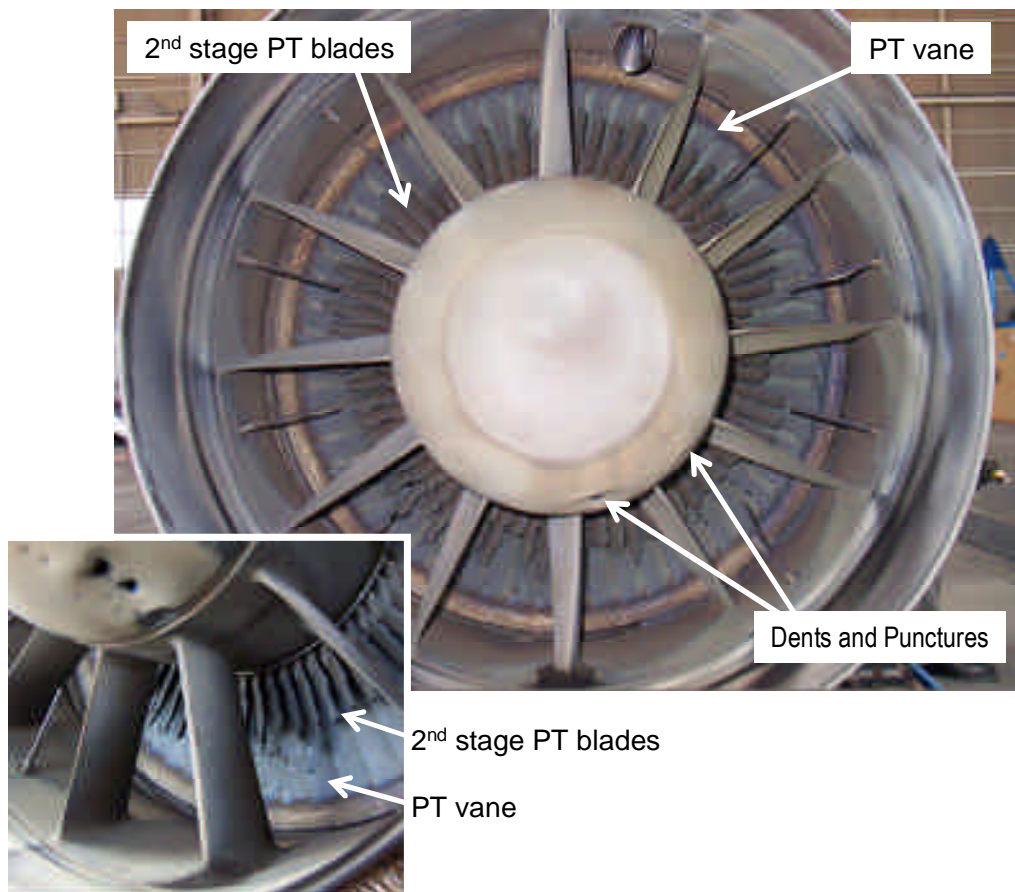
Photo 12 2nd stage PT blades

- (10) Multiple dents were found on the inner dome of the exhaust duct, some of which were punctured. (See Photo 12.)

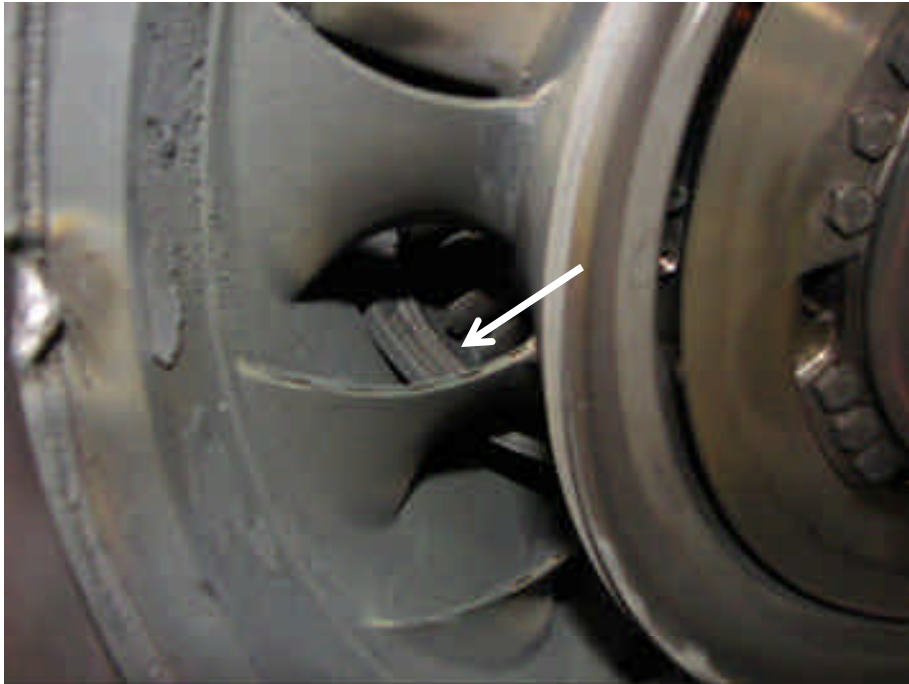
Photo 13 Inner drum of LPT vane segment trapped in inter-turbine vane

- (5) The trailing edge of the inter-turbine vane's outer drum had impact marks located approximately at the 6 o'clock to 9 o'clock positions. The inner drum from one of the LPT vane segments was found lodged in the inter-turbine vane. (See Photo 13.)

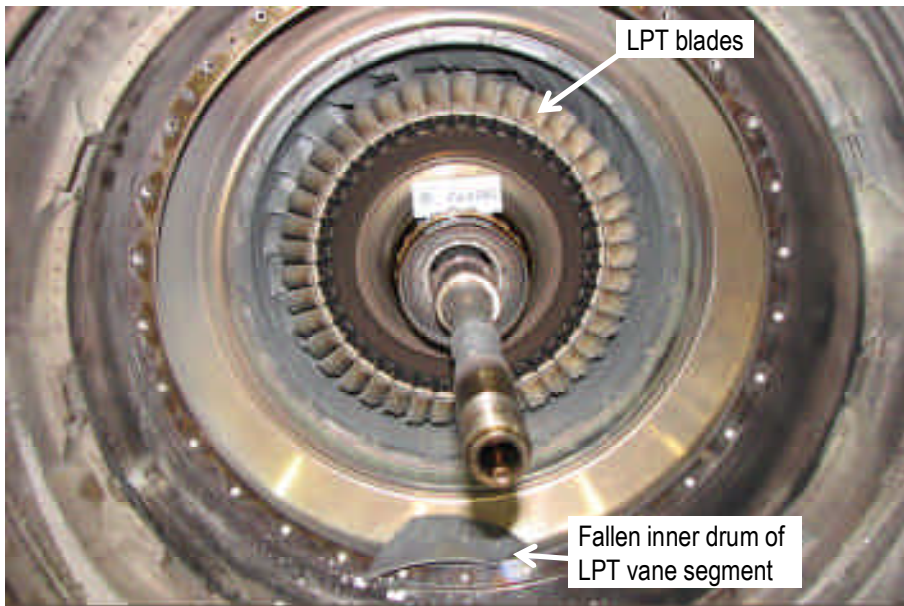
Photo 15 LPT disc

- (6) All of the LPT blades on the LPT disc assembly were found to be fractured at approximately midway along their length. The LPT blades had many impact dimples together with re-solidified molten material deposits. (See Photos 15, 16.)

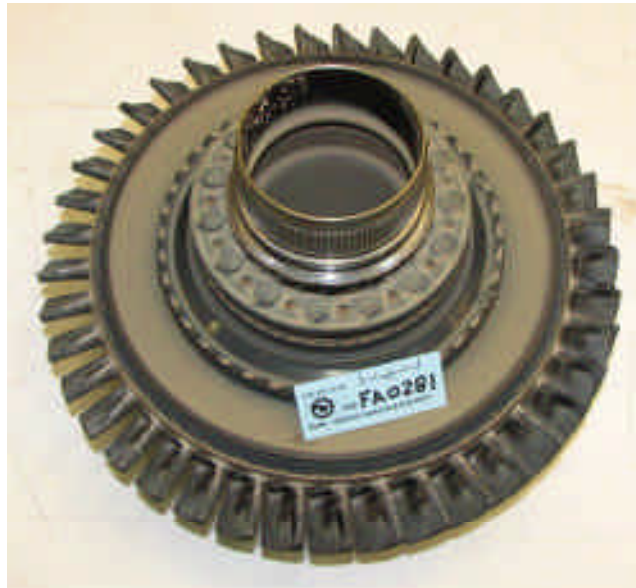
Photo 22 HPT disc – leading edge side

- (9) The HPT disc assembly had no visible damage on the blades when viewed from the trailing edge side. Due to damage to the HPT shroud segments, the HPT blade tip clearance was found to be excessive in the section located approximately between the 11 o'clock and 4 o'clock positions. (See Photo 21.) Removal of the HPT disc assembly revealed heat erosion on the leading edge of the blades, and the cooling cores at the tips of six of the blades were exposed. All of the HPT blades tips were heat eroded, oxidized and rubbed resulting in the exposure of their internal core passages to combustion gas at several locations. (See Photos 22, 23.)

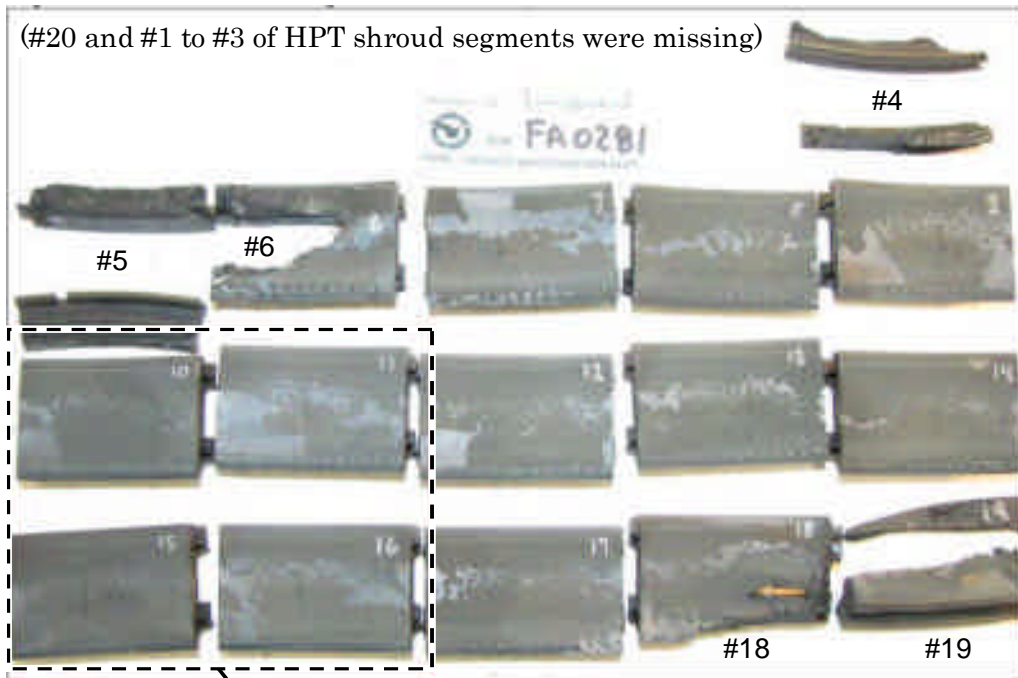
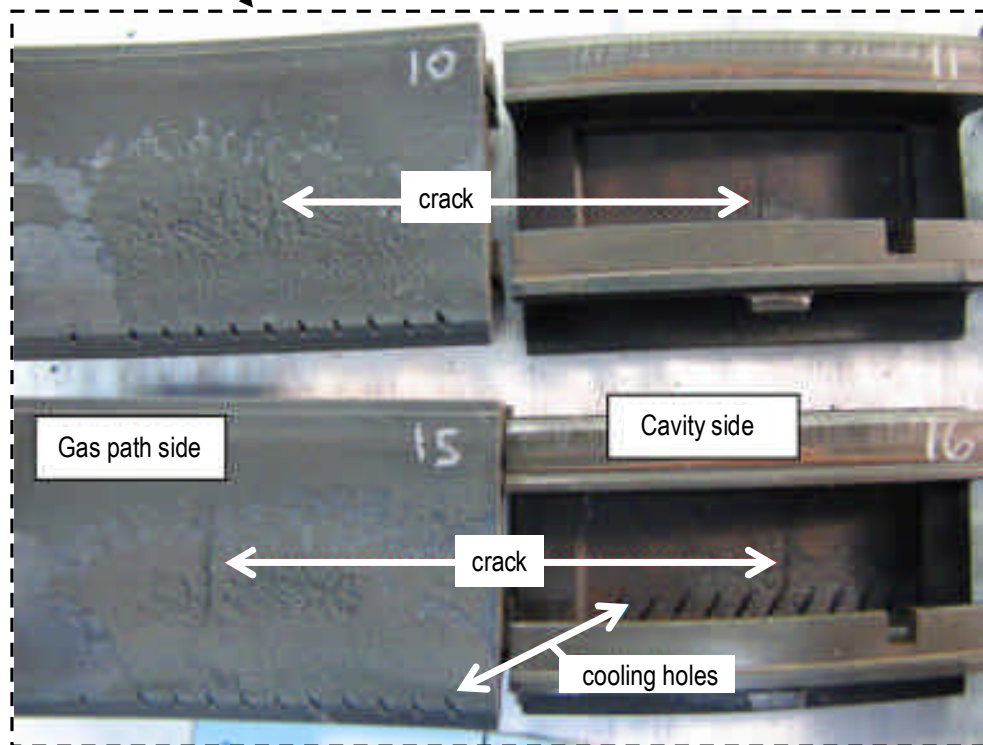
Photo 25 HPT shroud segments

The surface of the #18 HPT shroud segment showed a perforation, thus exposing the cooling cavity to the gas path, and the leading edge of the shroud was heat eroded. Some of the other HPT shroud segments showed axial cracking in the central section of the shroud surface. The turbine support case showed heat distress and cracks resulting from exposure to combustion gas. (See Figures 5, 6 and Photos 24, 25, 26.)
- (11) The HPT vane assembly was covered with soot, but the vane airfoils were free of major damage. The HPT vane support was burned on the outer side and covered with re-solidified molten material deposits at the location corresponding to the damaged section of the HPT shroud.

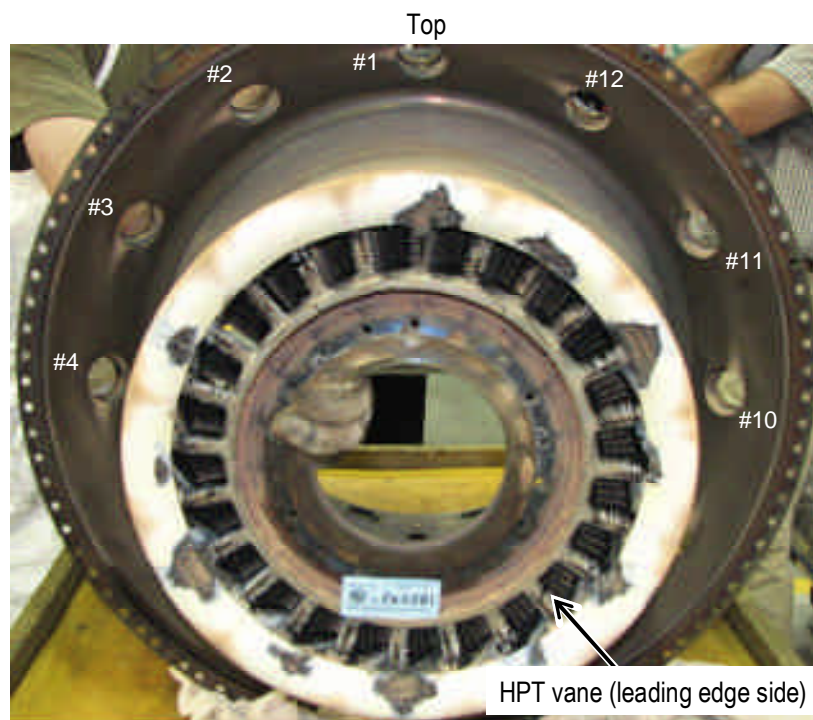
Photo 27 SED

- (12) The SED had missing heat shields at 11 locations due to heat distress, but it had no damage in the area at approximately the 1 o'clock position. (See Photo 27.)
